# Executive Summary

123 Sample Address, Your City, TX, 12345

# Engineer's Foundation Evaluation

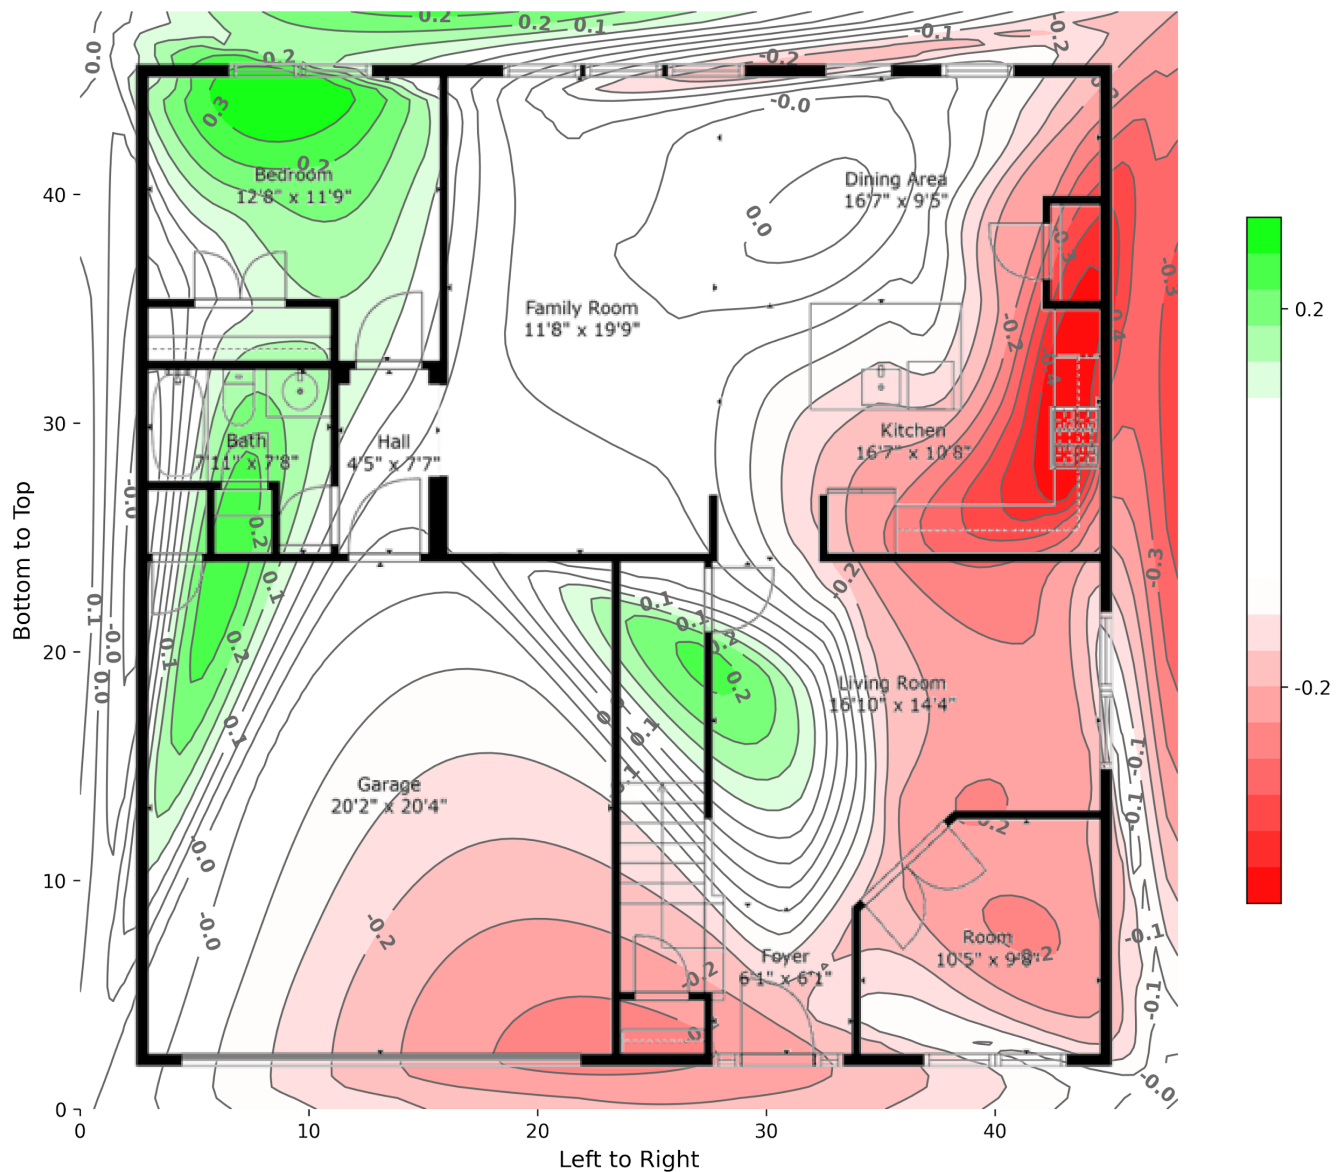
**Elevation Plot Difference Graphic (Figure F)**

A previous elevation plot completed in 1998 was available to use as a baseline of movement progression. As part of this evaluation, a contour mesh showing the elevation differences between the current contour mesh and the baseline was processed and is shown below.

The mesh contour graphic above in Figure F shows areas in red that are lower than the baseline elevation plot and areas of green that are higher than the baseline elevation plot (from the provided drawing completed in 1998). The darker the color (both red and green) the larger/smaller the elevation differences.
