TEXAS RESIDENTIAL INSPECTION

1234 Main Street
El Paso TX 79924

01/24/2026 9:00AM

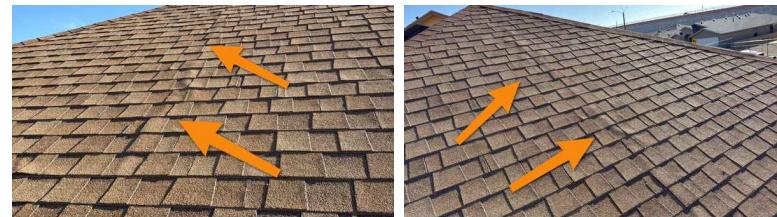
West

One or more of the shingles were observed to be lifting.

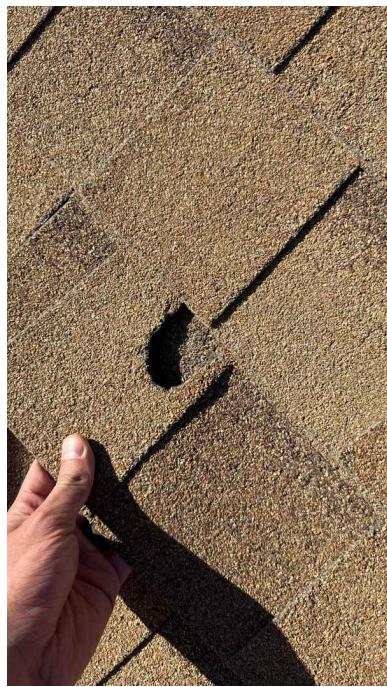
**2: Shingles - Damaged**

Damaged shingles were observed.

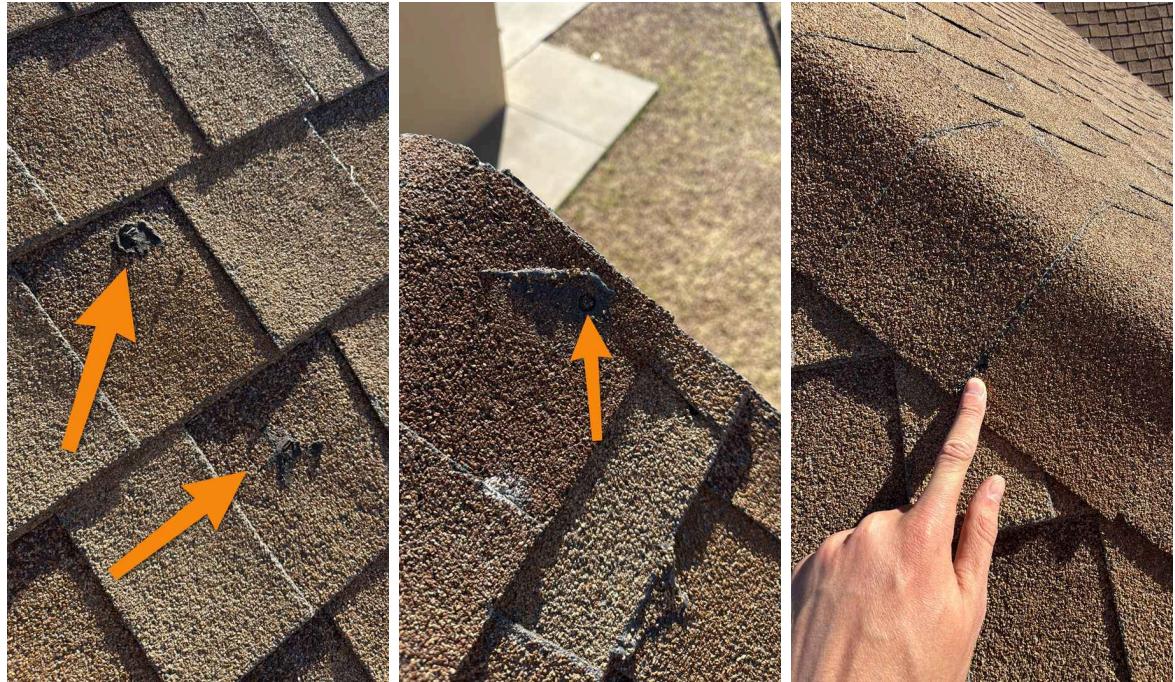
3: Shingles - Exposed Fastener(s)

Exposed fasteners were observed at the shingles in one or more locations and should be sealed to prevent water intrusion.

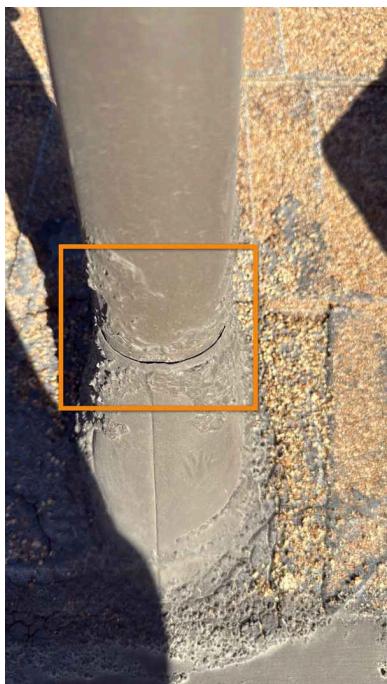
5: Flashing - Seal Plumbing Boots

One or more of the plumbing vent stack rubber boots needs to be sealed to prevent water intrusion at this location.

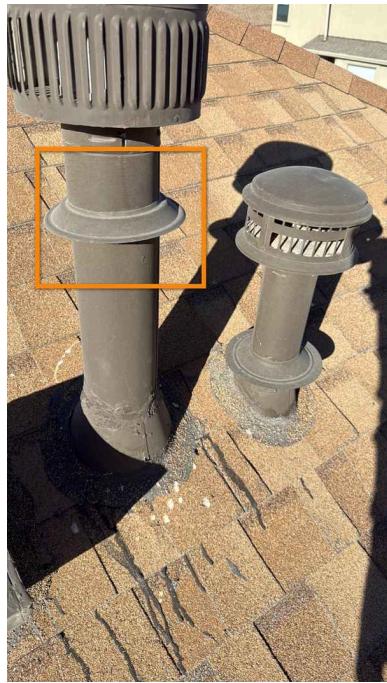
6: Flashing - Storm Collar Improper

The storm collar at the gas equipment roof level vent pipe is not properly installed and/or positioned over the roof jack. The storm collar needs to be properly positioned over the roof jack and sealed to help prevent water intrusion within the roof structure.

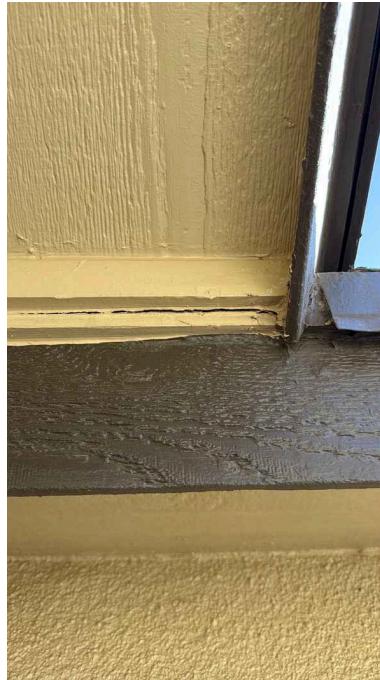
1: Wood Trim Damaged

The wood veneer trim has some deterioration or damage. The condition causing this should be identified and corrected. Recommend replacement of trim.

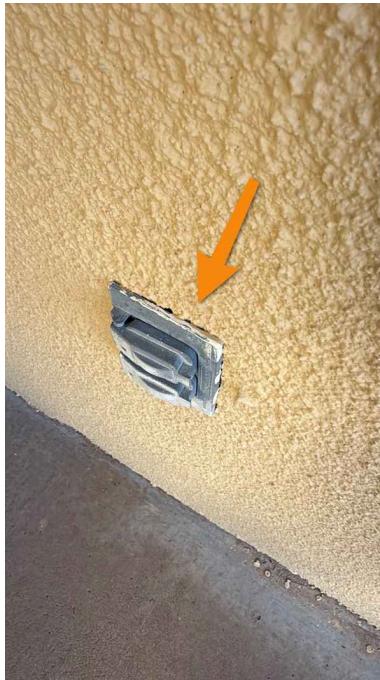
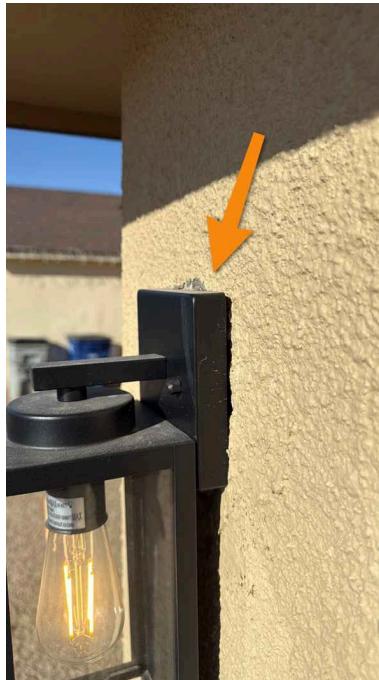
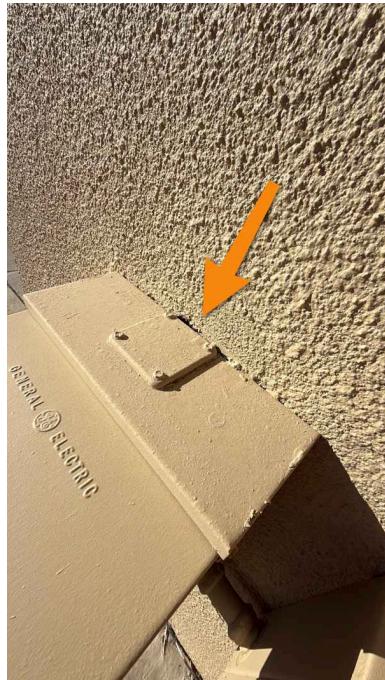
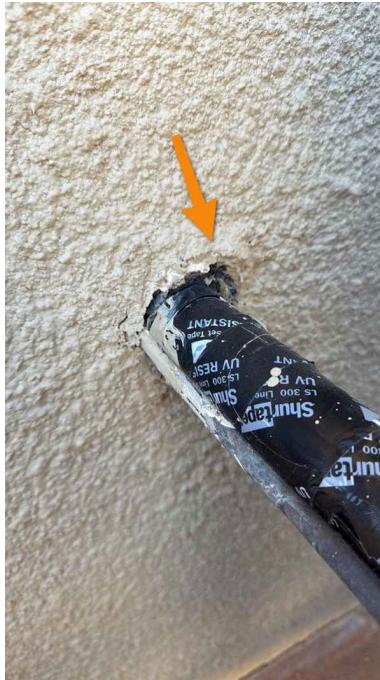
**2: Stucco - Lacks Sealant around Openings**

Failing or missing sealant was observed at and around the stucco type veneer/cladding and the wall opening interfaces (windows, doors, electrical outlets, plumbing outlets, etc.) This condition should be improved to help prevent water intrusion at these locations. It is recommended to use an industry approved NP1 sealant.

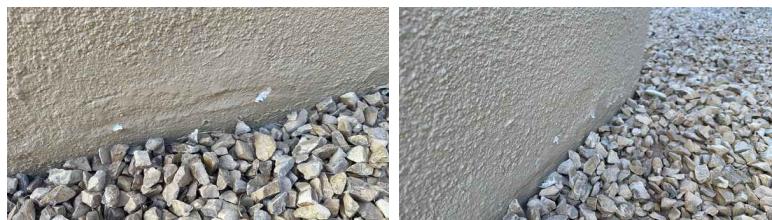
East

Peeling paint and soft stucco was observed. The cause of this condition should be further investigated and corrected as needed.

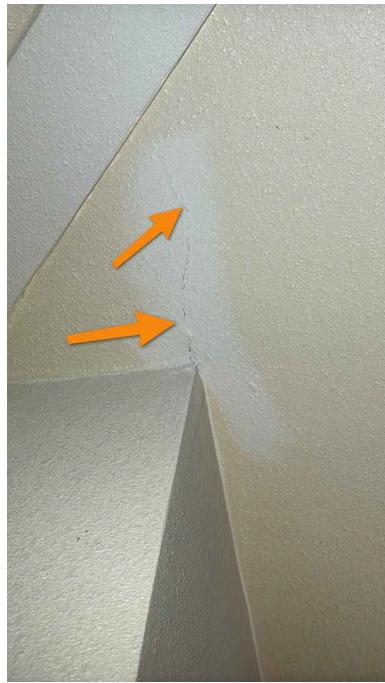
**F. Ceilings and Floors***Comments:***1: Ceiling - Joint Cracks**

Ceiling joint cracks were observed. This is not indicative of major structural movement.

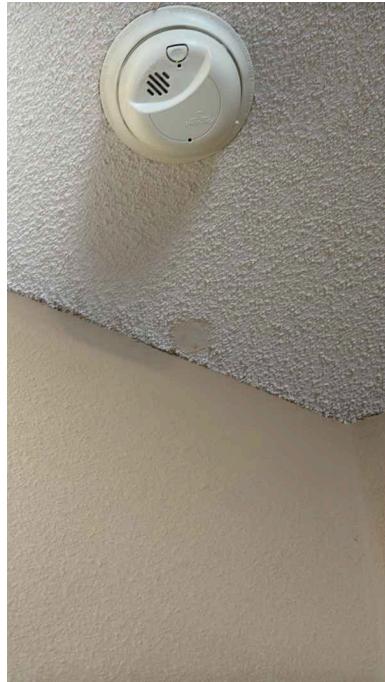
2: Ceiling - Texture Damaged

The ceiling texture has some deterioration and/or damage.

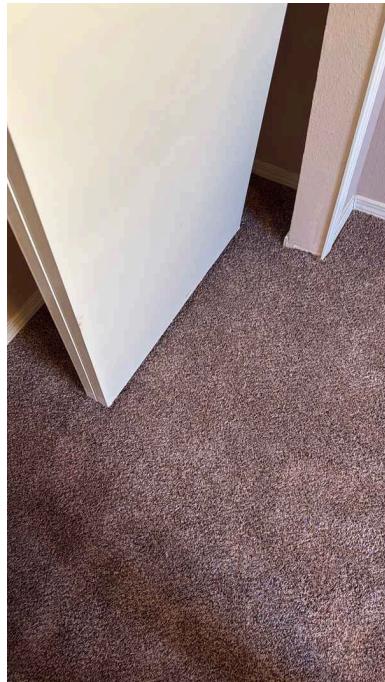
1: Door - Hardware Missing

The door hardware is missing.

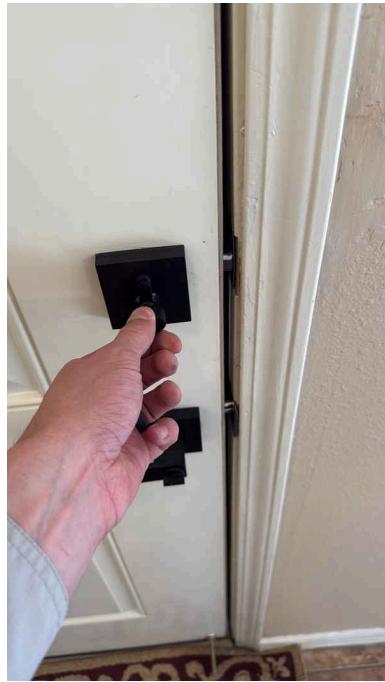
2: Door - Hardware not Functioning

The door hardware does not function properly.

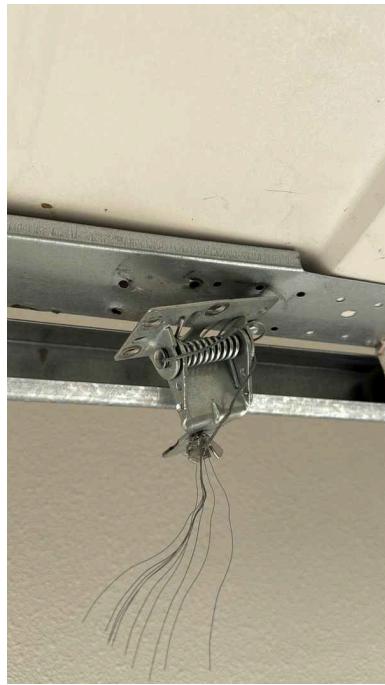
3: Door - Hardware Damaged

The door hardware is damaged and/or is not functioning properly.

Recommendation: Contact a qualified garage door contractor.

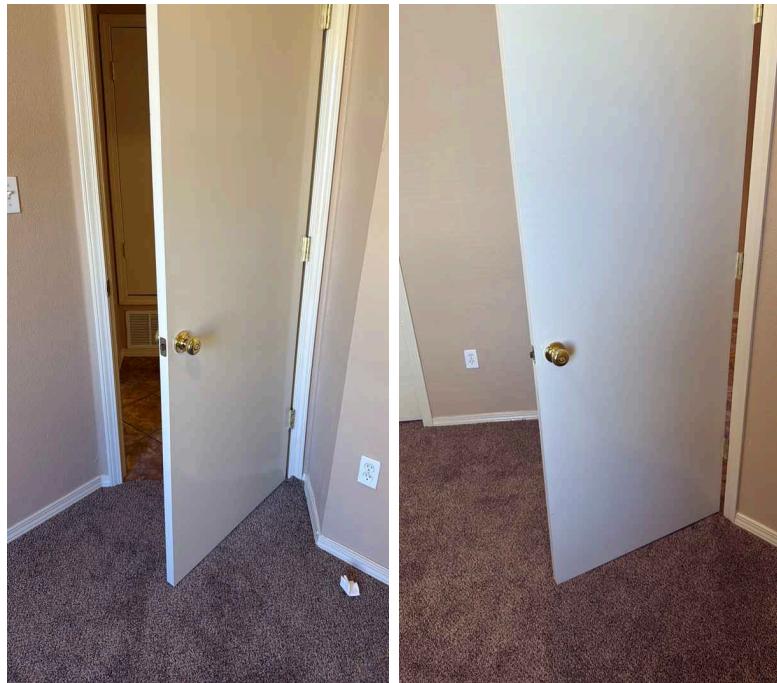
**4: Out-of-Level Door**

The door does not remain in the open position and closes on its own when released.

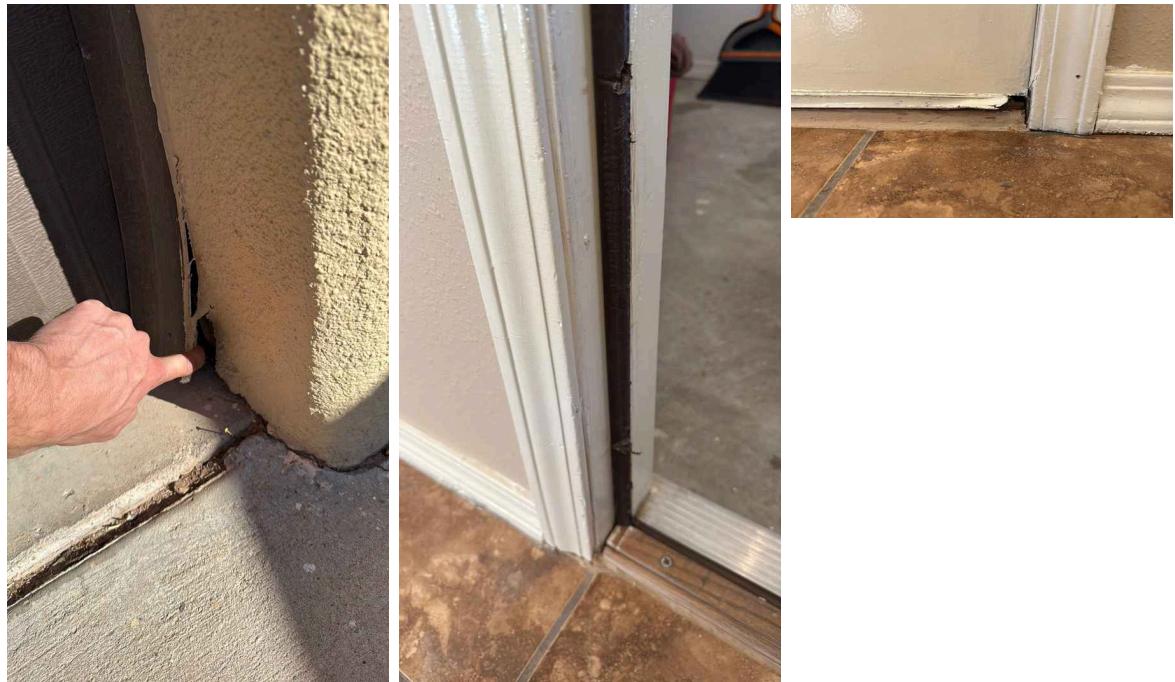
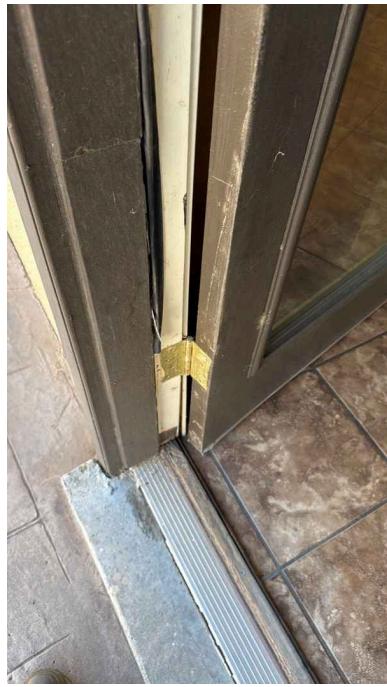
5: Door - Weather-stripping Improvements

Weather-stripping improvements are recommended.

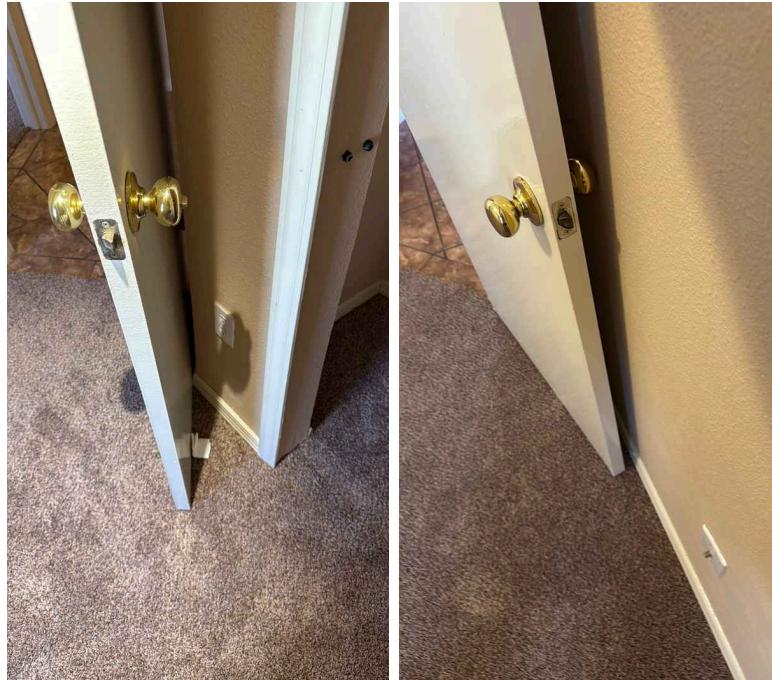
6: Door - Missing Stops

One or more doors is missing a door stop mechanism.

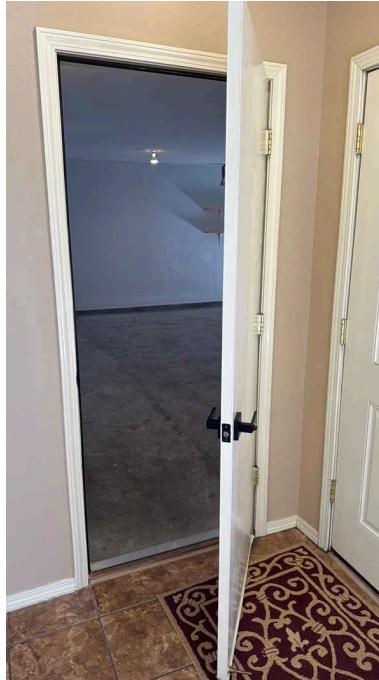
7: Garage Entry - Not Self Closing

The garage entry door is not equipped with a self-closing device.

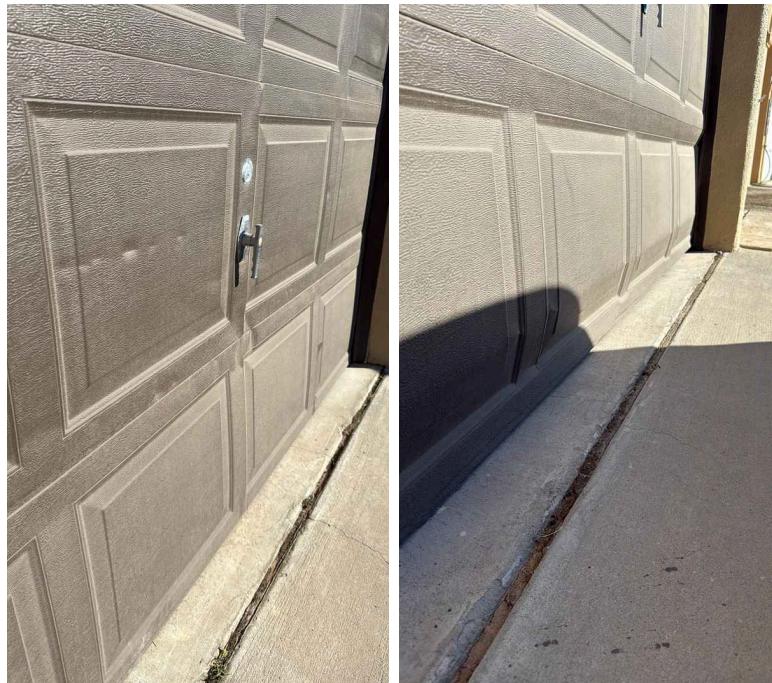
8: Garage Door - Damaged

Some damage to the overhead garage door was observed.

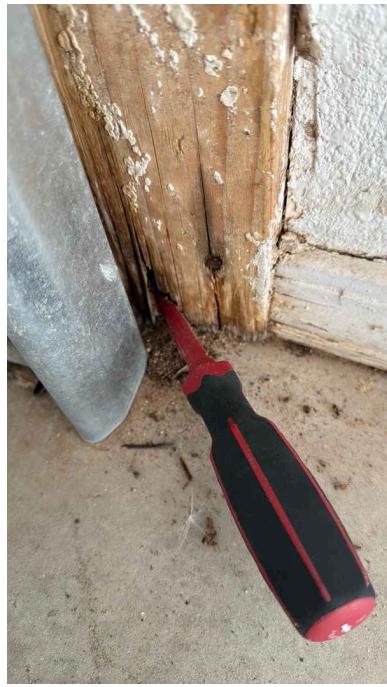
9: Garage Door - Trim Damage

The overhead garage door panel(s) and/or panel trim has some deterioration and/or damage.

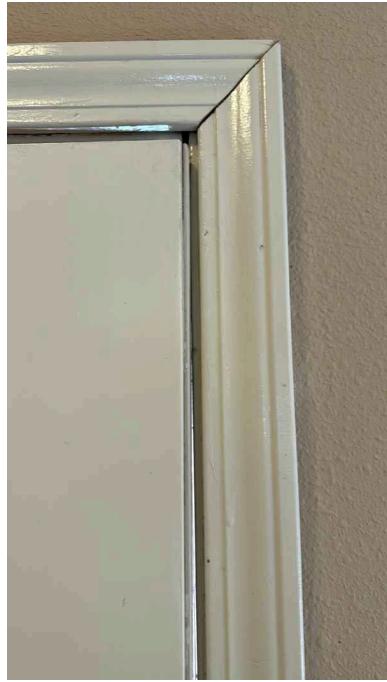
10: Door Rubs

The door was noted to rub on the frame and should be adjusted for better performance.

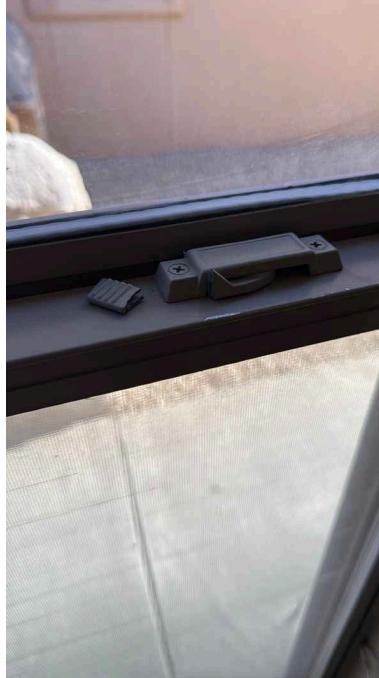
1: Window Lock Missing

Window lock(s) were observed to be damaged and/or missing.

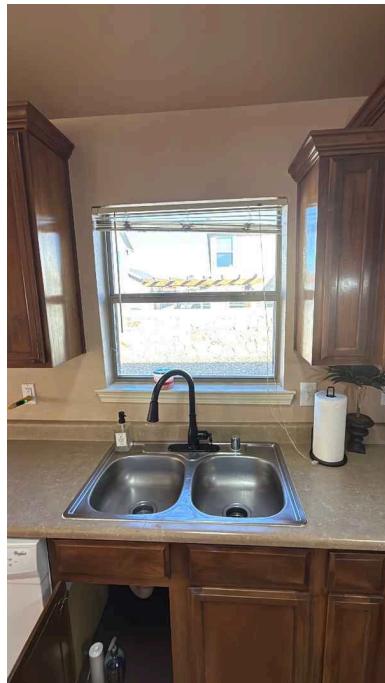
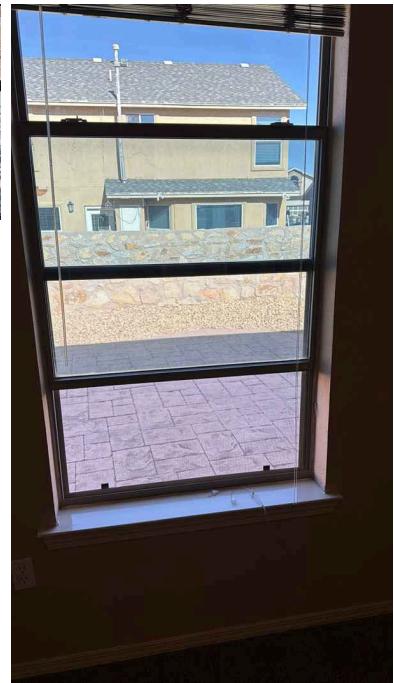
**2: Difficult to Operate**

One or more of the windows were observed to be stiff and hard to operate. Recommend repair as needed. It is important for bedroom windows to operate easily for emergency egress purposes.

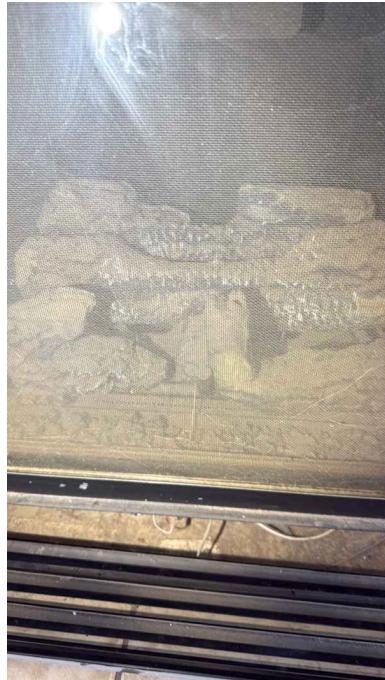
2: Dirty Firebox

Firebox was noted to be dirty and should be cleaned prior to use for fire safety purposes.

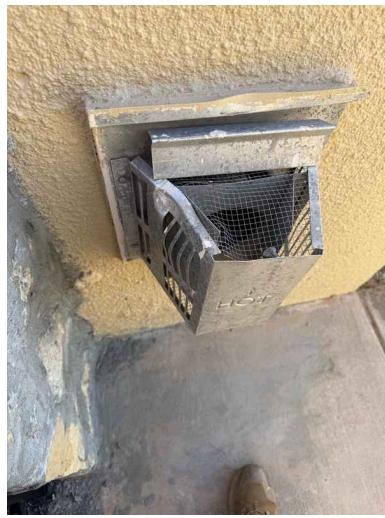
**3: Damaged Vent**

The vent was noted to be damaged.

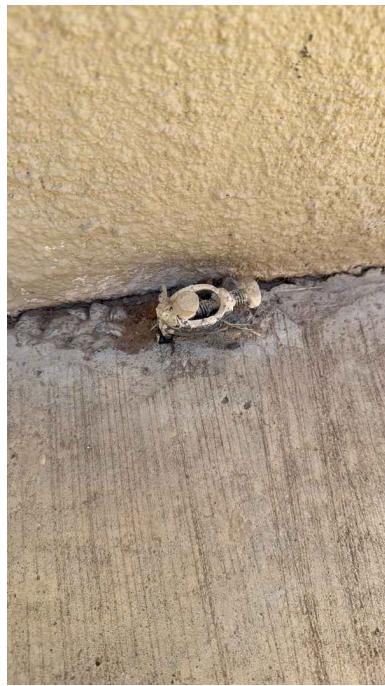
Note: The connection to the ground electrode rod is below finished grade. The connection should be made above finished grade or with an approved clamp listed for burial. The connector in place is inaccessible and cannot be determined for proper use at the time of this inspection.

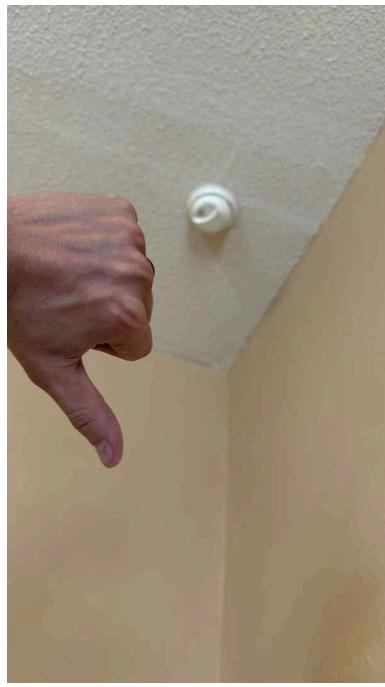
Primary Bedroom

One or more of the smoke alarms did not respond properly when tested.

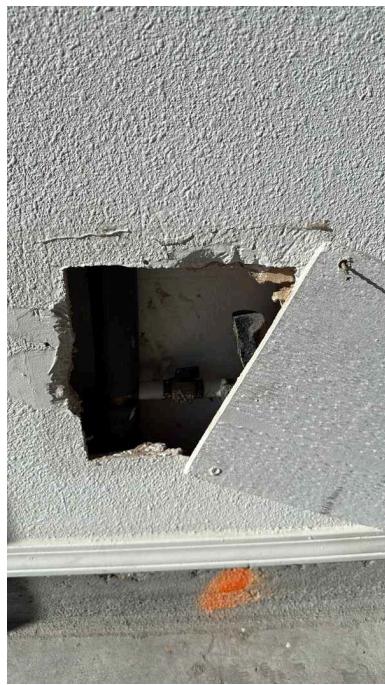
Static Water Pressure Reading: Over 80 psi

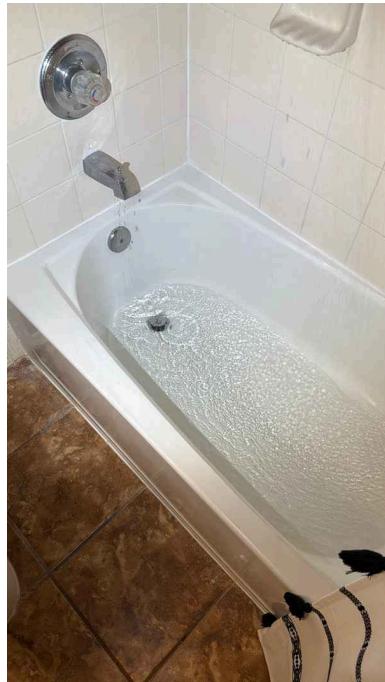
Secondary Bathtub

Several of the drains within the structure related to one or more of the toilets, sinks, showers or tubs were observed to be slow draining. This could indicate some type of blockage or defect with the main drain. It is recommended to have the inaccessible and buried pipes scoped with a camera to further evaluate the cause of this condition. This evaluation should occur prior to the expiration of any time limitations such as option or warranty periods.

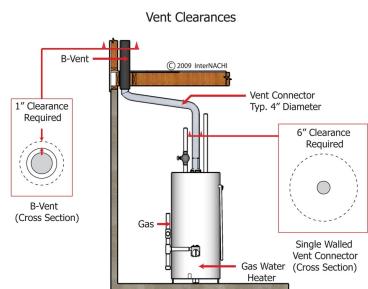
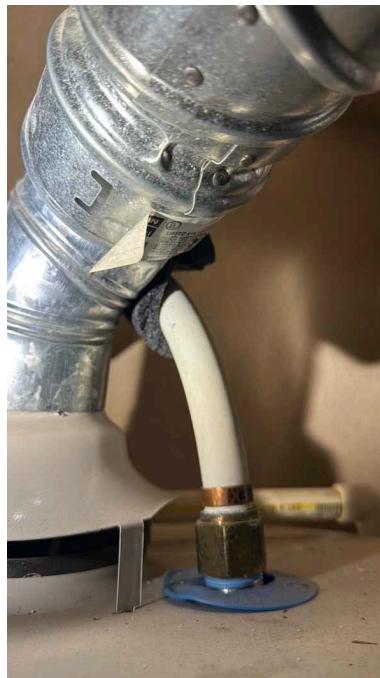
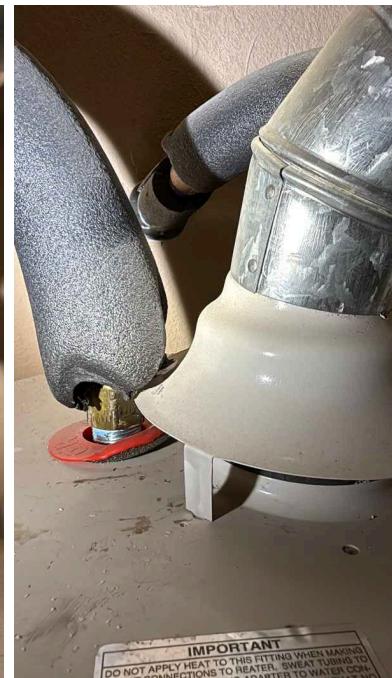
The water heater flue (vent pipe) has inadequate clearance from combustible materials. Double walled vent pipes should have at least 1-inch of clearance and single walled vent pipes should have at least 6-inches of clearance from combustible material. This condition is currently causing melting of foam insulation and should be corrected.

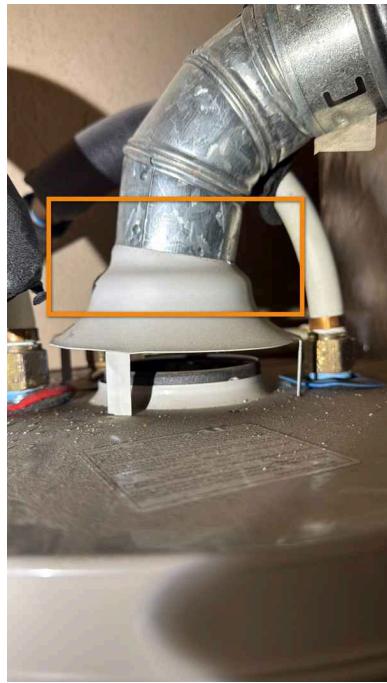
2: Vent - Missing 3 screws

The water heater flue connector should be mechanically attached to the draft hood and joints with a minimum of three sheet metal screws.

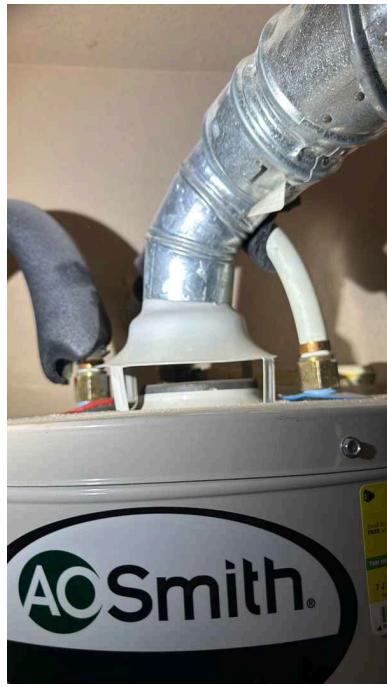
3: Signs of Backdrafting

Evidence of backdrafting was observed at the water heater exhaust vent, indicating improper venting of combustion gases. This condition can allow combustion byproducts, including carbon monoxide, to enter the living space and represents a safety concern.

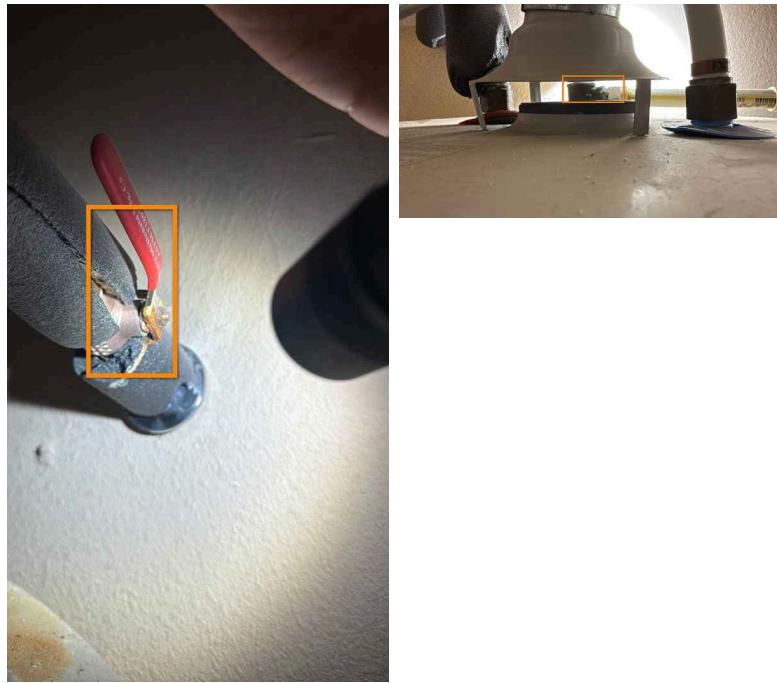
5: Corrosion

Corrosion was present at the water shut off and the TPR valve.

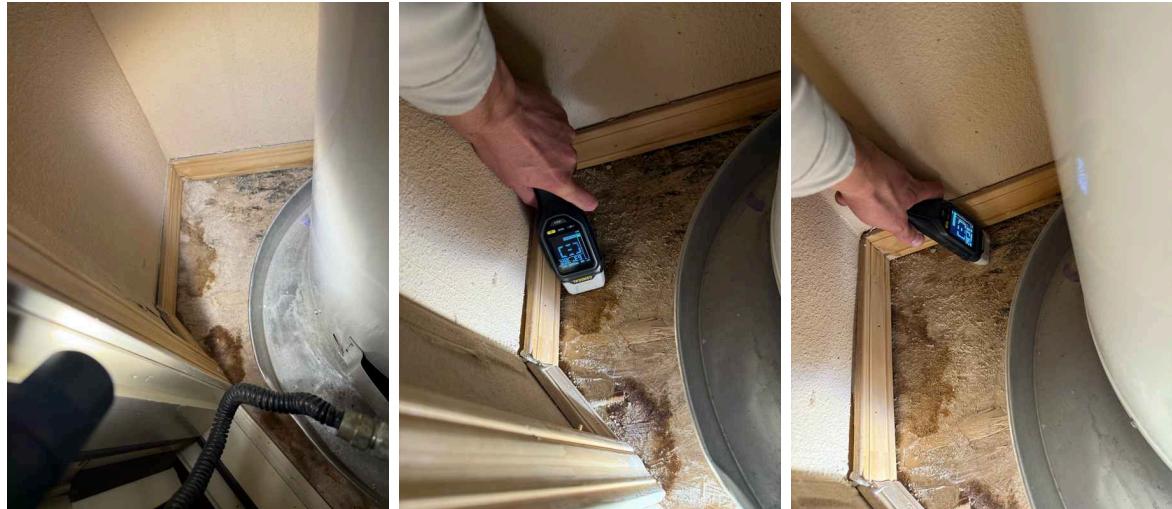
6: Previous Water Stains

Previous water staining was observed on surfaces within the water heater closet. At the time of inspection, no active moisture was detected with a moisture meter, and the area was dry. The staining appears to be from a

prior condition. Recommend monitoring for any signs of active leakage and having the water heater and associated plumbing evaluated if moisture or staining reoccurs.

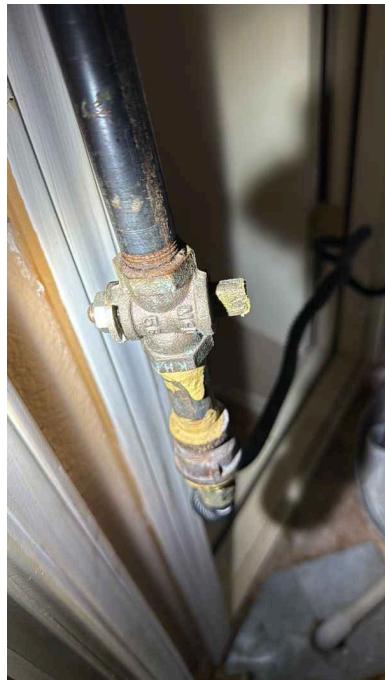
2: Old Gas Shut Off Valves

It is recommended that the older spring load gas valves be changed out to the new style ball valves.

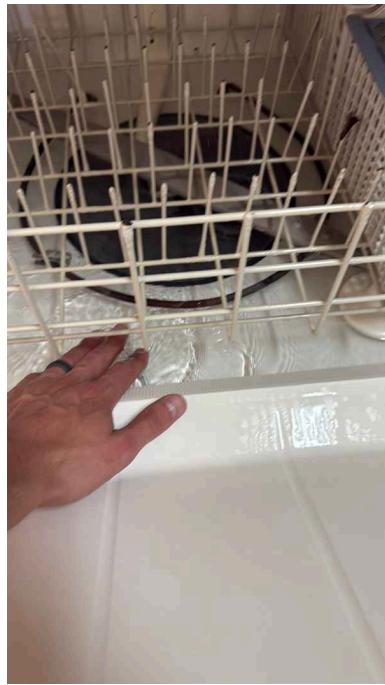
1: Improper Drainage

The dishwasher did not drain properly when operated. This condition should be further evaluated and corrected as necessary.
