TEXAS RESIDENTIAL INSPECTION

1234 Main Street
El Paso TX 79924

PROPERTY INSPECTION REPORT FORM

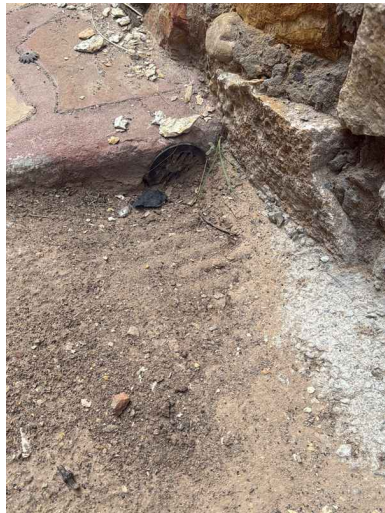
2: Sub Surface Drain Clogged

There is an underground and/or surface drainage system in place. It appears that the surface water collector(s) and/or drain(s) are clogged and/or filled with debris. This condition will adversely affect the performance of the drainage system and corrective measures are needed at this time.

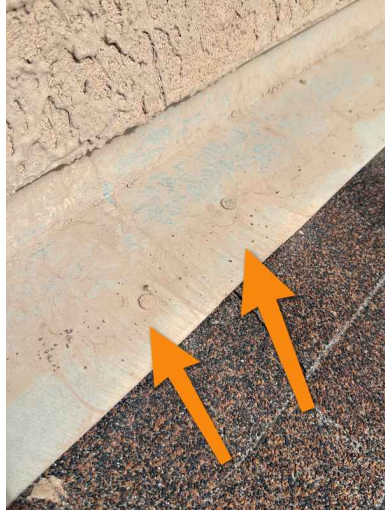
Exposed fasteners were observed at the shingles in one or more locations.

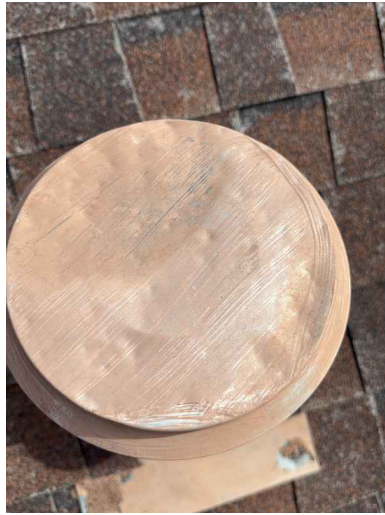
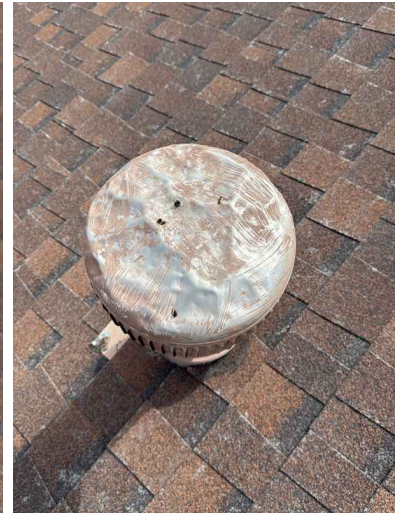
3: Flashing - Damaged

The flashing is damaged and should be repaired or replaced.

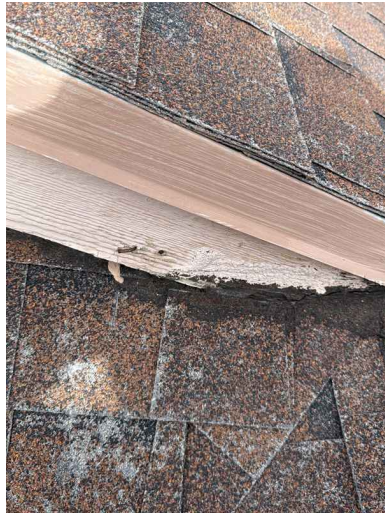
1: Fascia Damaged

The fascia board material has some deterioration and/or damage.

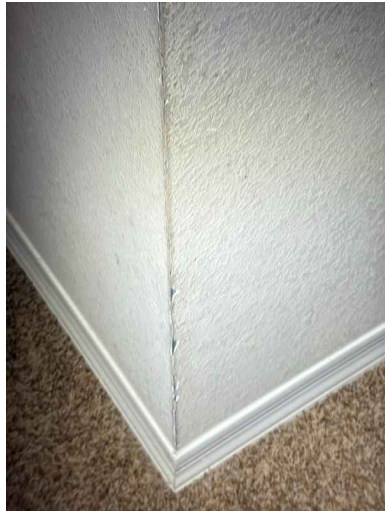
1: Texture - Damaged

The wall texture has some deterioration and/or damage.

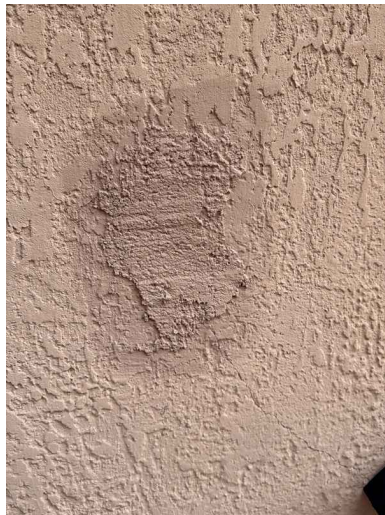
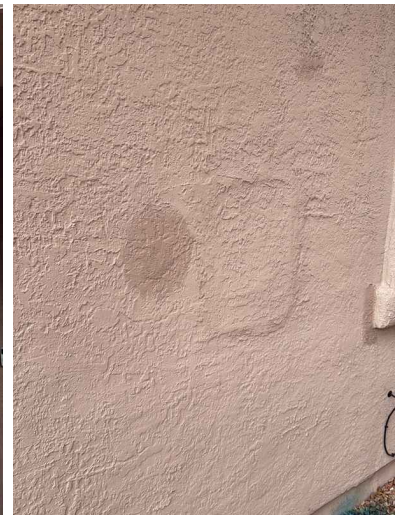
2: Patches/Repairs Present

Note: There is evidence of painting and patching to the walls. This condition could limit the inspectors visual observations and ability to render accurate opinions as to the performance of the structure.

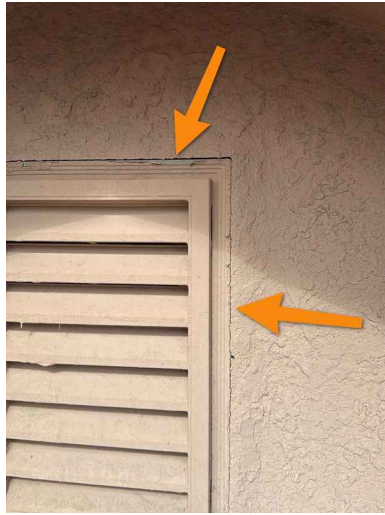
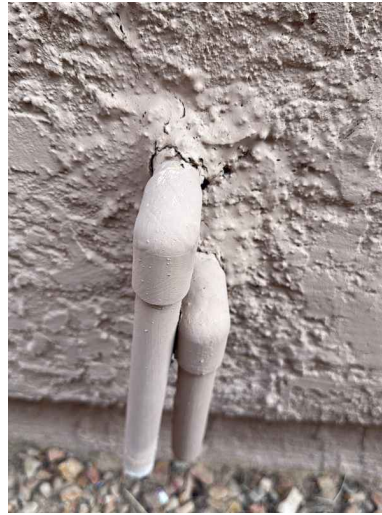
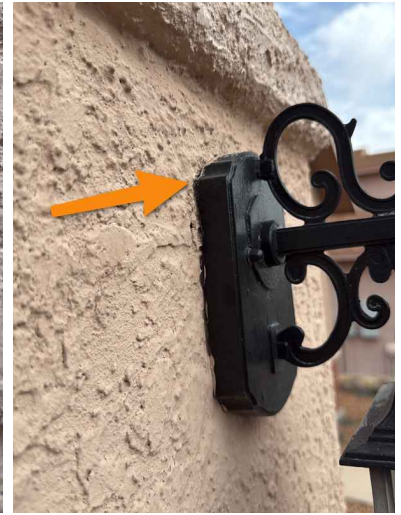
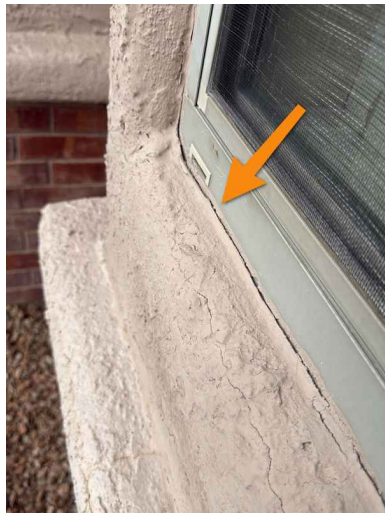
3: Sealant - Exterior Penetrations

The area between the exterior cladding / veneer and all of the wall penetrations / openings need to be properly sealed. Areas such as utility connections, windows, downspouts, hose bibbs, lighting fixtures, receptacles etc.

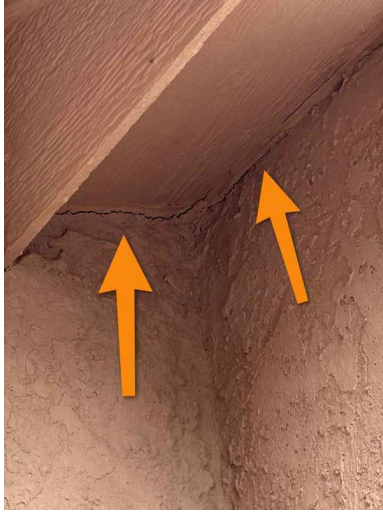
4: Sealant - Siding Joints

All joints between two different types of siding should be properly sealed. It is recommended to use elastomeric sealant.

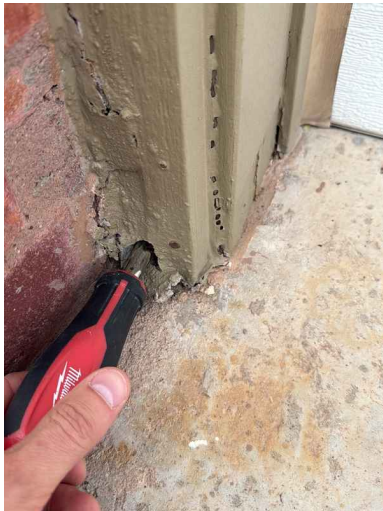
5: Wood Trim Damaged

Garage

The wood veneer trim has some deterioration or damage.

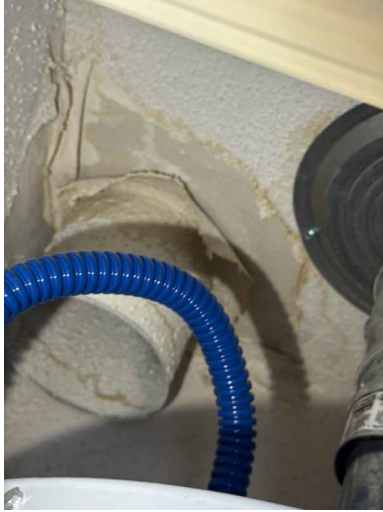
2: Ceiling - Water Damage

Water stains and water damage was observed on the ceiling finishes. The cause and remedy should be further evaluated and corrected as necessary.

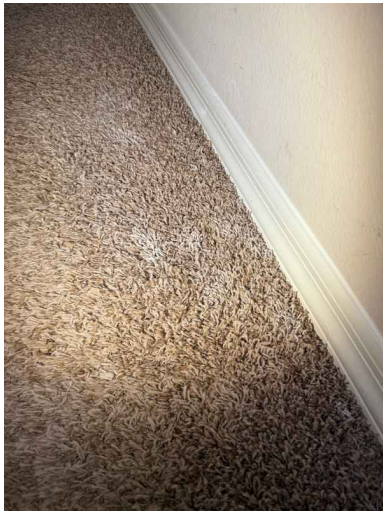
3: Floor - Stained

Hallway

The floor covering is stained in one or more locations of the home.

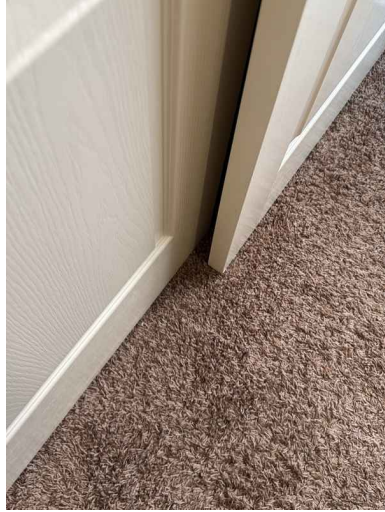
1: Door - Hardware Missing

The door hardware is missing.

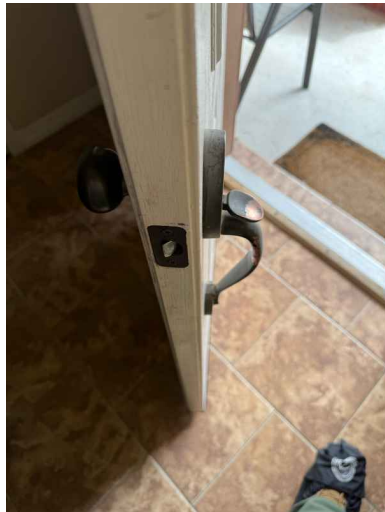
2: Door - Hardware not Functioning

The door hardware does not function properly.

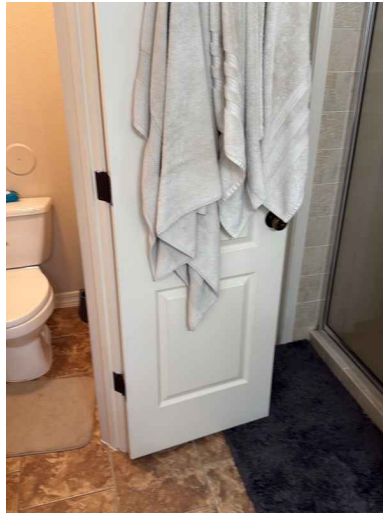
3: Door - Out of Square

Some of the interior doors are out of square and swings fully open. Recommend adjusting.

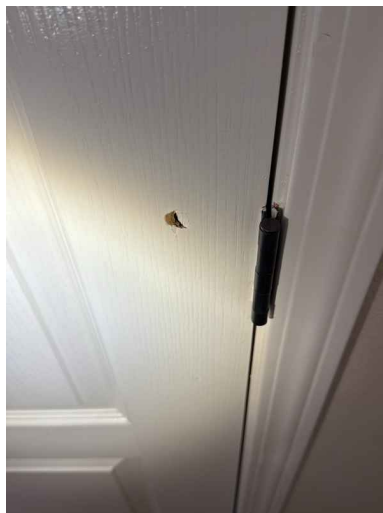
4: Door - Damaged Finish

The door finish is worn/damaged.

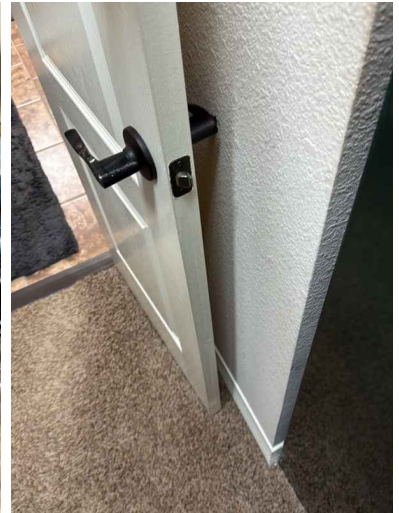
5: Door - Missing Stops

One or more doors is missing a door stop mechanism.

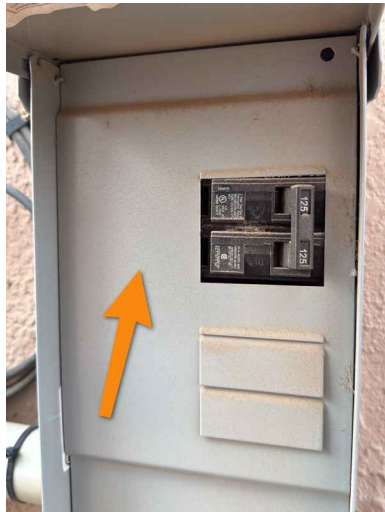
The breakers (overcurrent devices) in the electrical panel are not properly labeled.

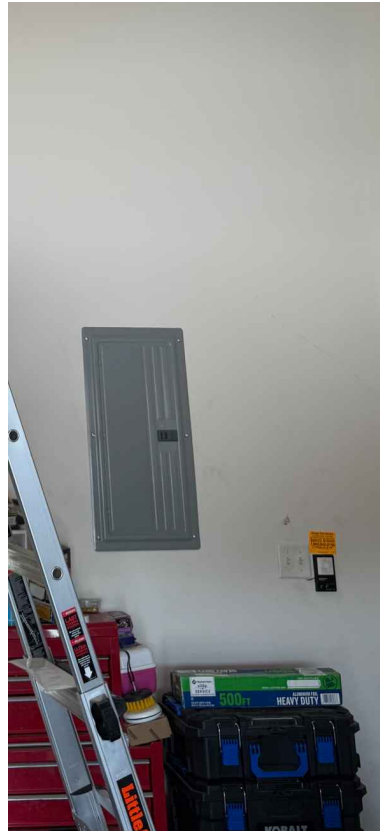
2: Improper Clearance

The panel box does not have proper clearance in front of the cabinet. The panel box cover plate (Dead Front) and/or cabinet should be readily accessible and cover easily removable at all times. Under current electrical standards, the accessible workspace around the panel box should be at least 36-inches in depth in front of the cabinet and 30-inches in width or the width of the equipment. Clothes, shelves, cabinets, foliage, etc should not block the workspace in front of the cabinet.

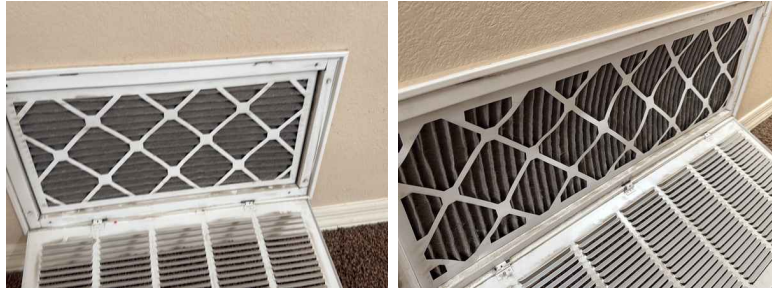
The dirty air filter should be replaced.

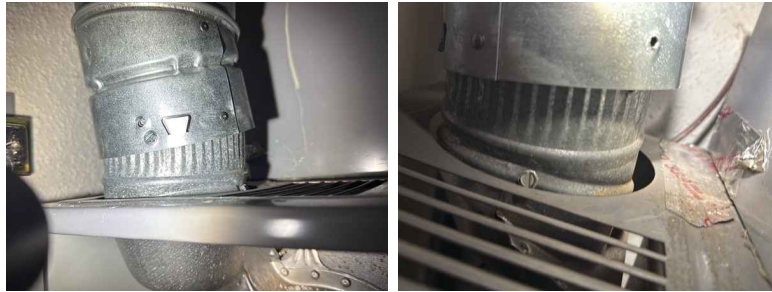
2: Vent Pipe Improper Installation

The vent pipe is not properly mounted at the top of the gas heater. This condition should be corrected for safety.

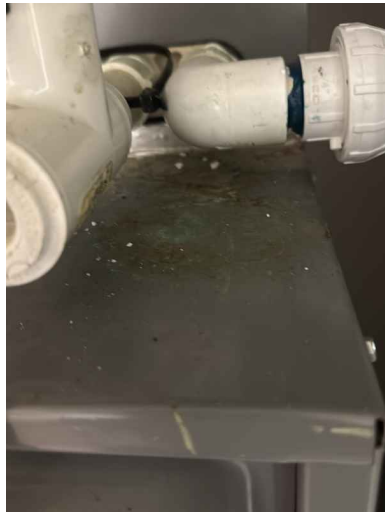
Note: Previous water leakage was observed from around the base of the indoor coil housing. This condition should be closely monitored and corrected if necessary.

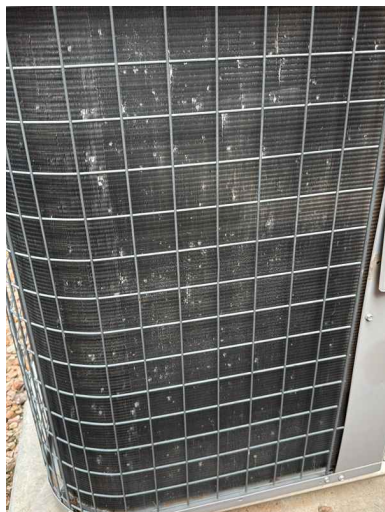
3: Damaged Condenser Fins

The fins of the outdoor portion of the air conditioning system were observed to be damaged. This condition can reduce the efficiency of the system.

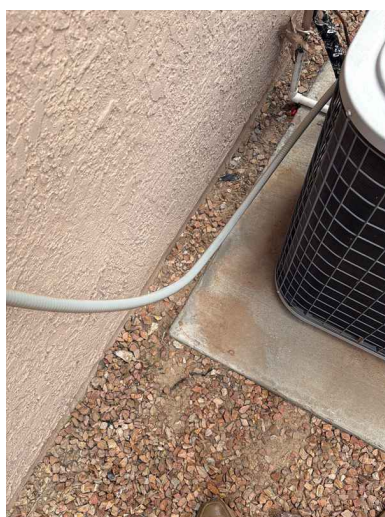
4: Conduit Loose

The electrical wire conduit has pulled loose at the outside condenser housing and/or service disconnect.

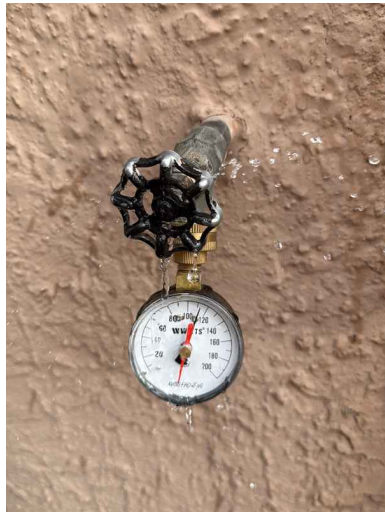
Front

The exterior water hose bibb (faucet) is leaking at the handle when operated.

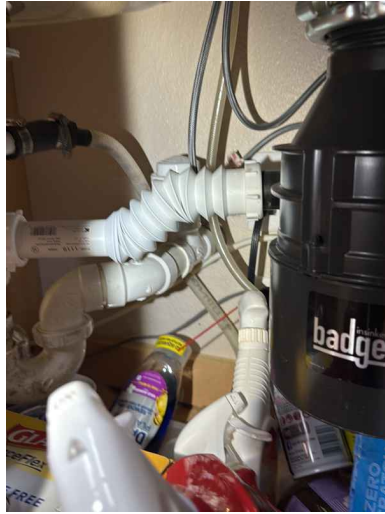
The drain line is made of corrugated material. It is recommended to use smooth wall/PVC type material to prevent blockage.

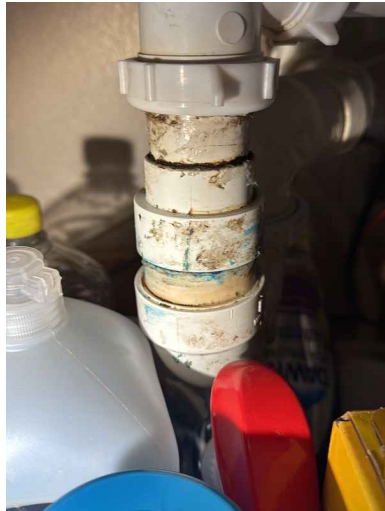
5: Sink - Previous Leaks

Kitchen

Note: Previous water leaks were observed at and/or around the drain connections under the sink with the bottom of the cabinet noted to be damaged. This would indicate previous problems and should be closely monitored and corrected when necessary.

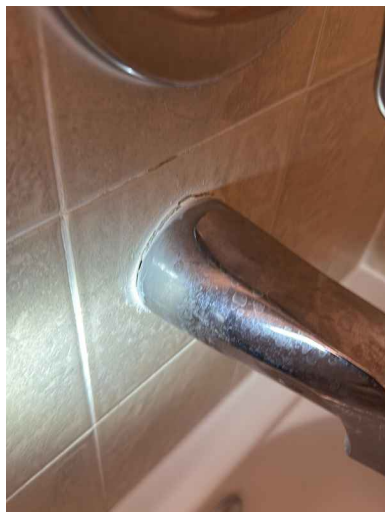
6: Bathtub/Shower - Caulking Improvements

Cracked, deteriorated and/or missing bathtub enclosure grout and/or caulking should be repaired or replaced as necessary.

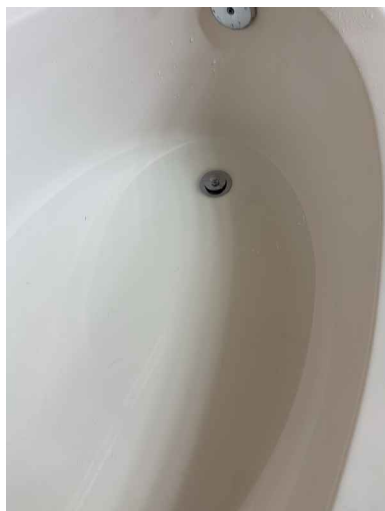
7: Bathtub - Slow Drain

Primary bath

The bathtub was observed to drain slowly, suggesting that an obstruction may exist.

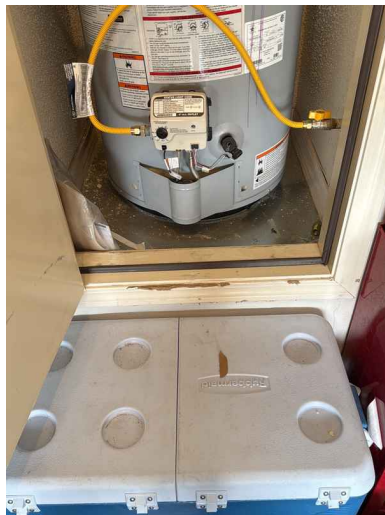
There is no pan installed under the water heater.

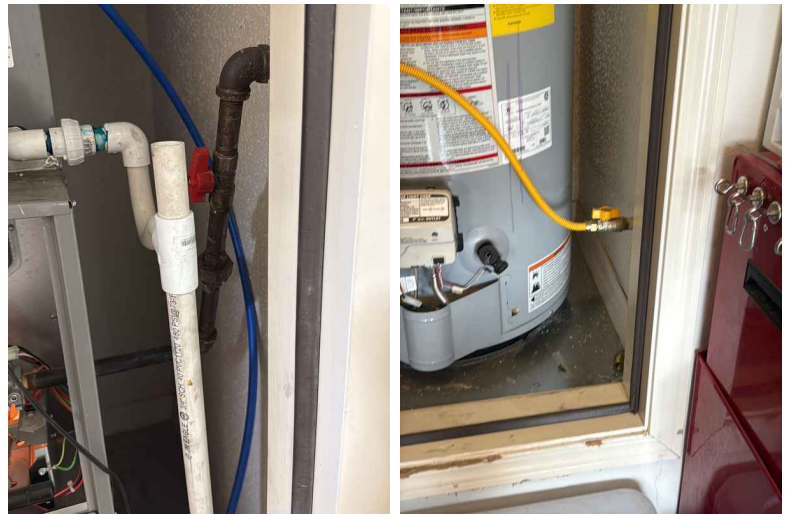
1: No Sediment Trap

The gas supply line is not equipped with a sediment trap just before the gas appliance connector. This condition does not meet current installation requirements and should be corrected.

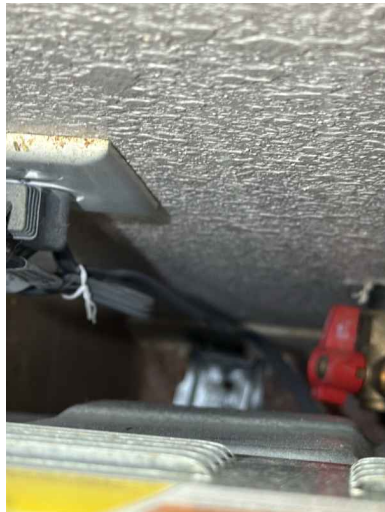
Recommend improvements in better securing the anti-tip device for safety.

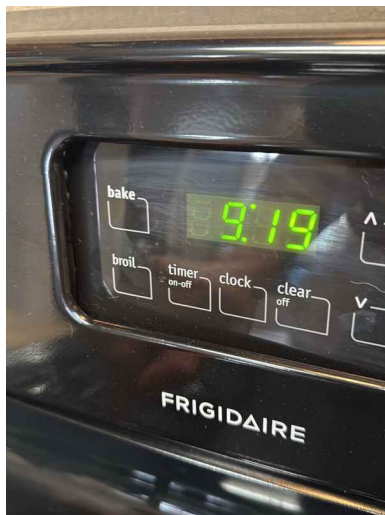
2: Loose control board

The control board on the stove was noted to be loose.

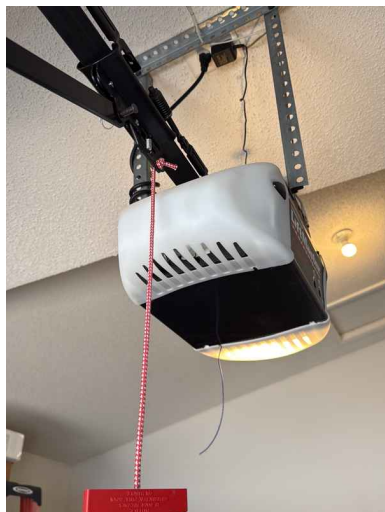
The garage door light was inoperative at the time of inspection.

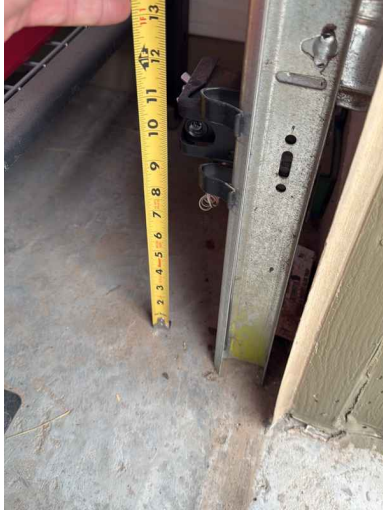
3: Resistance Test Failed

The garage door opener DID NOT automatically reverse under reasonable resistance when closing. Improvement may be as simple as adjusting the sensitivity control on the opener.
