## NEW MEXICO RESIDENTIAL REPORT

1234 Main Street  
El Paso, TX 79924

Buyer Name  
12/20/2025 9:00AM

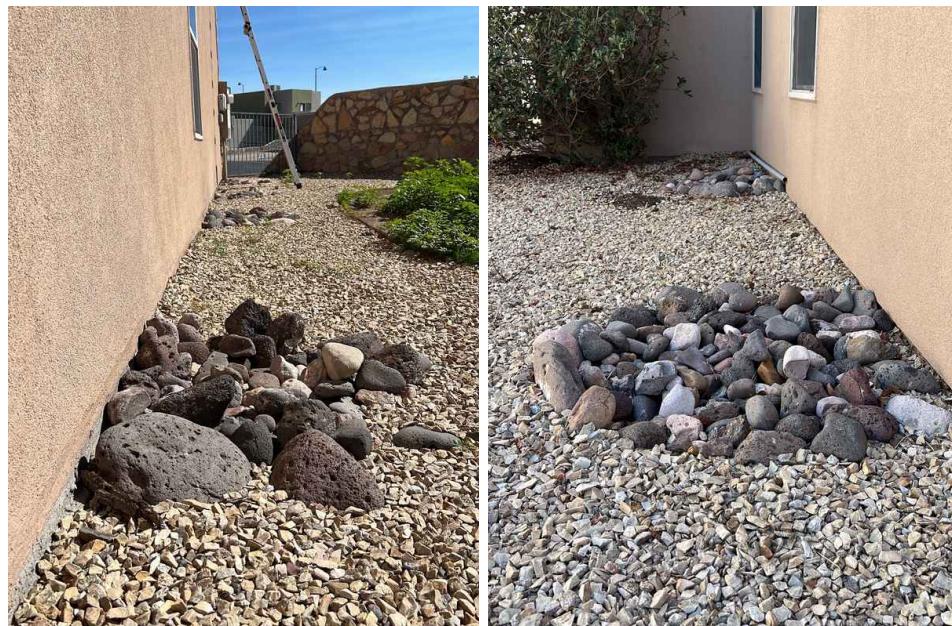
Marginal site drainage was observed. Proper drainage is needed to help prevent water from standing and/or ponding next to the foundation beam. Corrective measures may be needed if the water stands within 10-feet of the foundation perimeter beam for more than 24-hours.

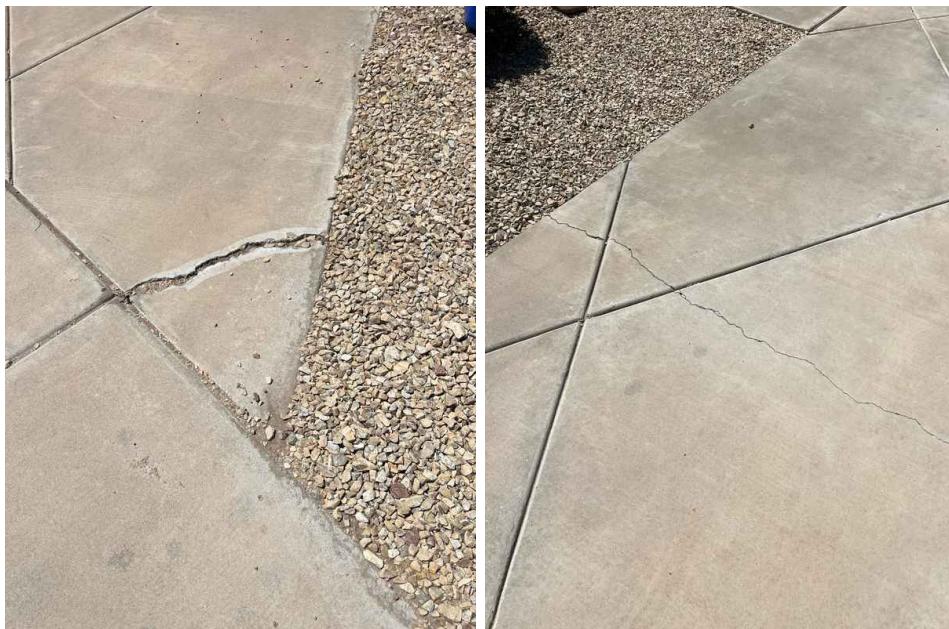
2.2.2 B. Grading, Drainage, Site

### FLATWORK CRACKS

Flatwork cracks present can be patched or caulked to prevent water intrusion and further movement.

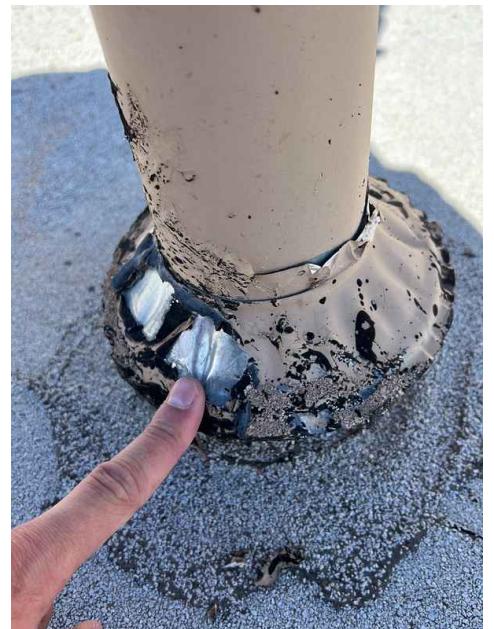
### 2.3.1 C. Roof Covering Materials

The flashing needs to be painted to prevent rust and/or UV damage.

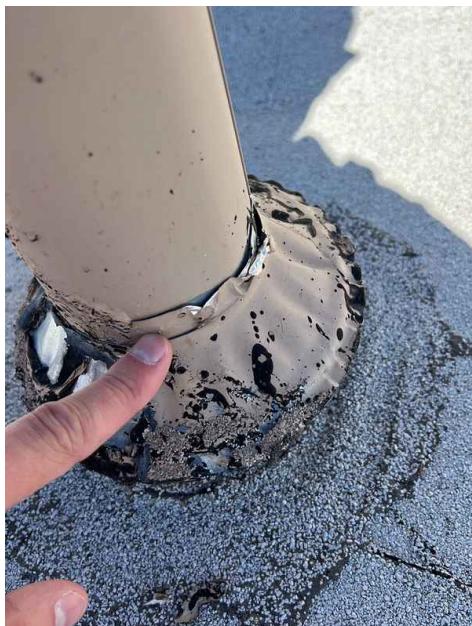
### 2.3.2 C. Roof Covering Materials

The storm collar(s) at the roof level gas equipment vent pipe(s) need to be properly sealed to help prevent water intrusion into the structure.

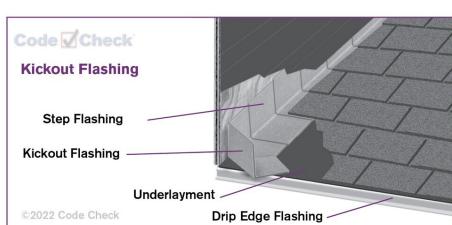
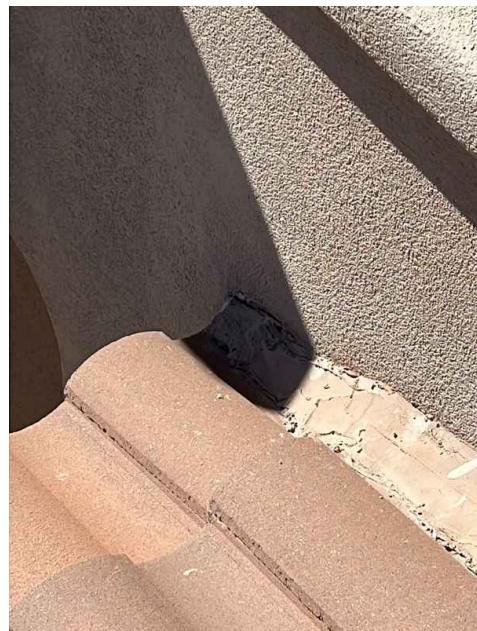
### 2.3.3 C. Roof Covering Materials

#### **FLASHING - MISSING KICKOUT**

There was no kickout flashing details observed at the lower bottom edge of the roof line interface and the sidewall that continues past the edge of the roof. The lack of this kickout flashing will allow water to penetrate at these points.

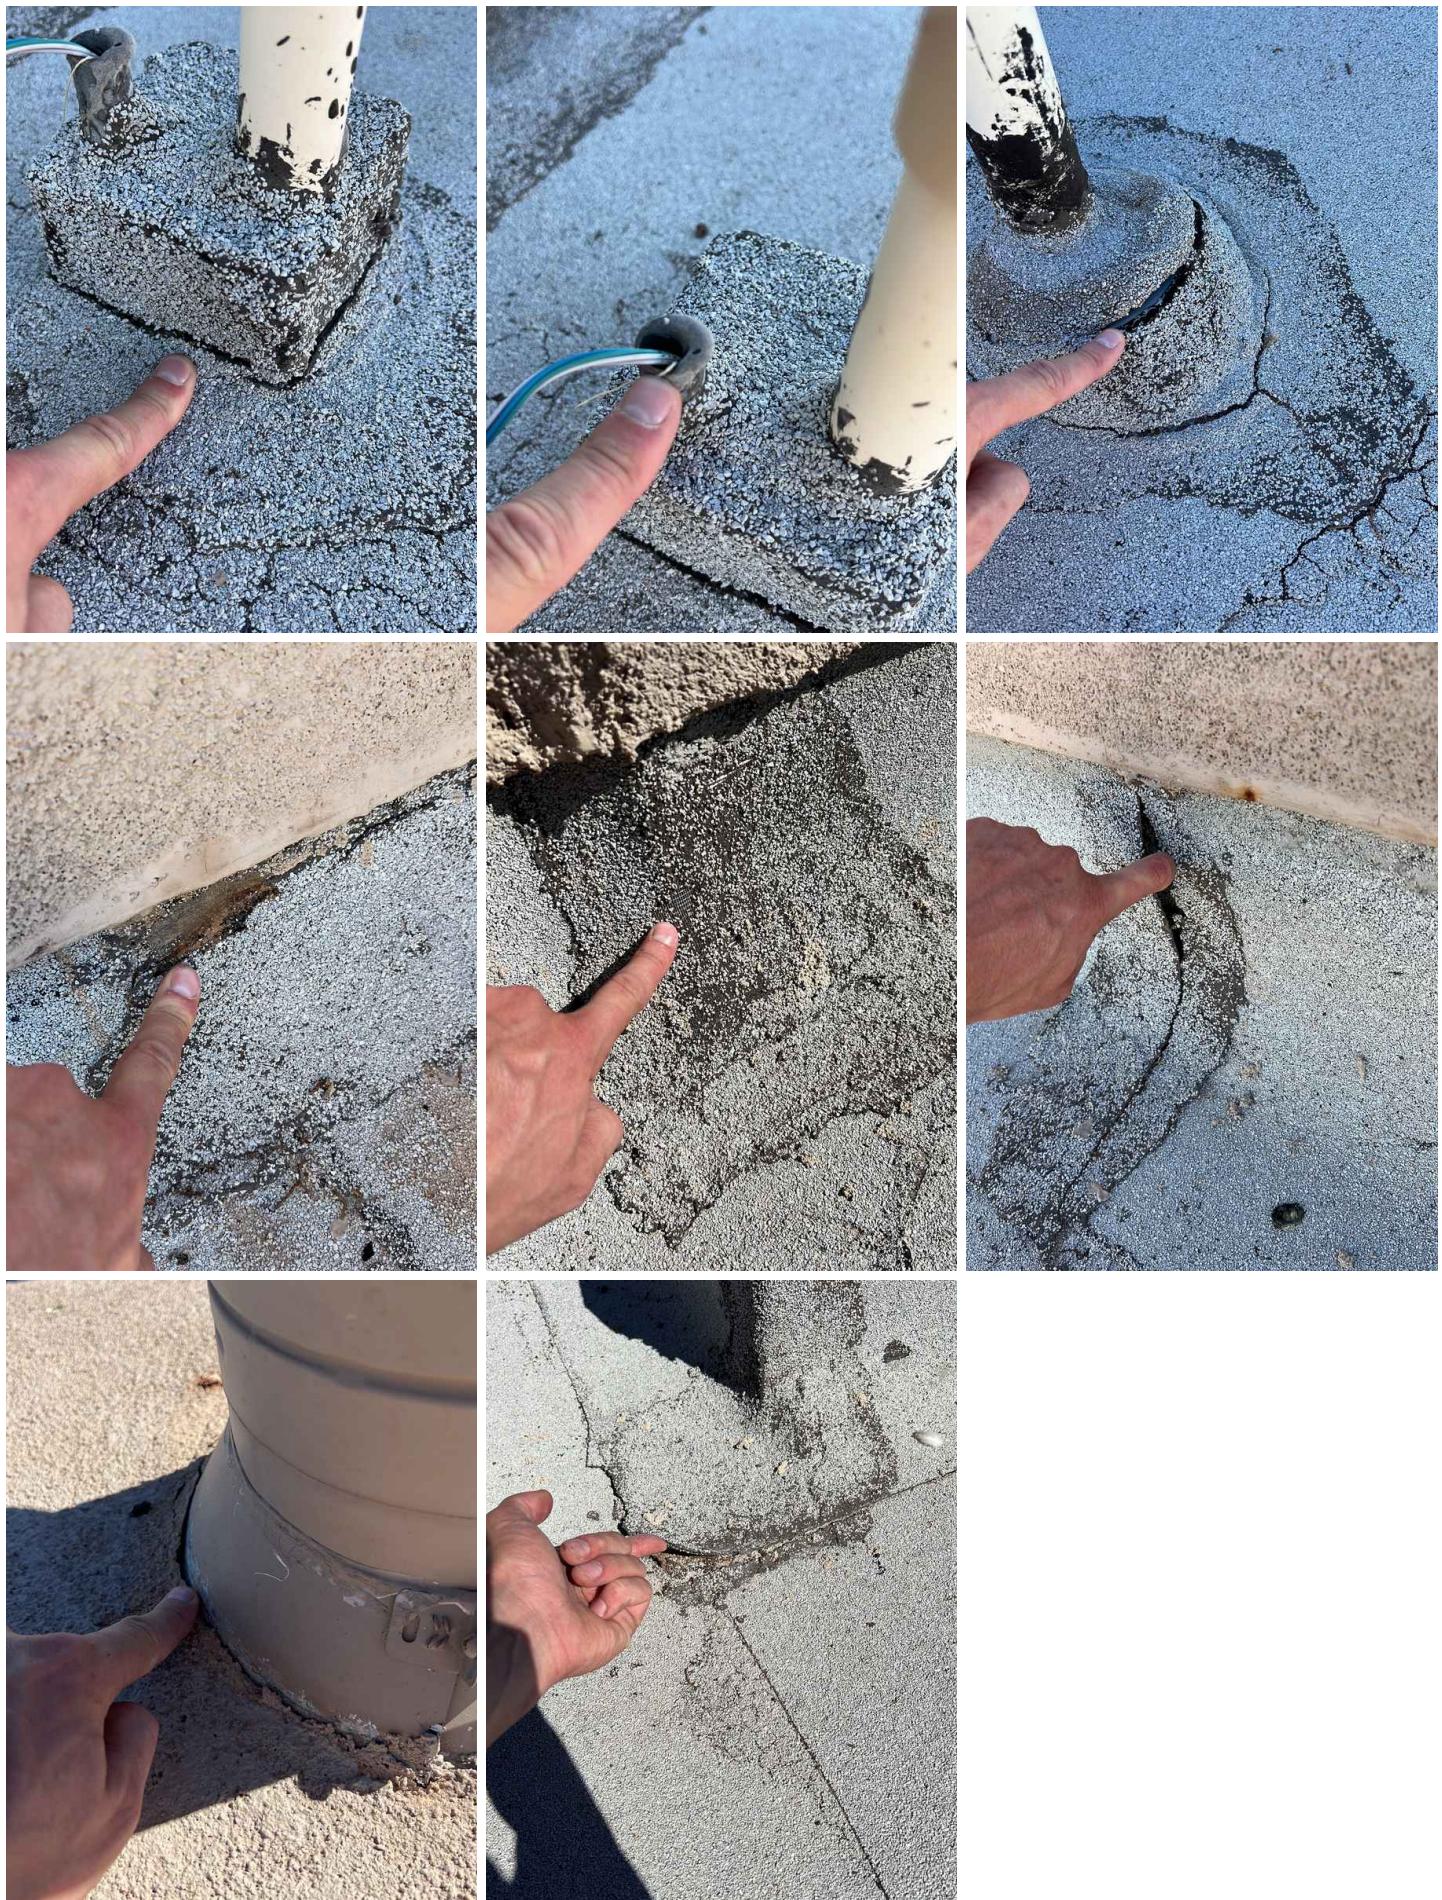
### 2.3.4 C. Roof Covering Materials

#### **SEALANT IMPROVEMENTS**

The inspector noted areas of degraded and cracked sealant. Recommend sealant improvement in these areas to prevent water intrusion.

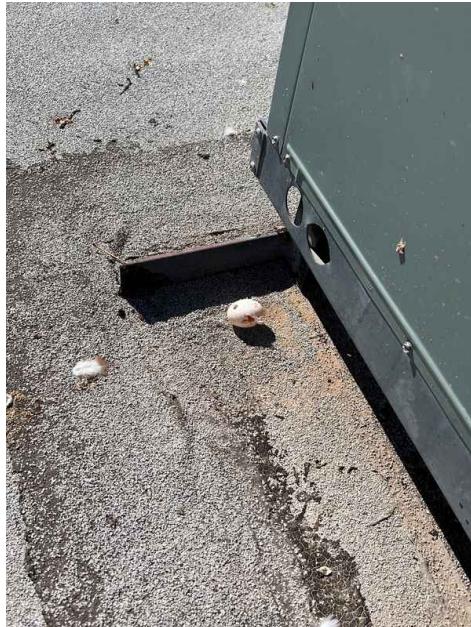
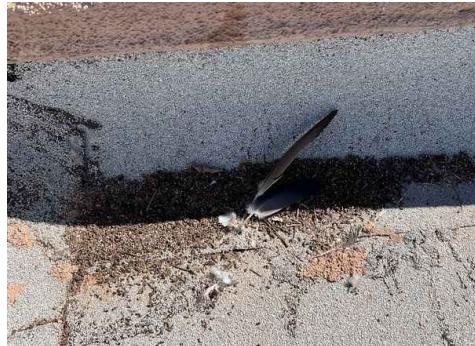
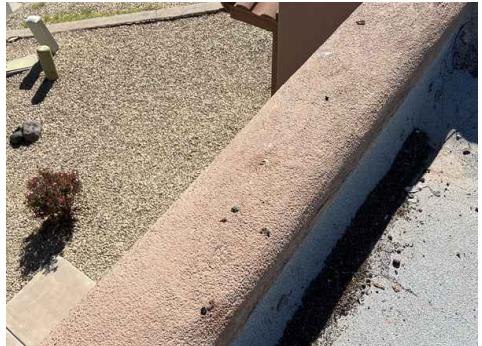
## 2.3.5 C. Roof Covering Materials

**ANIMAL ACTIVITY**

Signs of animal activity. Recommend pest control as needed to prevent damage to roofing membrane.

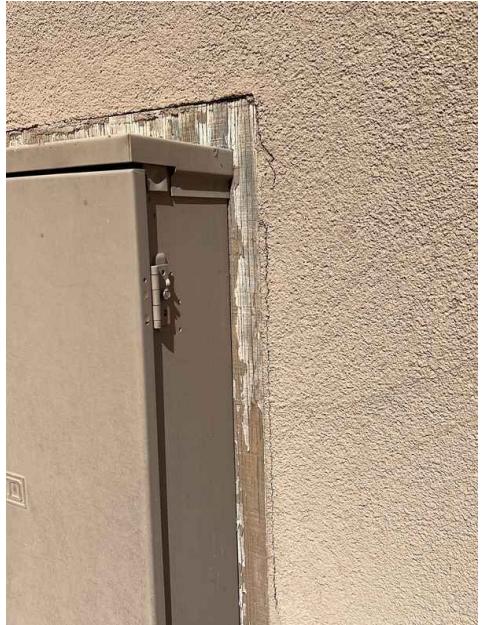
## 2.5.1 E. Walls (Interior and Exterior), Countertops, Cabinets

Exterior wood type surfaces need a fresh coat of paint to protect from exposure.

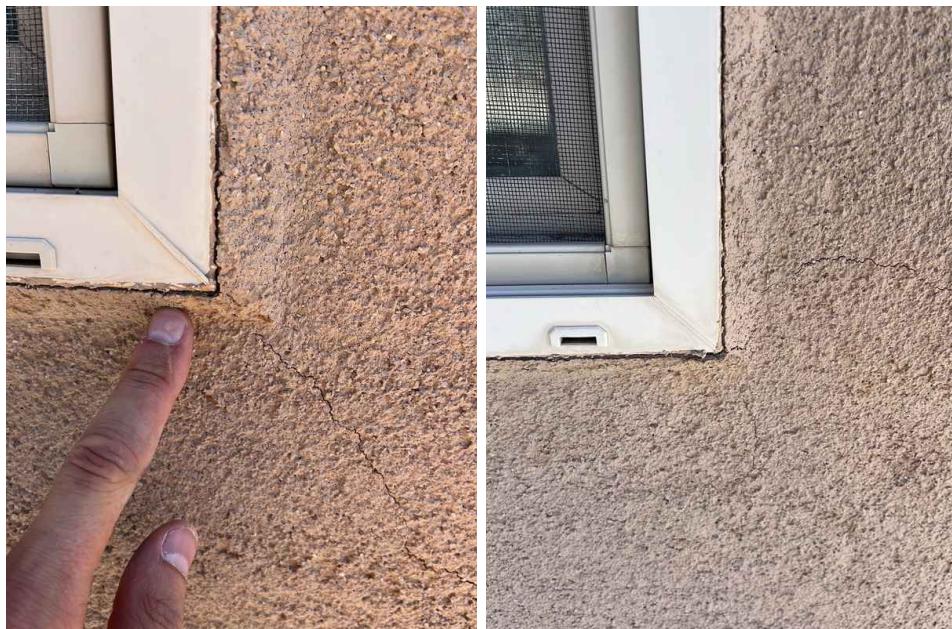
## 2.5.2 E. Walls (Interior and Exterior), Countertops, Cabinets

Failing or missing sealant was observed at and around the stucco type veneer/cladding and the wall opening interfaces (windows, doors, electrical outlets, plumbing outlets, etc.) This condition should be improved to help prevent water intrusion at these locations. It is recommended to use an industry approved NP1 sealant.

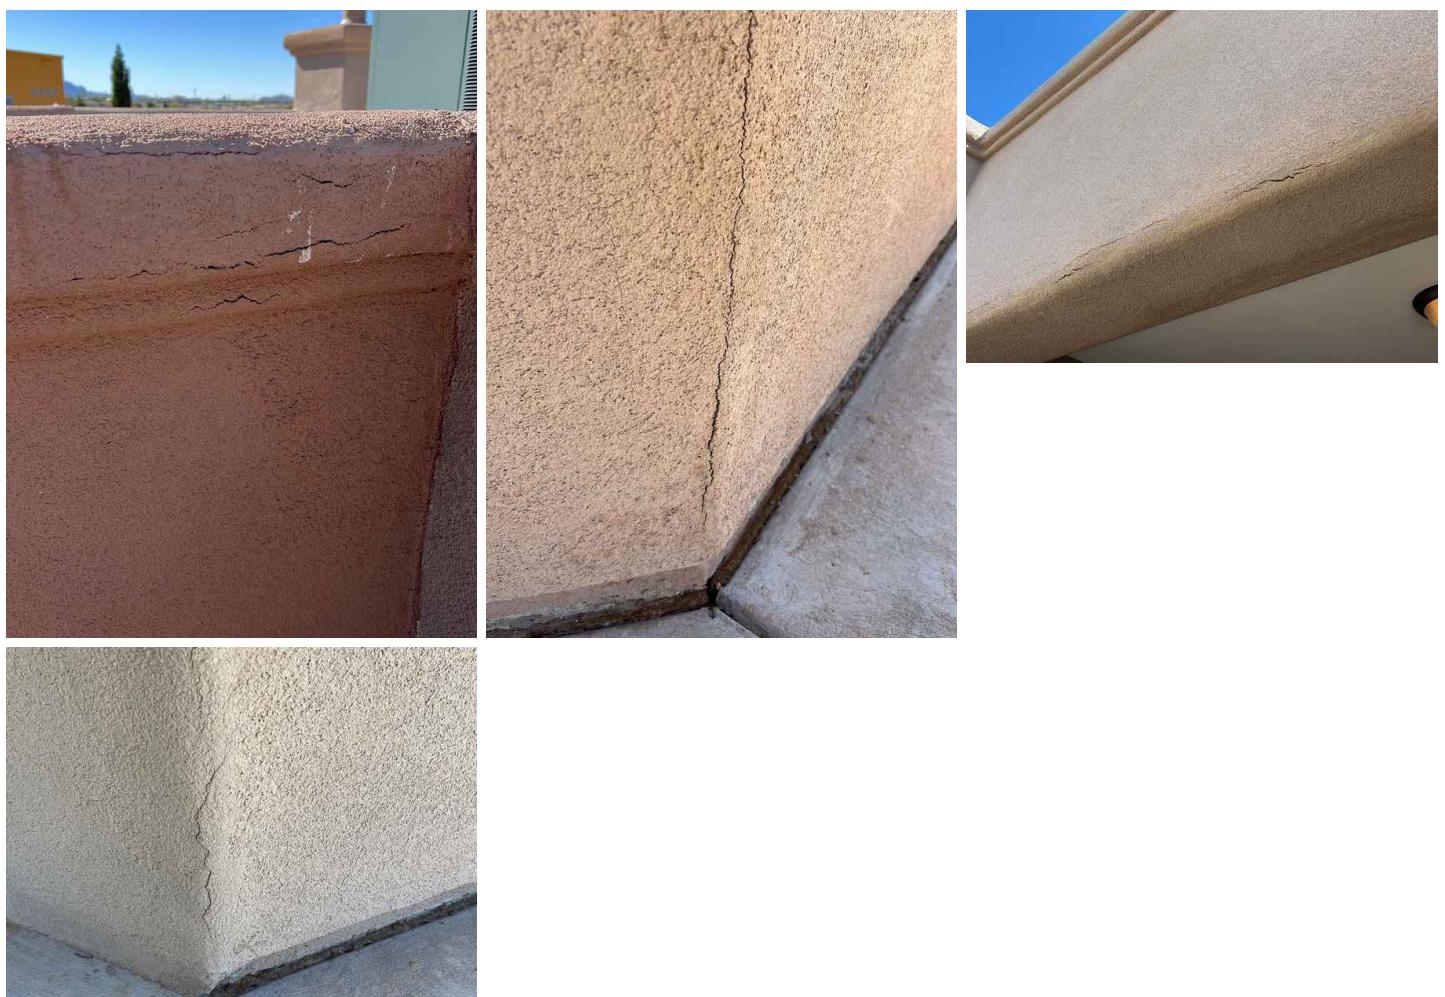
## 2.5.3 E. Walls (Interior and Exterior), Countertops, Cabinets

**STUCCO - CRACKS**

Cracking of the stucco type veneer/cladding was observed. This condition should be further evaluated and corrected as necessary.

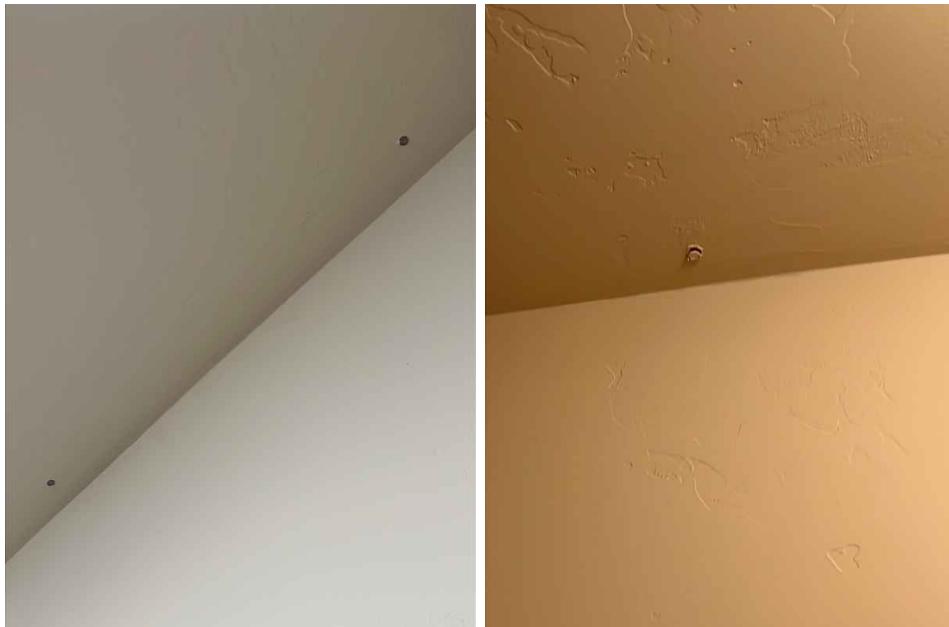
## 2.6.2 F. Ceilings and Floors

**NAIL POPS**

Note: Nail heads were observed to be pushing through the interior finish in one or more locations.

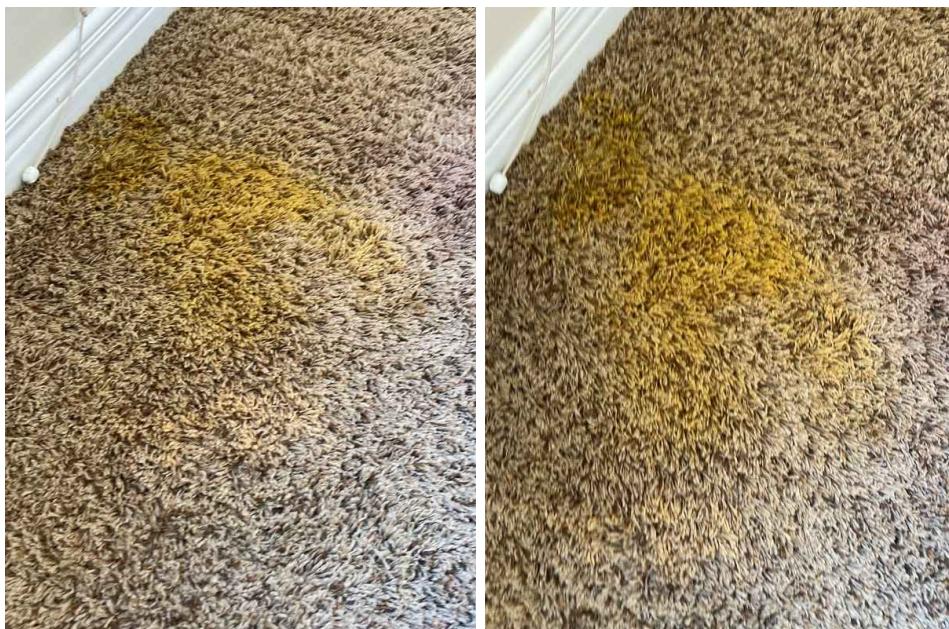
## 2.6.3 F. Ceilings and Floors

The floor covering is stained in one or more locations of the home.

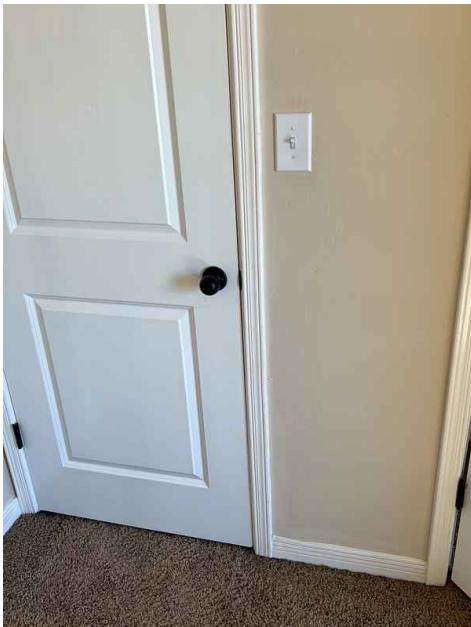
## 2.7.1 G. Doors (Interior and Exterior)

The door is sticking.

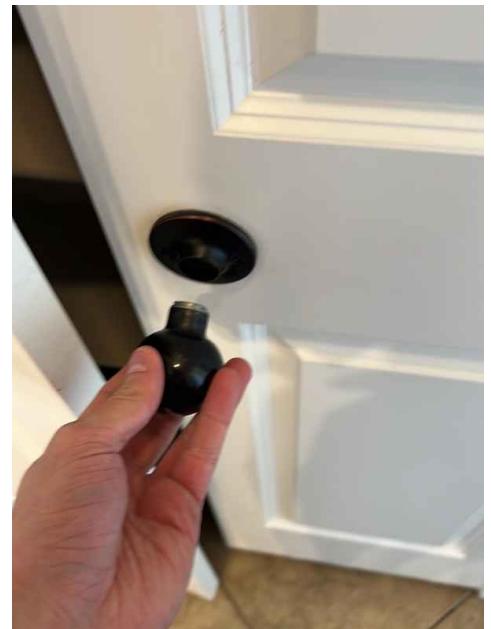
## 2.7.2 G. Doors (Interior and Exterior)

The door hardware is loose.

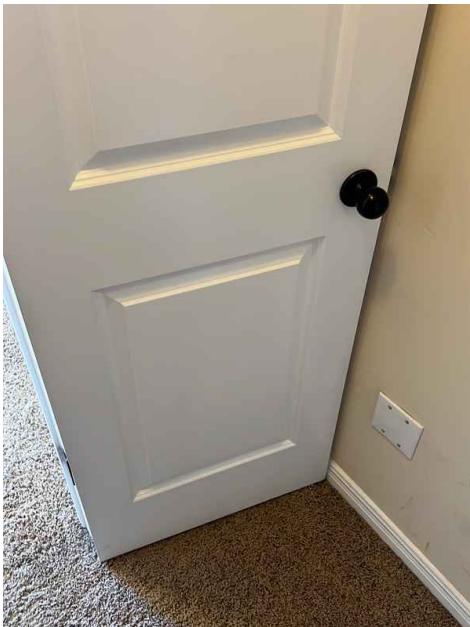
## 2.7.3 G. Doors (Interior and Exterior)

One or more doors is missing a door stop mechanism.

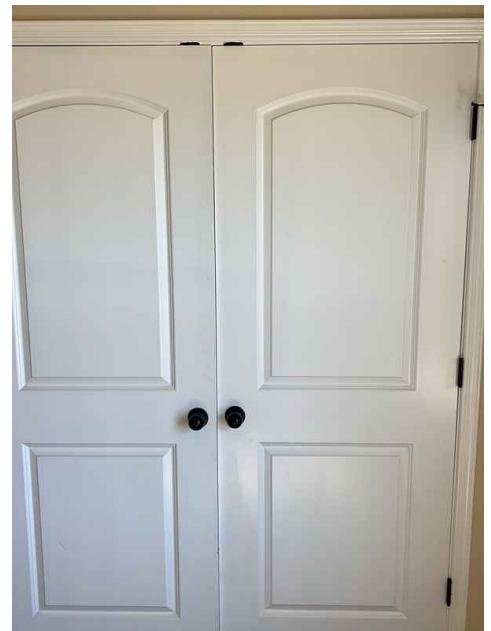
## 2.7.4 G. Doors (Interior and Exterior)

This door is difficult to operate. Recommend improvements for better function.

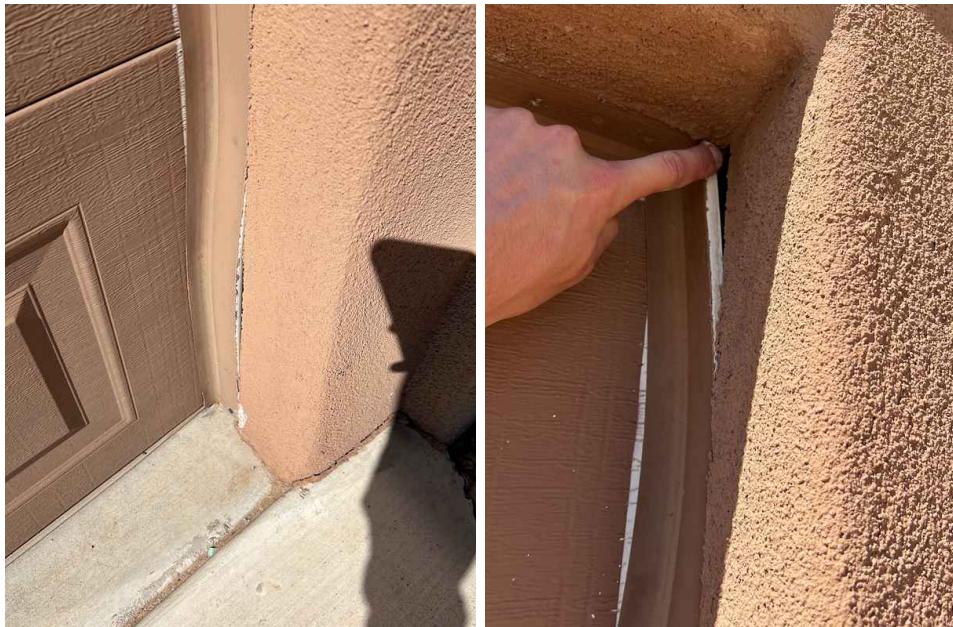
## 2.7.5 G. Doors (Interior and Exterior)

The weather-stripping at the bottom of the overhead garage door is loose and should be re-secured.

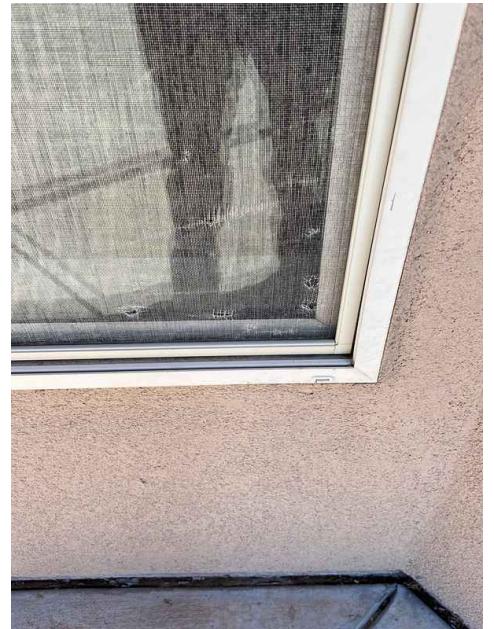
## 2.8.1 H. Windows

One or more of the window screens were observed to be damaged.

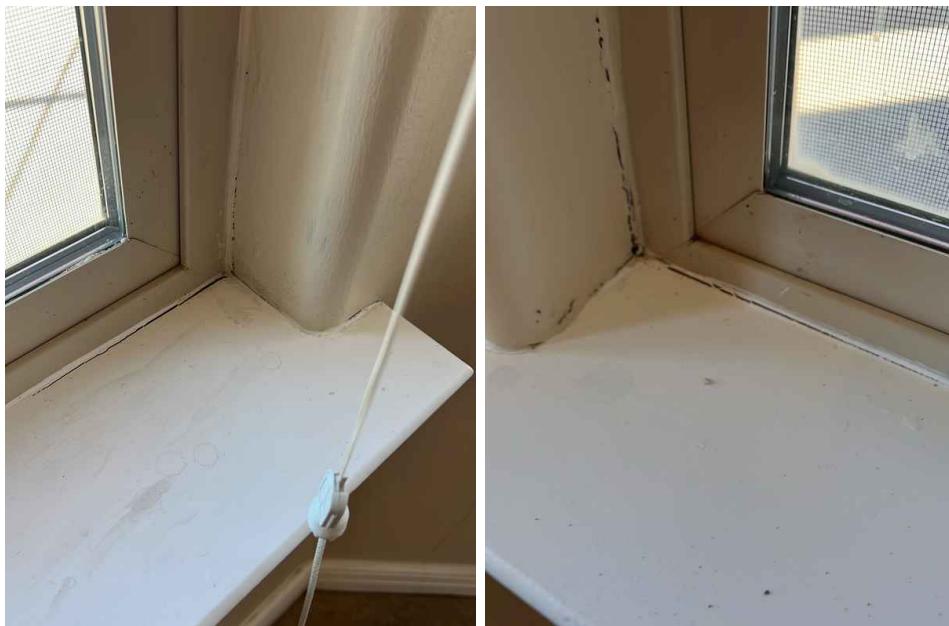
## 2.8.2 H. Windows

Areas of cracked or degraded interior sealant around window frames can be improved.

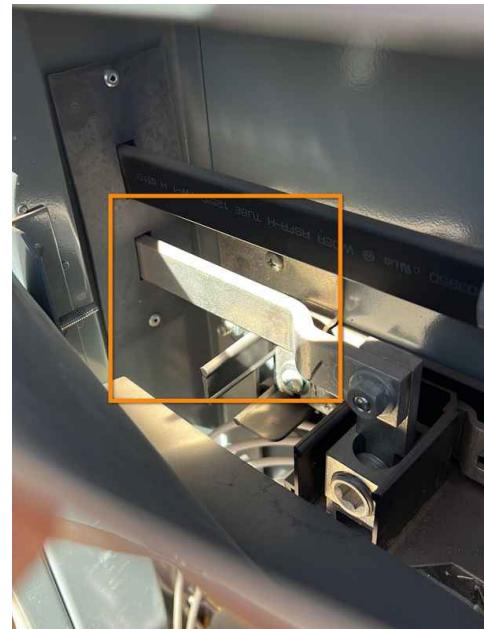
A service entrance conductor was noted to be missing insulation. This may contact the panel and become energized. Recommend further evaluation and correction by a licensed electrical contractor.

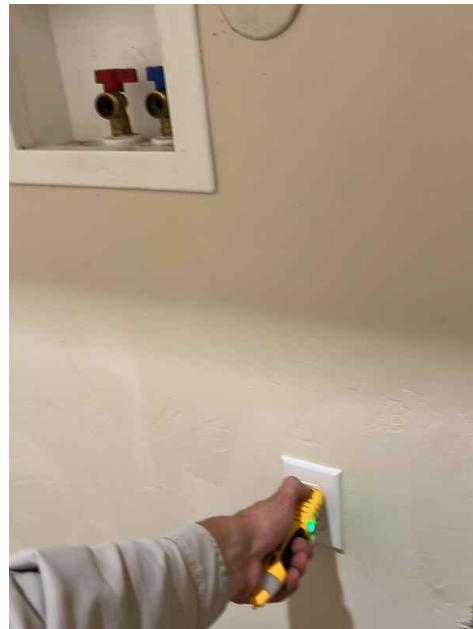
## 3.2.1 B. Branch Circuits, Connected Devices, and Fixtures

**MISSING GFCI**

A GFCI receptacle can provide protection for other receptacles downstream on the circuit. GFCI protection can be provided by GFCI breakers, blank face devices, or GFCI receptacles

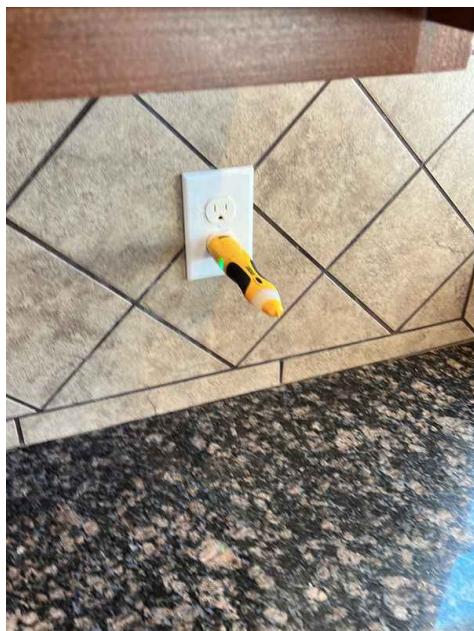
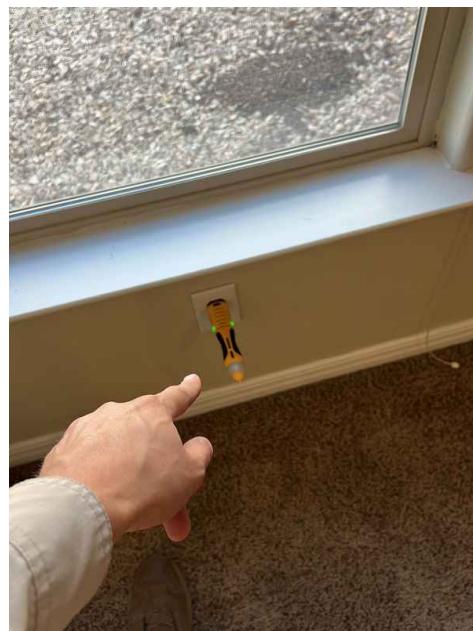
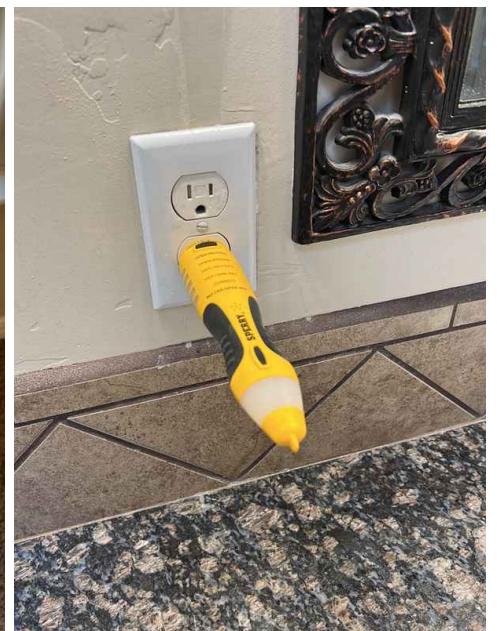
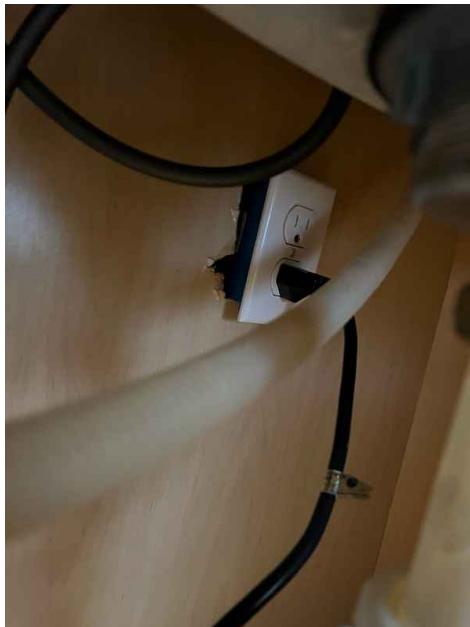
### 3.2.2 B. Branch Circuits, Connected Devices, and Fixtures

One or more of the receptacles were observed to be loose at the wall mount.

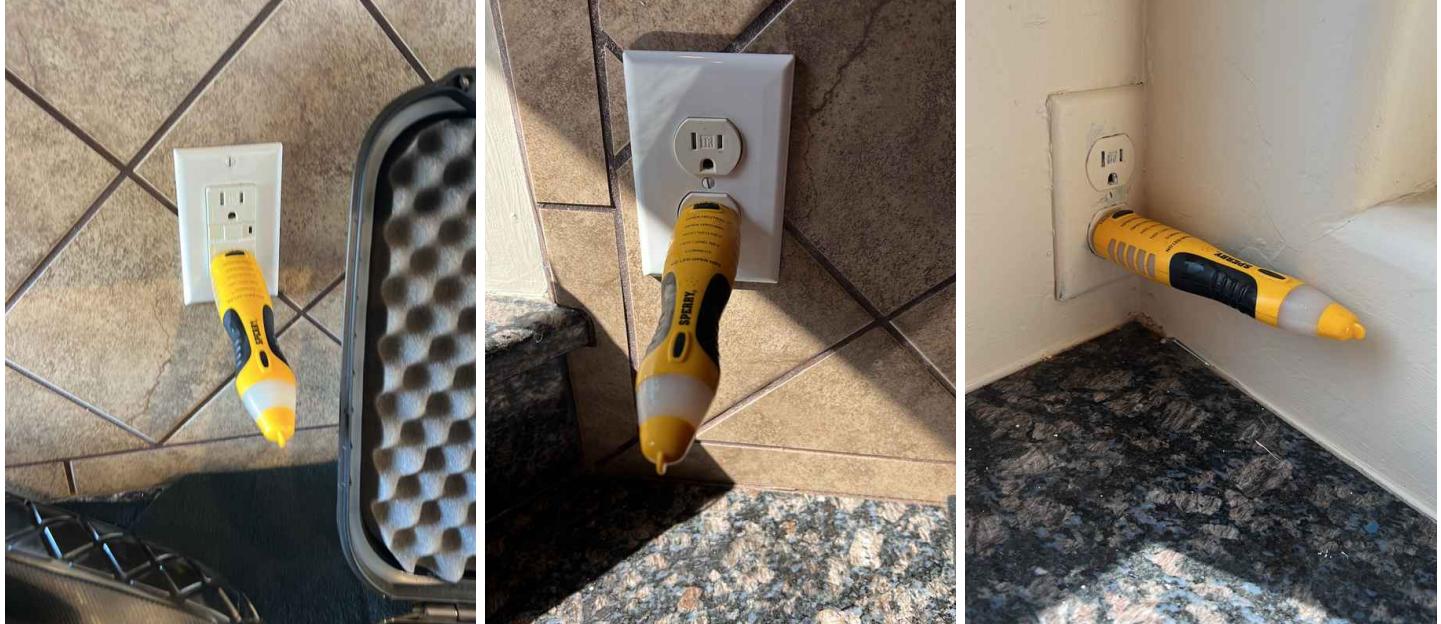
## 3.2.3 B. Branch Circuits, Connected Devices, and Fixtures

One or more of the receptacles appears to be inoperative. This receptacle(s) and circuit should be investigated and corrected as necessary.

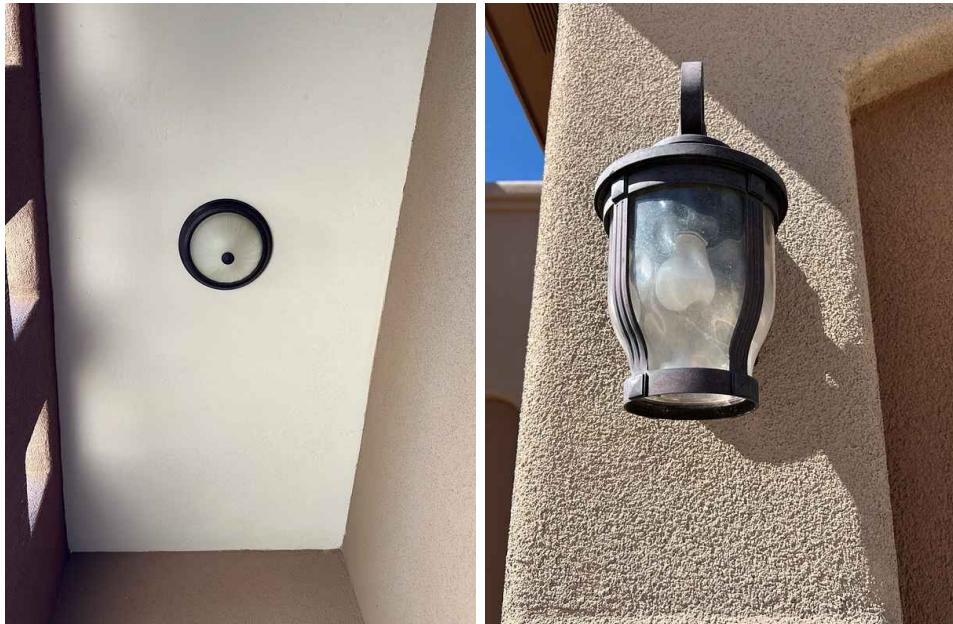
One or more of the light fixtures appear to be inoperative. This may be due to a bad bulb or some other unknown condition. This condition should be further evaluated and corrected as necessary.

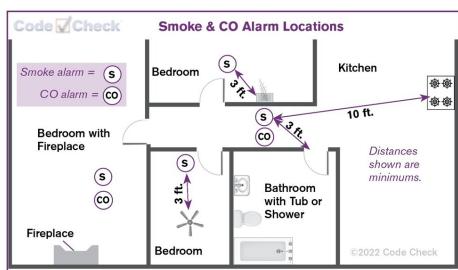
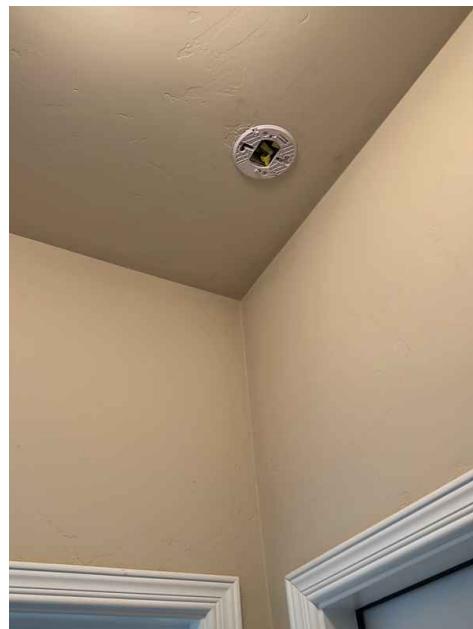
### 3.2.6 B. Branch Circuits, Connected Devices, and Fixtures

There are not enough smoke and/or CO alarms located in the home. Under current building standards, there should be a smoke alarm located in each sleeping room, Smoke and CO alarms outside each separate sleeping area in the immediate vicinity of the sleeping rooms, and on each additional story of the dwelling.

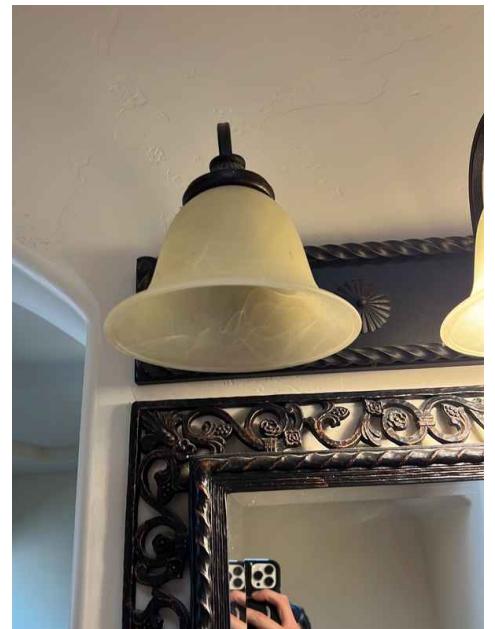
### 3.2.7 B. Branch Circuits, Connected Devices, and Fixtures

A light fixture was missing a lightbulb.

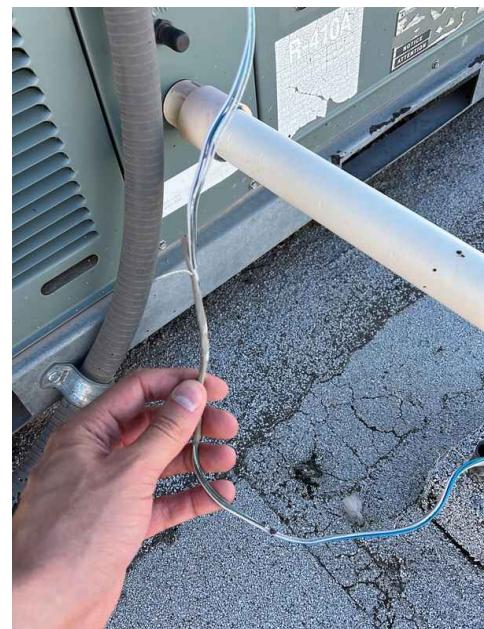
Low-voltage wire was noted to have degraded sheathing.  
Recommend correction to prevent from causing functional issues.

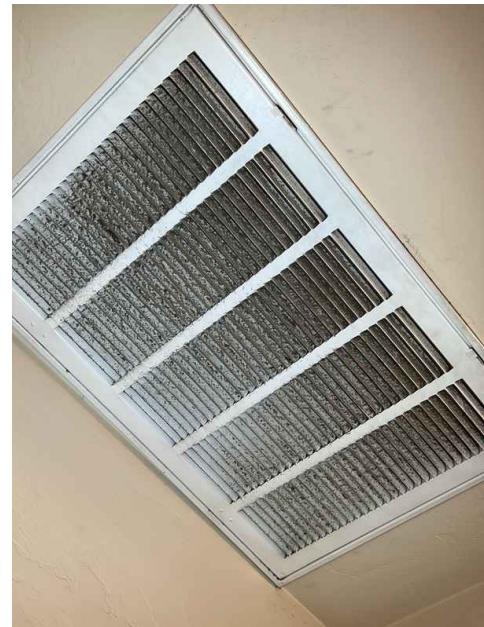
### 4.3.1 C. Duct Systems, Chases, and Vents

There is visible dust on the return air grill. Recommend cleaning.

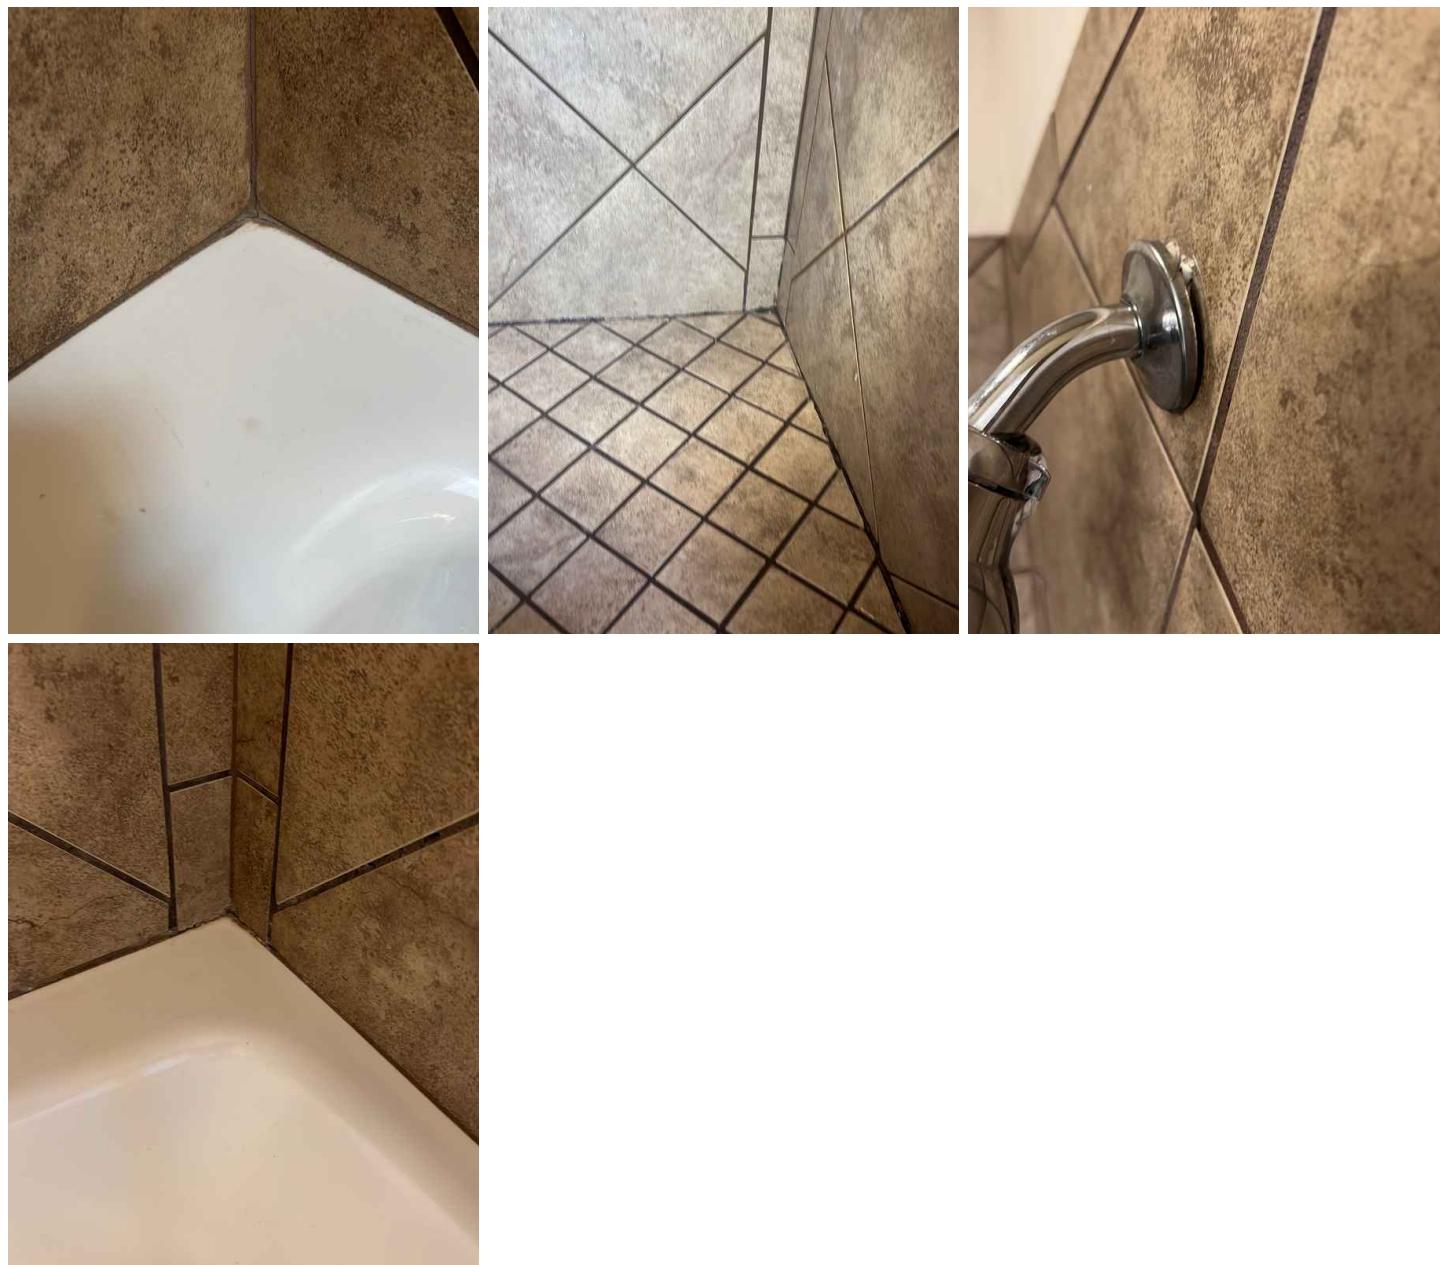
Cracked, deteriorated and/or missing bathtub enclosure grout and/or caulking should be repaired or replaced as necessary.

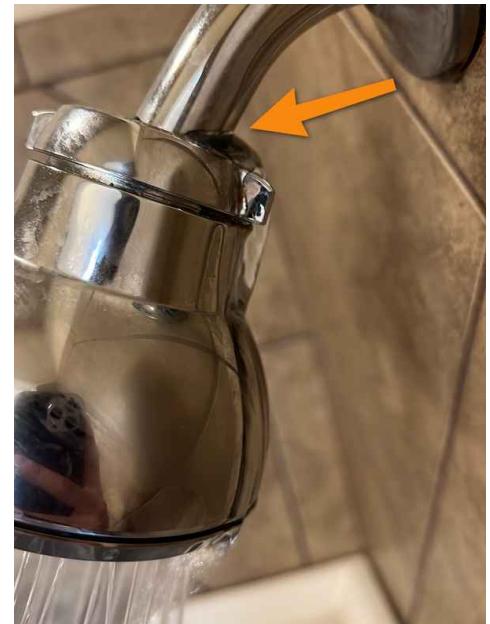
## 5.1.3 A. Plumbing Supply, Distribution Systems, and Fixtures

The shower head is damaged and does not appear to be functioning properly.

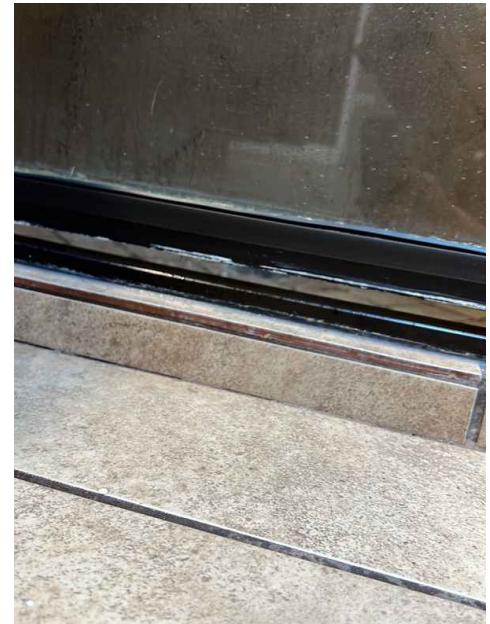
## 5.1.4 A. Plumbing Supply, Distribution Systems, and Fixtures

The shower door weatherstripping is damaged/missing.

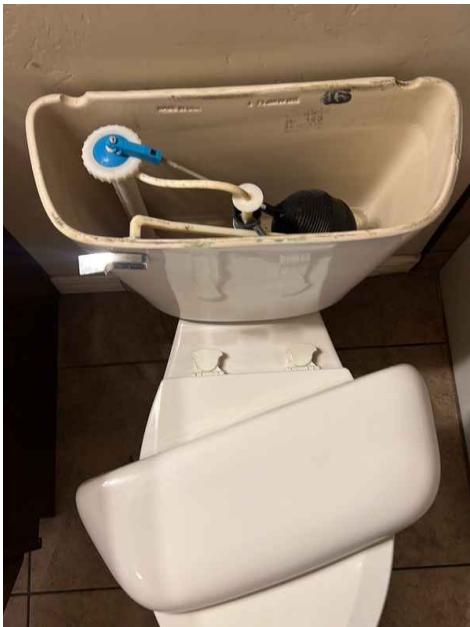
## 5.1.5 A. Plumbing Supply, Distribution Systems, and Fixtures

The water was turned off to the commode at the time of this inspection. This condition should be further evaluated and corrected as necessary.

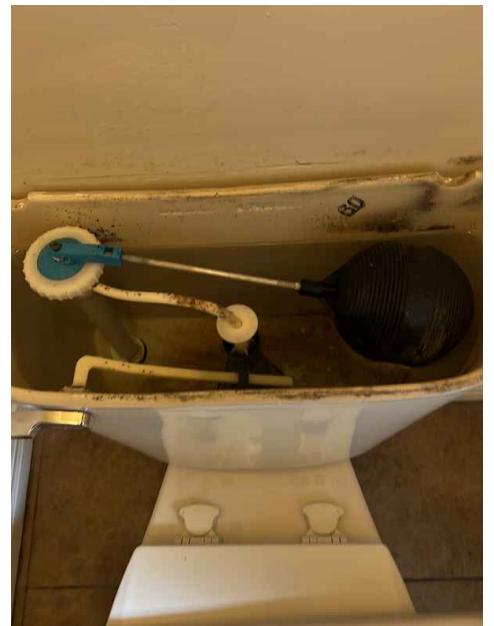
## 5.1.6 A. Plumbing Supply, Distribution Systems, and Fixtures

The toilet was noted to have water running in the tank after the initial fill.

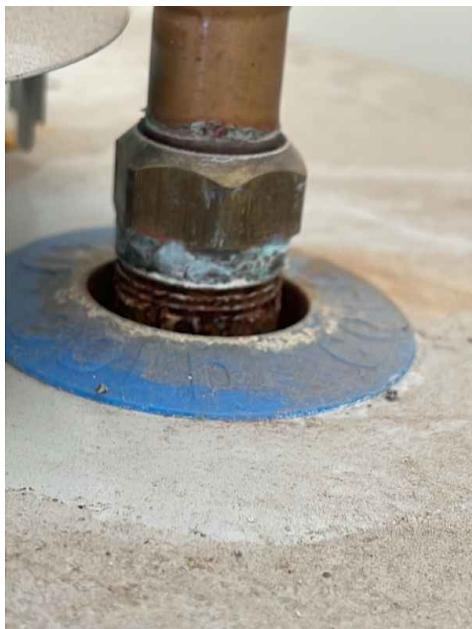
## 5.3.1 C. Water Heating Equipment

Some corrosion was observed at the water supply connections at the top of the water heater.

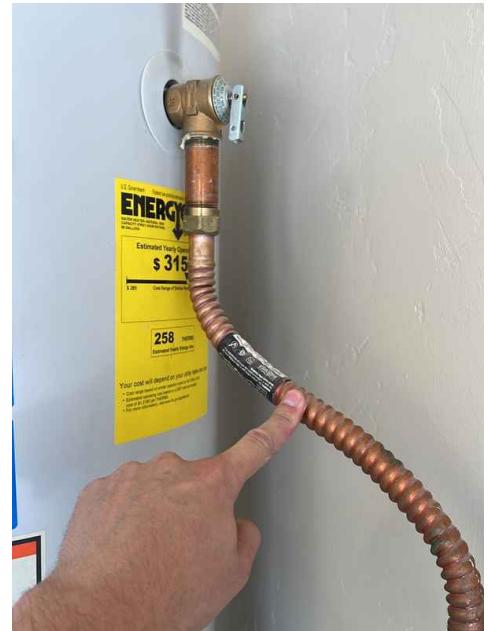
The temperature and pressure relief (TPR) valve discharge pipe is undersized. The TPR discharge pipe should not be reduced.

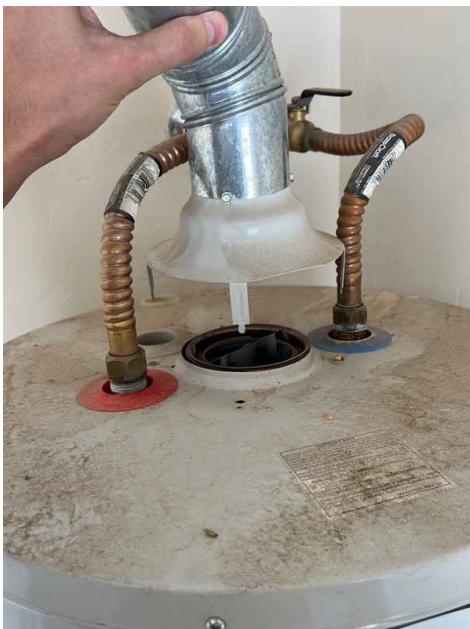
### 5.3.4 C. Water Heating Equipment

The vent pipe is not properly mounted at the top of the water heater. This configuration will emit Carbon Monoxide into the heater compartment, which is a known safety hazard.

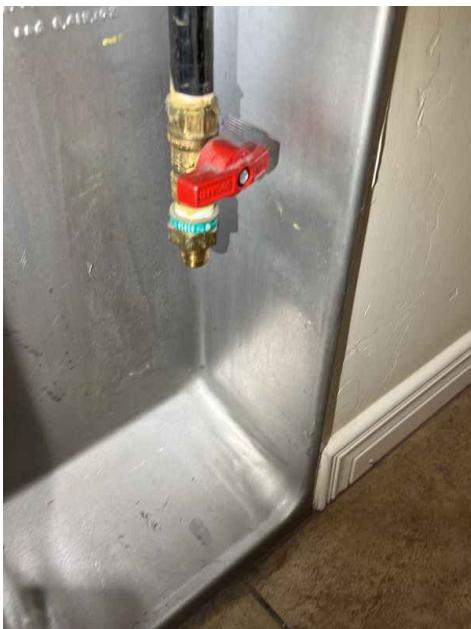
#### 5.5.2 E. Gas Distribution Systems and Gas Appliances

All unused gas valve ends should be capped off for safety purposes.

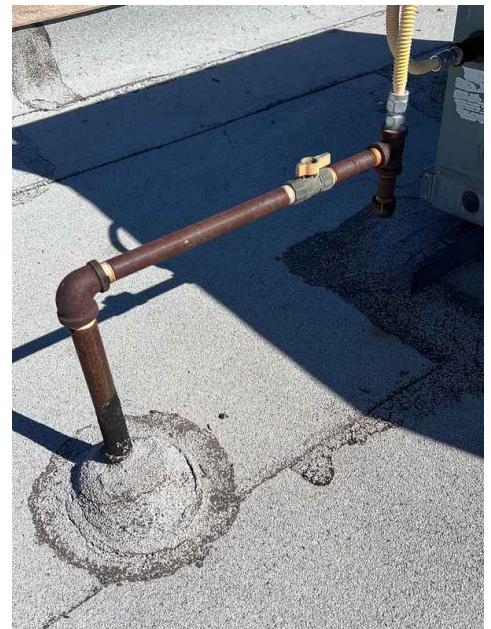
#### 5.5.3 E. Gas Distribution Systems and Gas Appliances

Exterior gas line presented with some surface rust and should be painted to properly protect the surface.
