## NEW MEXICO RESIDENTIAL REPORT

1234 Main Street  
El Paso, TX 79924

Buyer Name  
12/20/2025 9:00AM

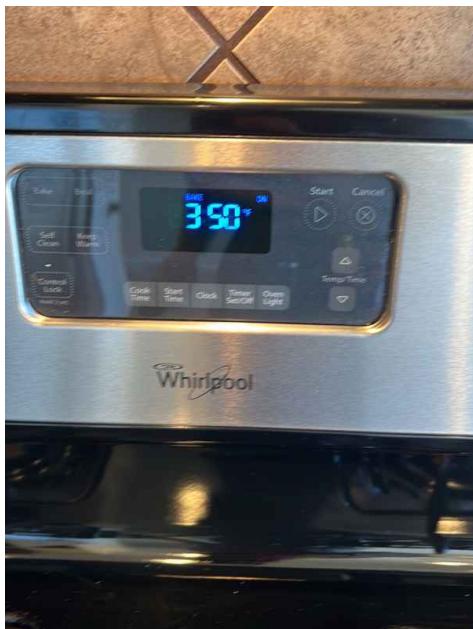
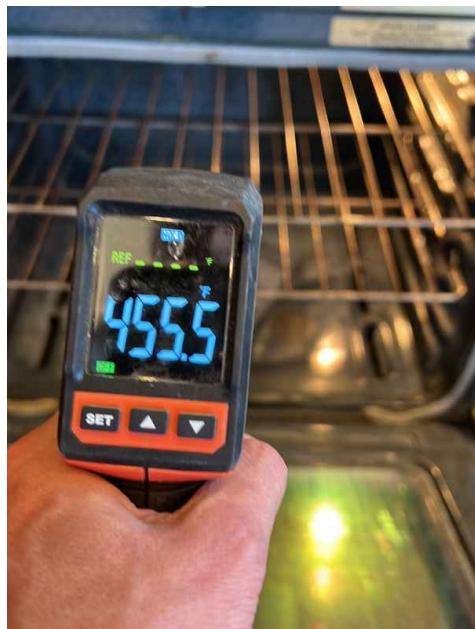
The temperature of the oven is not consistent with the temperature the control is set at.

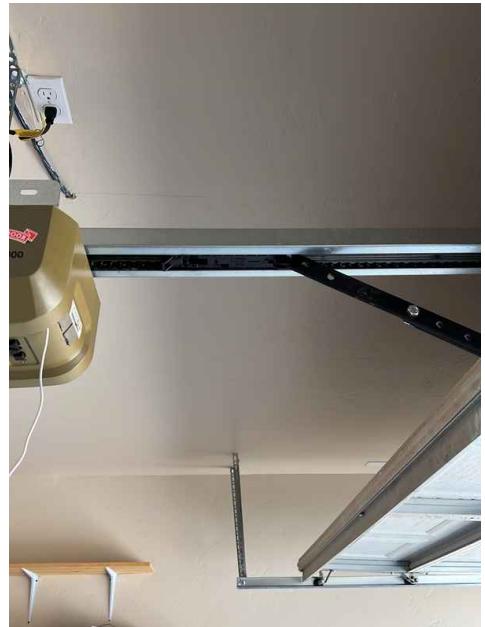
#### 6.7.1 G. Garage Door Operators

The manual release (emergency release) cord is missing at the garage door opener connection.

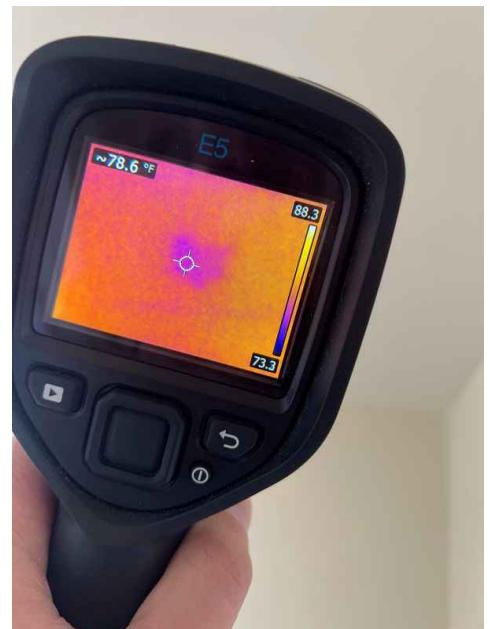
A temperature anomaly was noted in a secondary bathroom. This area was tested for moisture with a moisture meter however was found to be dry. It is recommended that this area is closely monitored for any stains.
