AGAVE PROPERTY INSPECTIONS, PLLC

## NEW MEXICO RESIDENTIAL

1234 Main Street  
El Paso, TX 79924

08/27/2025 9:00AM

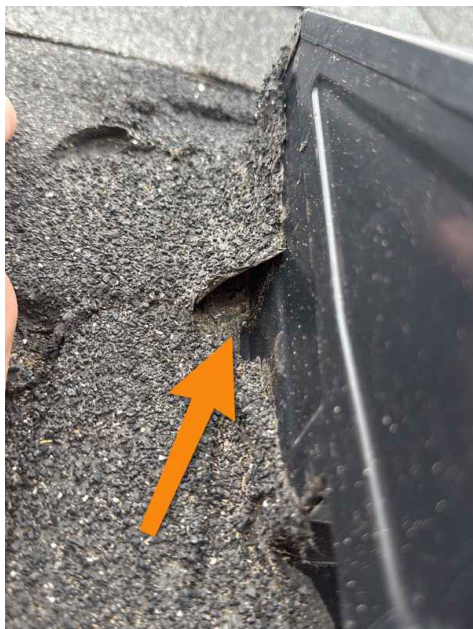
One or more of the shingles were observed to be lifting and should be properly sealed.

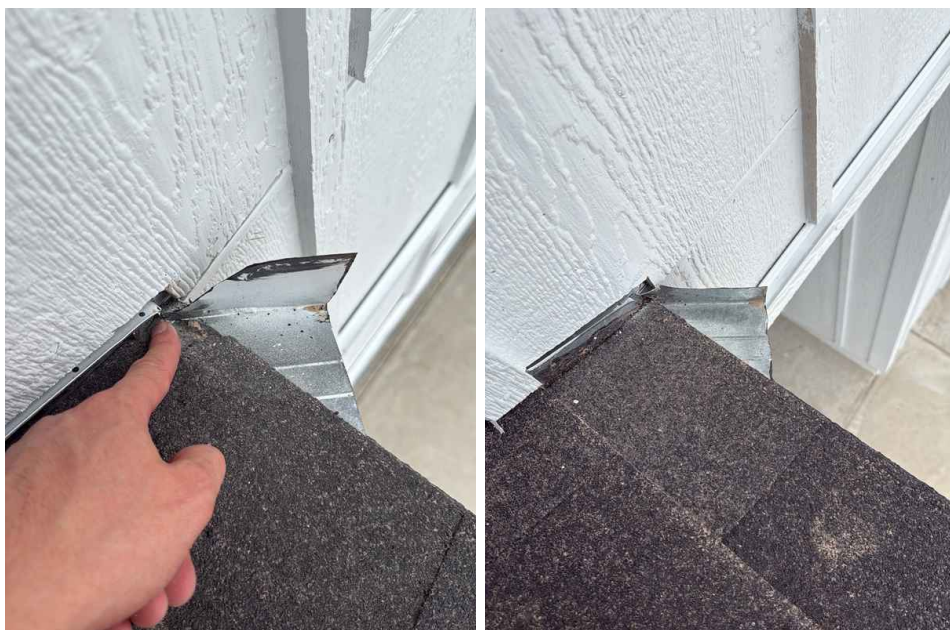
### 2.3.2 C. Roof Covering Materials

#### **FLASHING - IMPROPER INSTALLATION**

The flashing is not properly installed. This condition could allow water intrusion at this location.

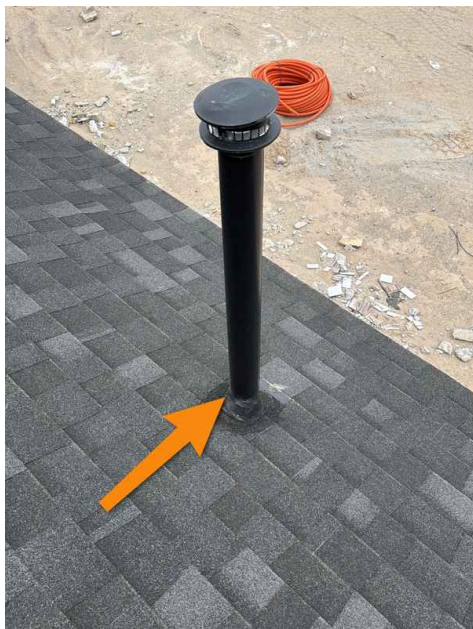
### 2.3.3 C. Roof Covering Materials

#### **FLASHING - STORM COLLAR MISSING**

The storm collar at the roof level vent pipe for the gas equipment is missing and should be replaced to help prevent water intrusion within the roof structure.

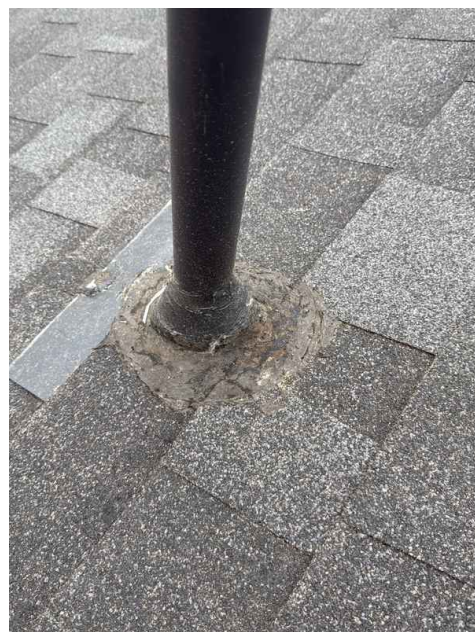
#### 2.3.4 C. Roof Covering Materials

##### **SEALANT MISSING GRANULES**

Sealant is missing granule protection.

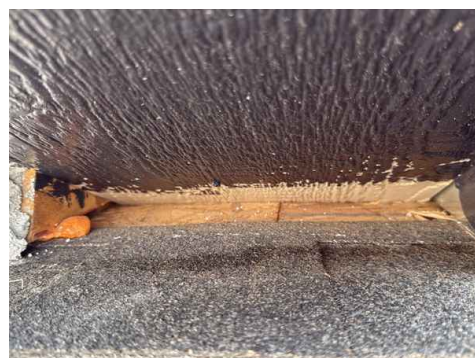
#### 2.4.1 D. Roof Structures, Attics, Ventilation, Insulation

##### **UNFINISHED AREAS**

One or more areas under the eaves is not fully finished and/or not fully sealed.

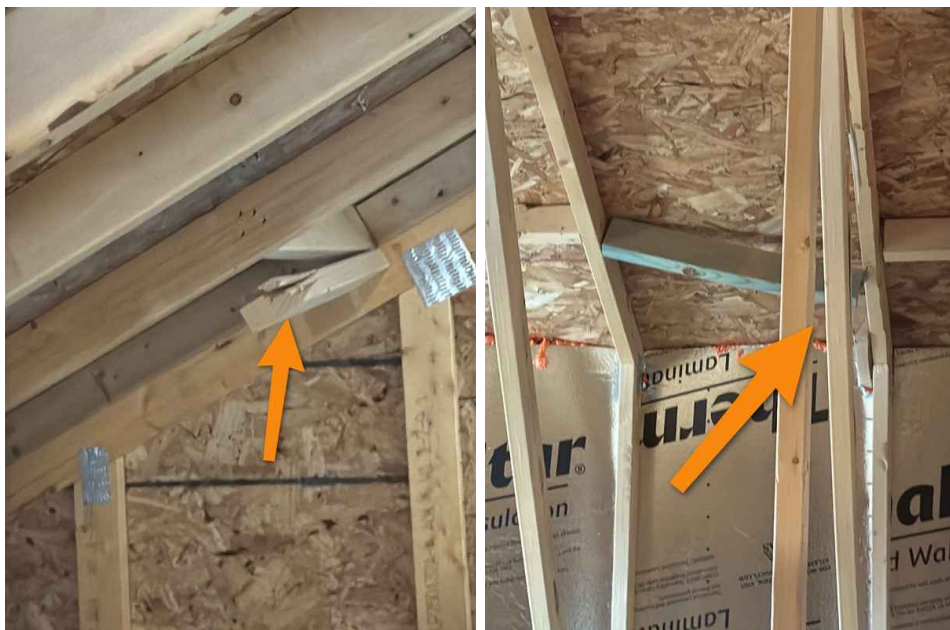
#### 2.4.2 D. Roof Structures, Attics, Ventilation, Insulation

##### **DAMAGED FRAMING**

One or more roof bracing members were noted to be damaged.

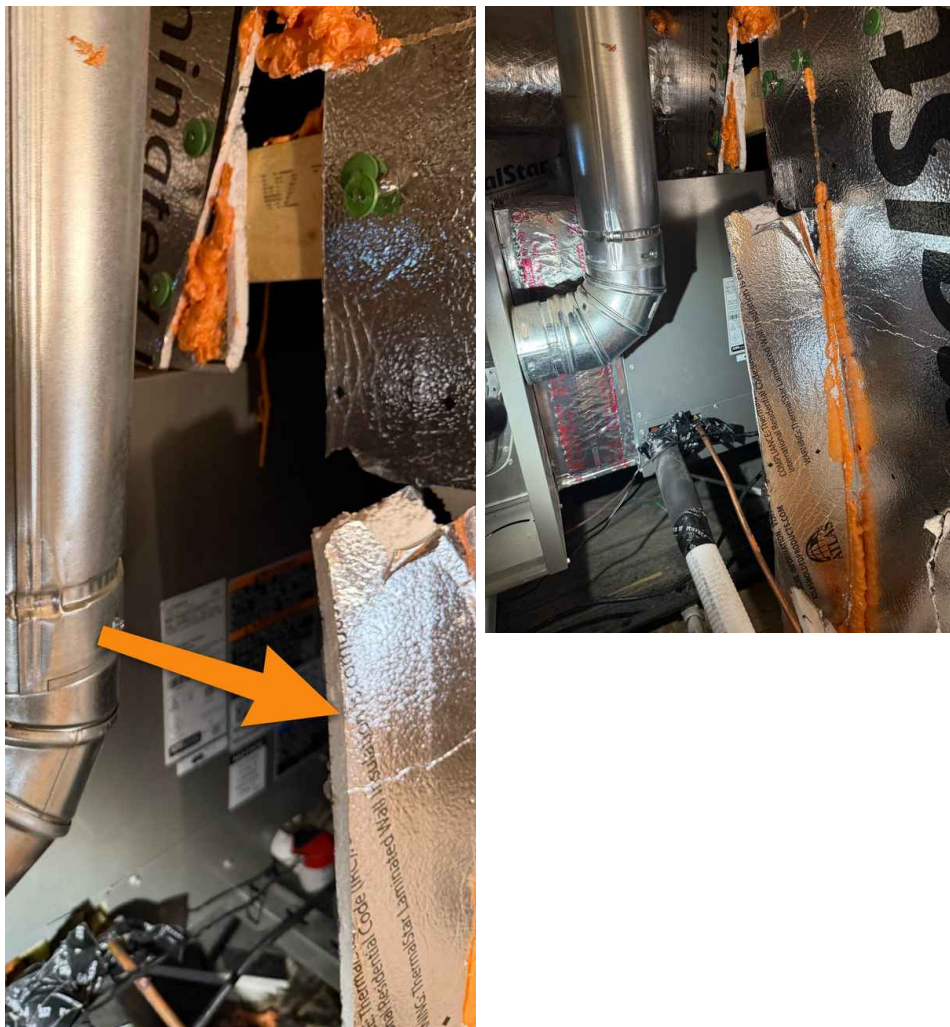
#### 2.4.3 D. Roof Structures, Attics, Ventilation, Insulation

##### **HVAC THROUGH INSULATED WALL**

The HVAC system is installed between a wall of foam board insulation. Some of the foam board is damaged near this area. Not all of the HVAC components are readily accessible for maintenance due to this installation. This may also reduce effectiveness of the foam insulation board.

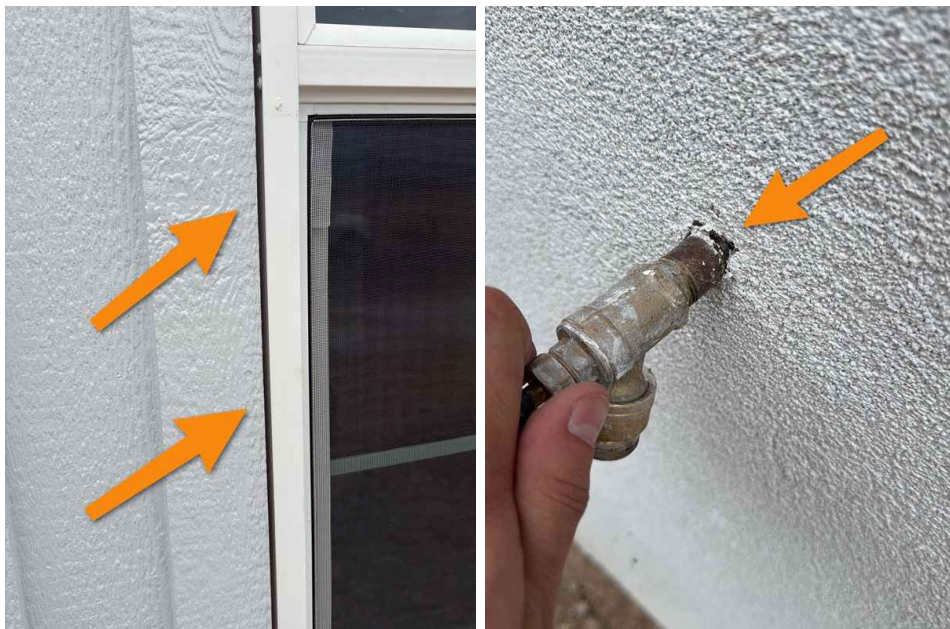
### 2.5.1 E. Walls (Interior and Exterior), Countertops, Cabinets

#### **SEALANT - EXTERIOR PENETRATIONS**

The area between the exterior cladding / veneer and all of the wall penetrations / openings need to be properly sealed. Areas such as utility connections, windows, downspouts, hose bibbs, lighting fixtures, receptacles etc. It is recommended to use an elastomeric caulking / sealant.

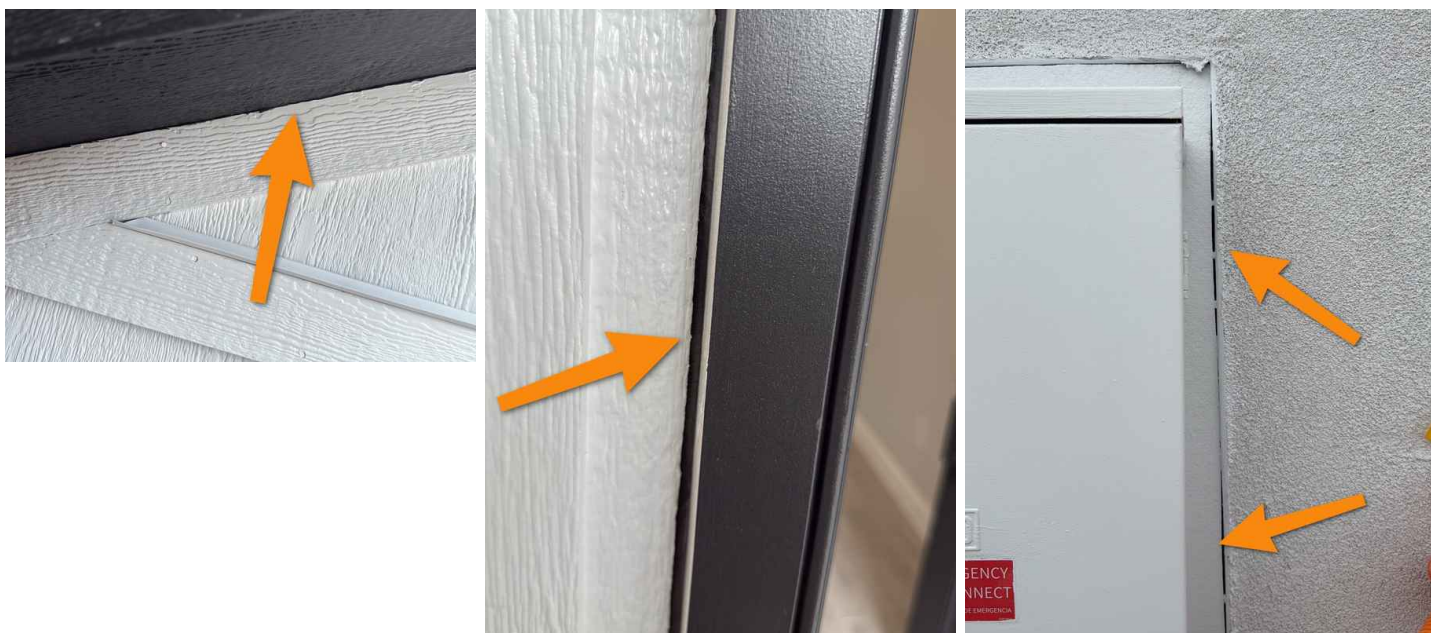
### 2.5.2 E. Walls (Interior and Exterior), Countertops, Cabinets

#### **SEALANT - SIDING JOINTS**

All joints between two different types of siding should be properly sealed. It is recommended to use elastomeric sealant.

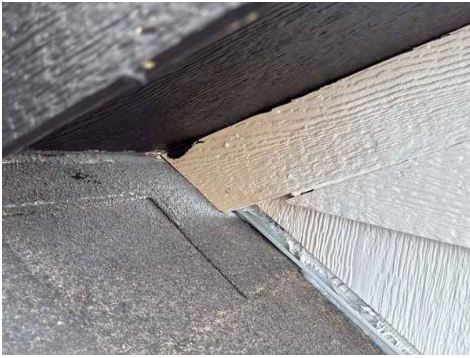
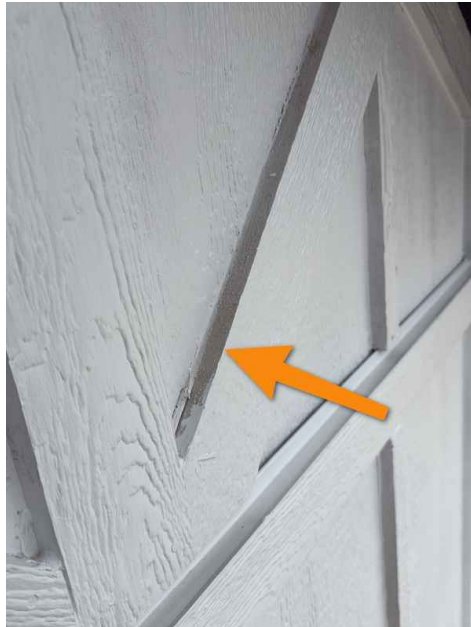
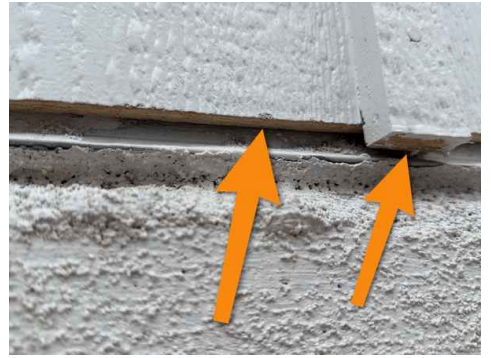
### 2.5.3 E. Walls (Interior and Exterior), Countertops, Cabinets

#### **PAINT IMPROVEMENTS**

Some exterior surfaces and/or trim need a fresh coat of paint to protect from exposure.

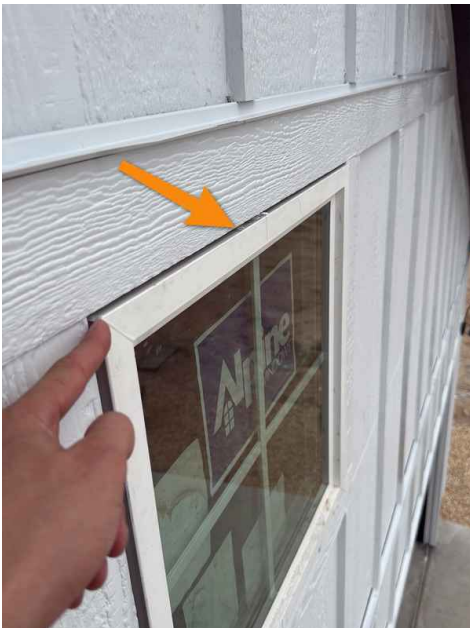
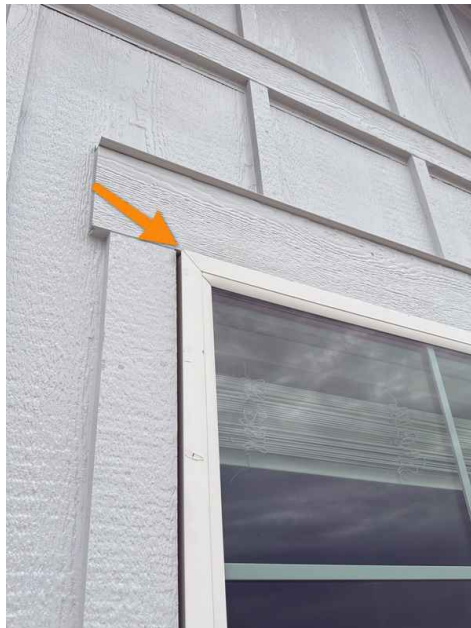
#### 2.5.4 E. Walls (Interior and Exterior), Countertops, Cabinets

##### **FLASHING - MISSING WINDOW HEADWALL**

The window headwall flashing is missing. Proper flashing is required to prevent water intrusion around the window, which can lead to moisture damage, mold growth, and deterioration of the surrounding wall assembly.

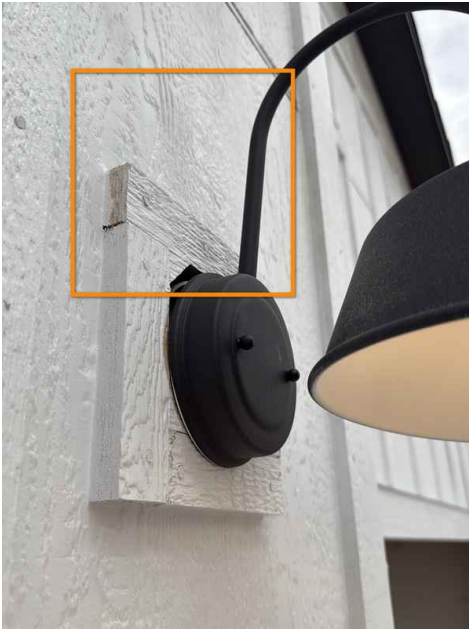
#### 2.5.5 E. Walls (Interior and Exterior), Countertops, Cabinets

##### **FLASHING - FIBER CEMENT TRANSITIONS**

The fiber cement siding is required to have Z-flashing and L-flashing at the siding transitions. It is recommended for the flashing to be installed to prevent water intrusion.

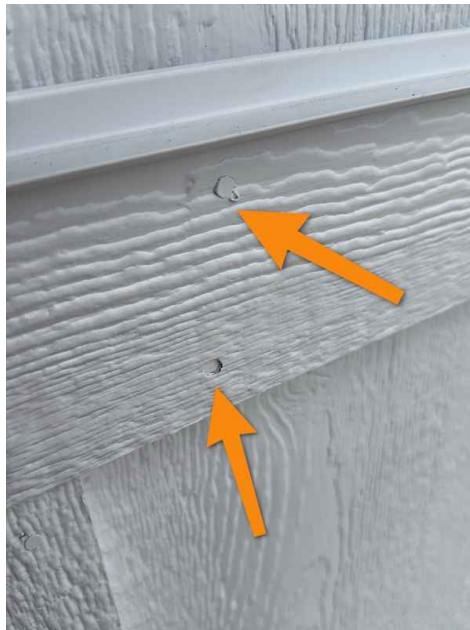
#### 2.5.6 E. Walls (Interior and Exterior), Countertops, Cabinets

##### **FIBER CEMENT - IMPROPER FASTENING**

The fiber cement siding is not properly fastened at the time of the inspection. Under current installation standards, all fiber cement fasteners should be flush with the siding.

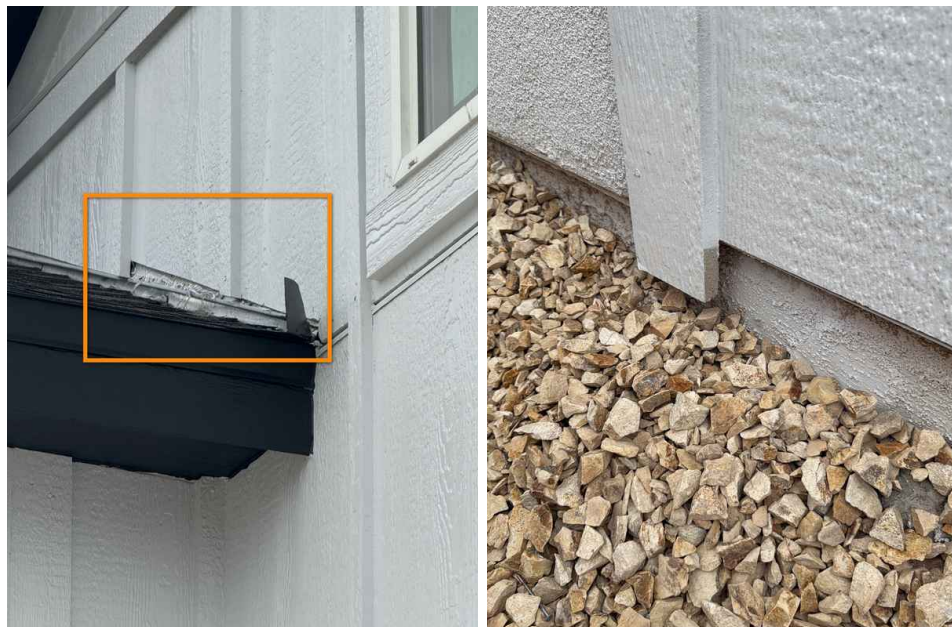
#### 2.5.7 E. Walls (Interior and Exterior), Countertops, Cabinets

##### **FIBER CEMENT - IMPROPER TRIM INSTALLATION**

The fiber cement trim is not properly installed.

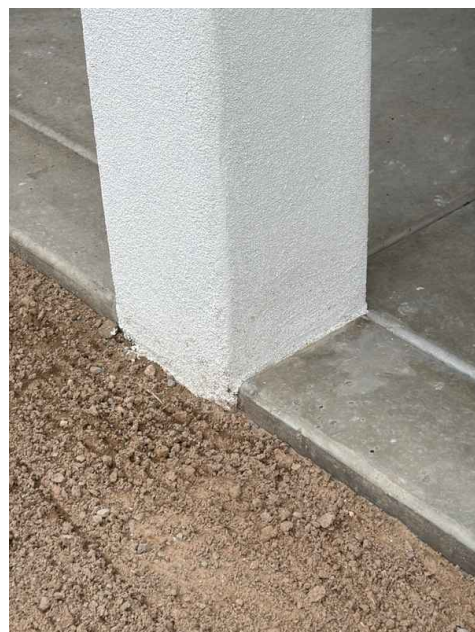
#### 2.5.8 E. Walls (Interior and Exterior), Countertops, Cabinets

### **STUCCO - FLATWORK CLEARANCE**

The exterior stucco type veneer/cladding has inadequate clearance from the concrete flatwork. Most manufacturers require a minimum of 2-inches of clearance from all concrete flatwork. It is common to install stucco in this manner locally however is not recommended by industry standards. It is important to ensure that no water pools next to the stucco.

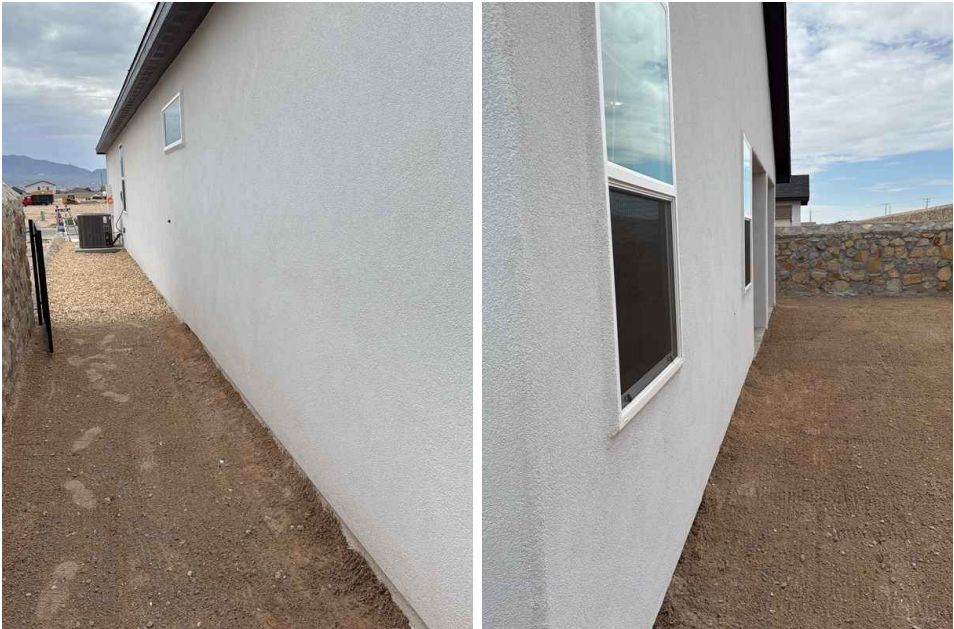
#### 2.5.9 E. Walls (Interior and Exterior), Countertops, Cabinets

### **STUCCO - LACKS CONTROL JOINTS**

The exterior stucco type veneer/cladding is missing one or more of its control and expansion joints. Control joints are recommended every 144 sq ft and expansion joints over windows and doors. If joints are not properly installed it can cause stucco to crack outside of the joints.

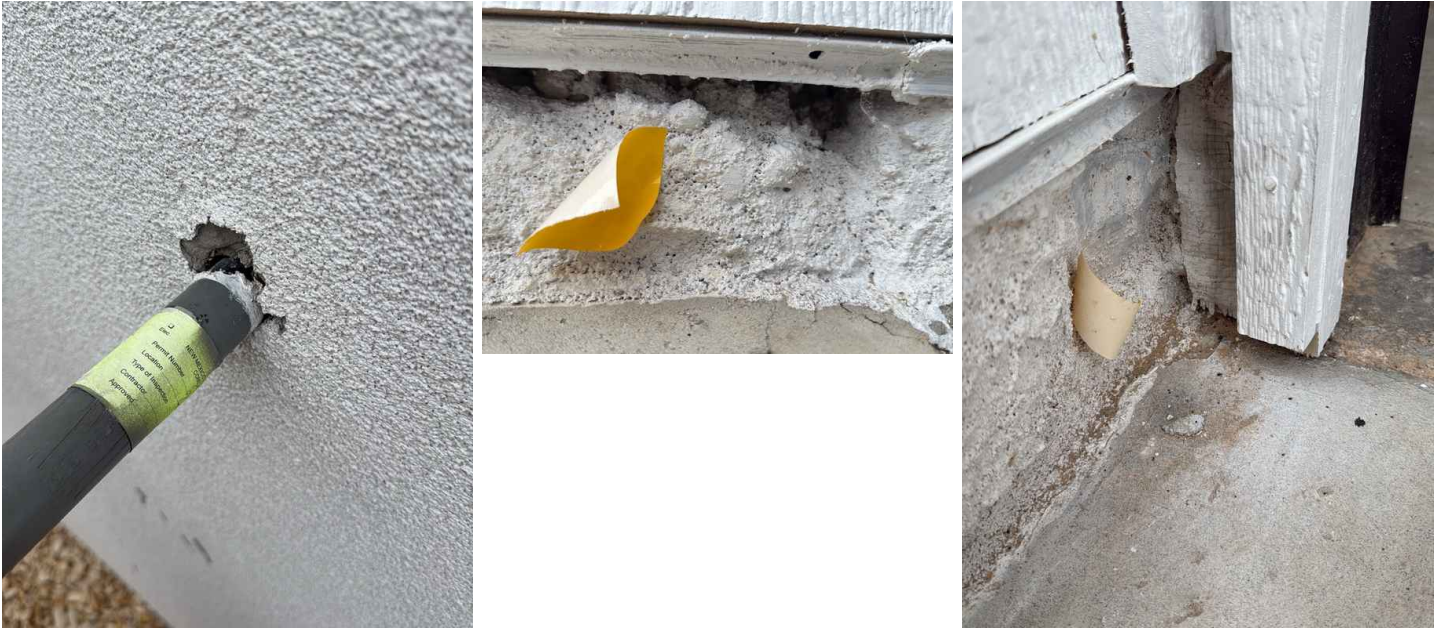
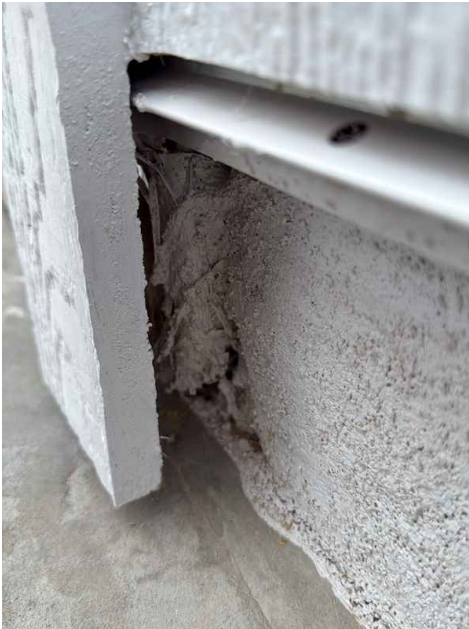
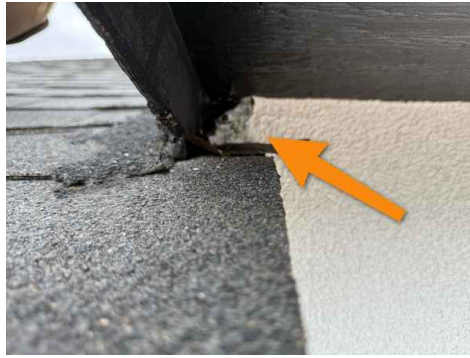
2.5.10 E. Walls (Interior and Exterior), Countertops, Cabinets

**UNFINISHED AREAS**

There were areas of unfinished wall areas noted.

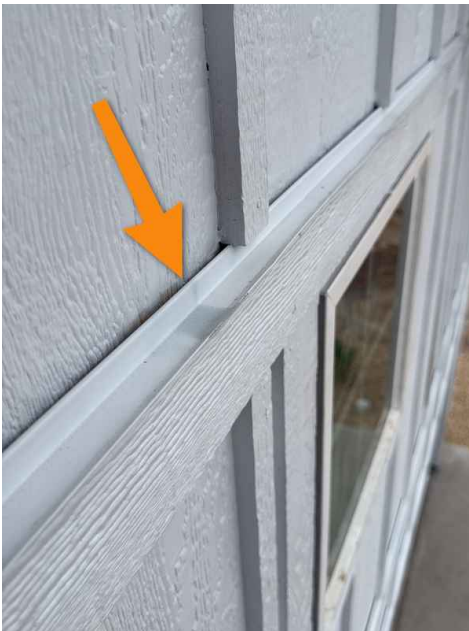
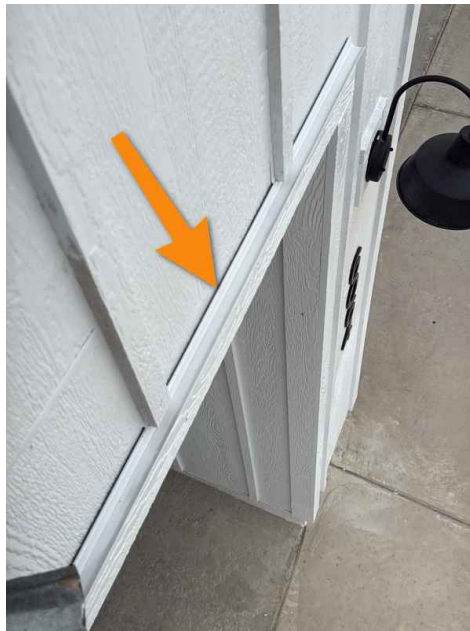
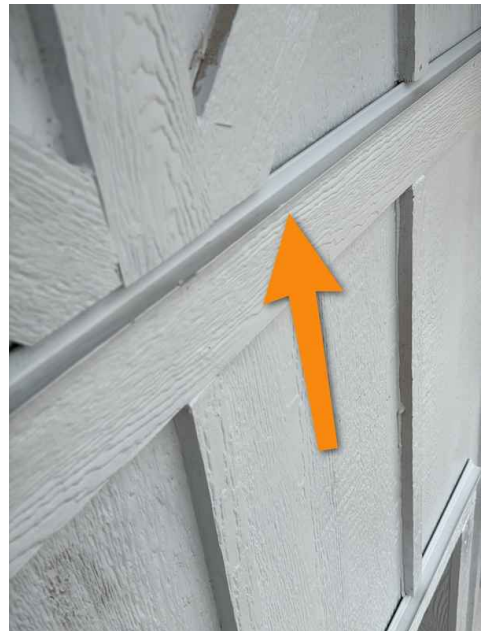
#### 2.5.11 E. Walls (Interior and Exterior), Countertops, Cabinets

##### **FLASHING UPSIDE DOWN**

The Z-flashing above the fiber cement siding is installed upside down. Incorrect flashing orientation can allow water intrusion behind the siding, leading to moisture damage or deterioration of building materials. Recommend correction by a qualified contractor to ensure proper water-shedding and compliance with installation guidelines.

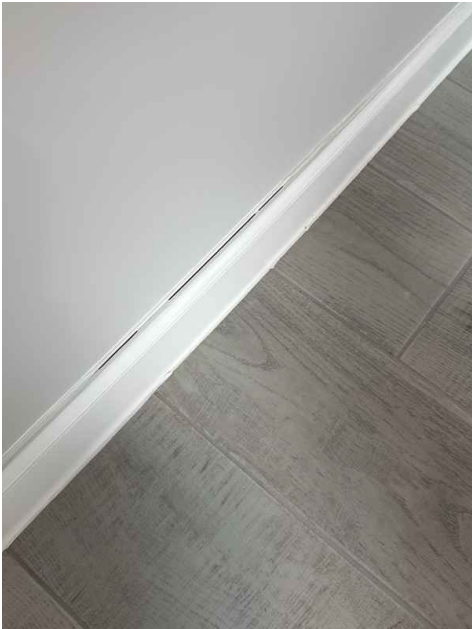
#### 2.5.12 E. Walls (Interior and Exterior), Countertops, Cabinets

##### **BASEBOARD CAULKING IMPROVEMENTS**

An area of needed caulk improvement between the wall and baseboard was observed.

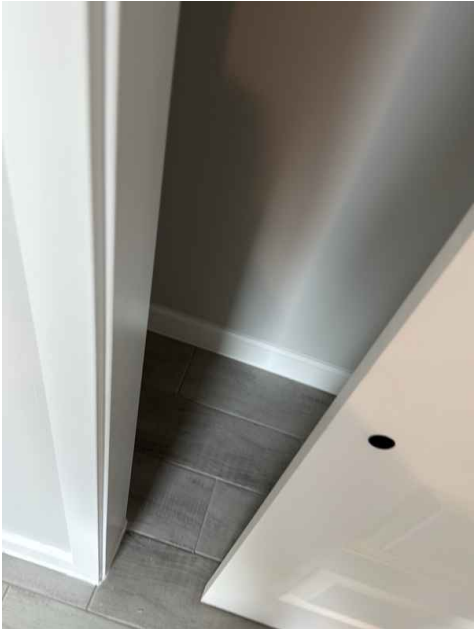
2.7.1 G. Doors (Interior and Exterior)

**DOOR - MISSING STOPS**

One or more doors is missing a door stop mechanism.

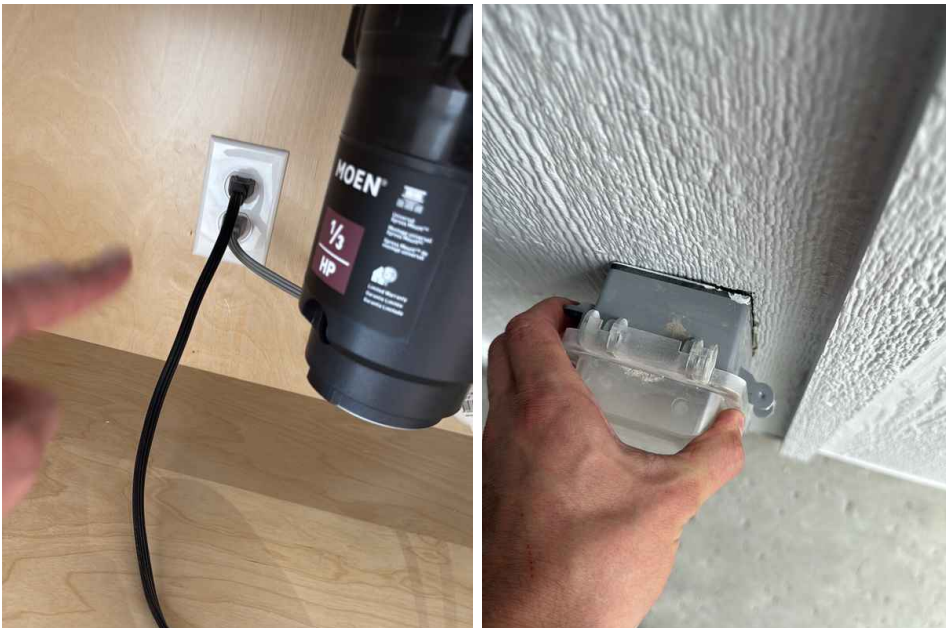
### 3.2.1 B. Branch Circuits, Connected Devices, and Fixtures

#### **LOOSE RECEPTACLES**

One or more of the receptacles were observed to be loose at the wall mount.

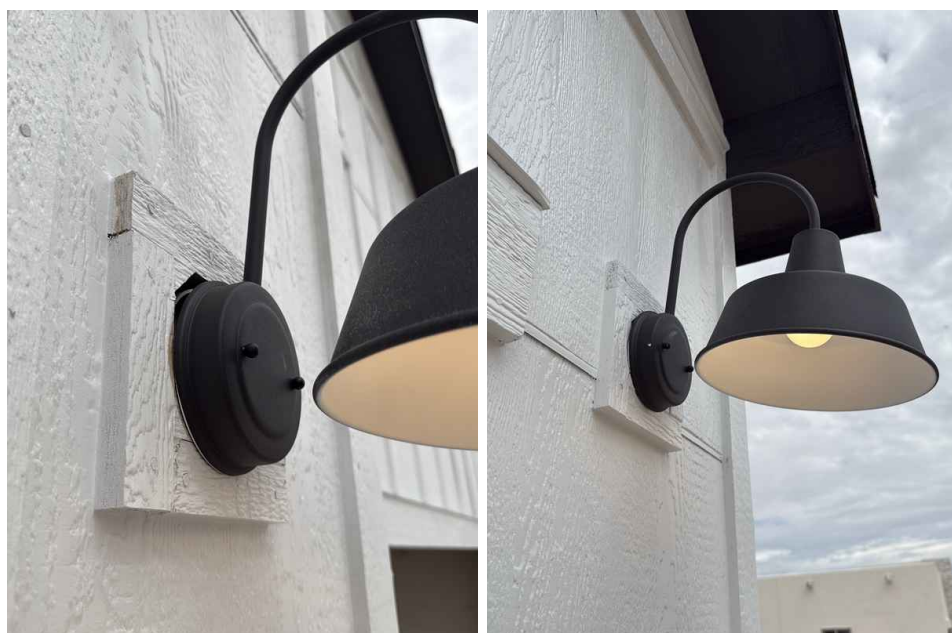
### 3.2.3 B. Branch Circuits, Connected Devices, and Fixtures

#### **LOOSE LIGHT FIXTURE**

Loose light fixture and poorly sealed areas noted.

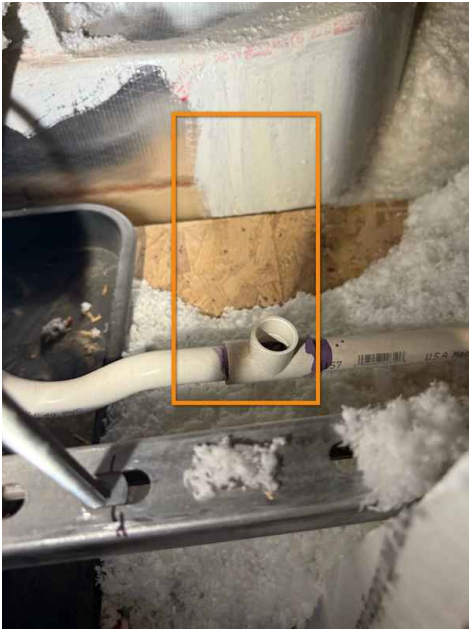
### 4.2.2 B. Cooling Equipment

#### **VERTICAL PVC RECOMMENDED**

Recommend adding vertical PVC piece to a height above drain connections to prevent overflow in the event of a clog.

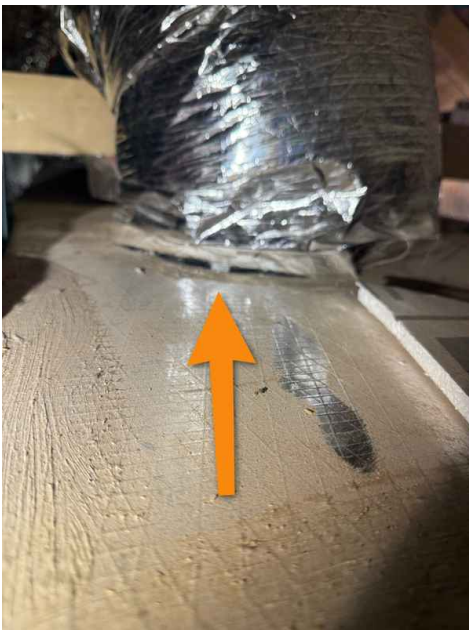
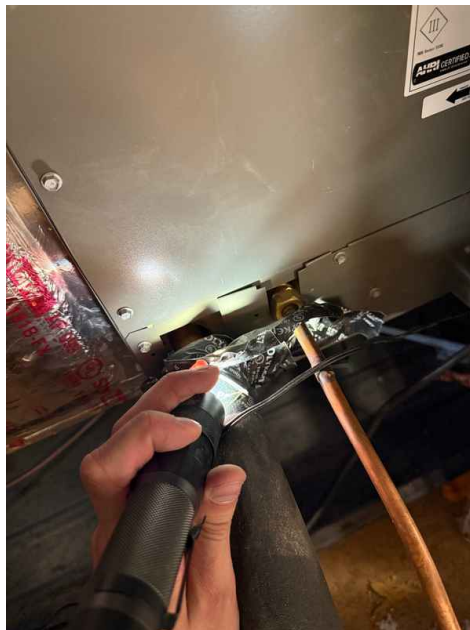
#### 4.3.1 C. Duct Systems, Chases, and Vents

##### **LOOSE JOINTS**

Loose fitting joints and/or openings in the ductwork should be sealed.

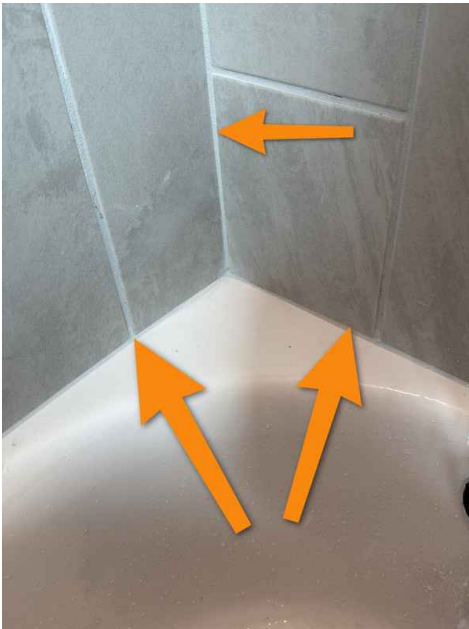
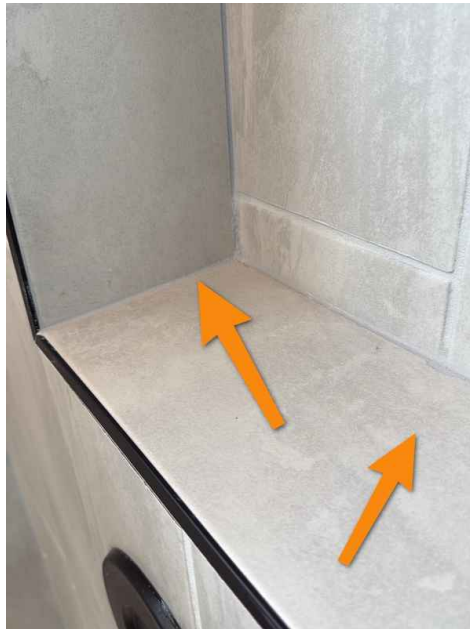
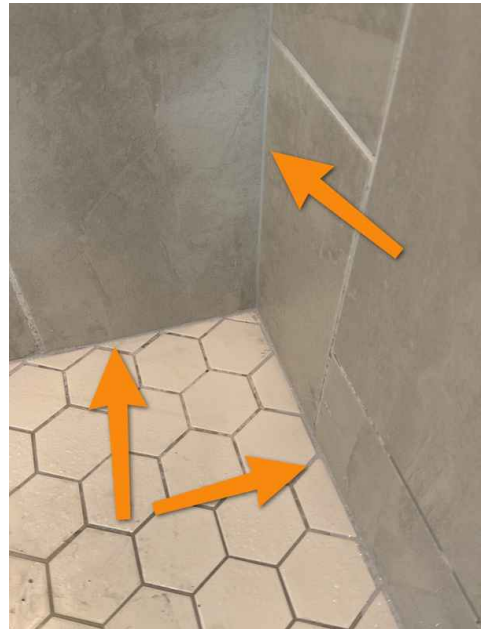
#### 5.1.3 A. Plumbing Supply, Distribution Systems, and Fixtures

Cracked, deteriorated and/or missing bathtub enclosure grout and/or caulking should be repaired or replaced as necessary.

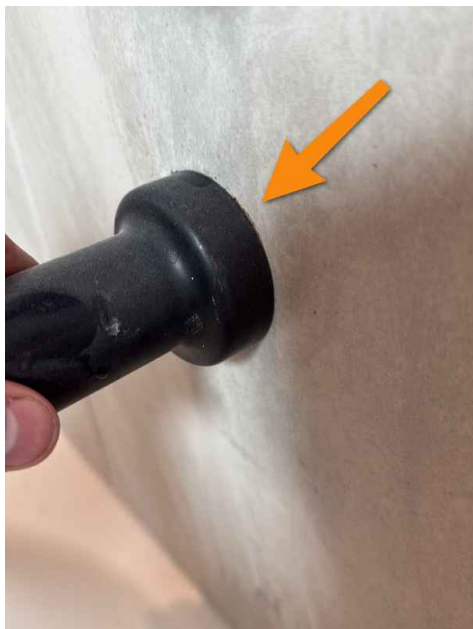
#### 5.1.4 A. Plumbing Supply, Distribution Systems, and Fixtures

The tub spout is not sealed at the wall. This condition has the potential to allow water to leak back into the wall cavity.

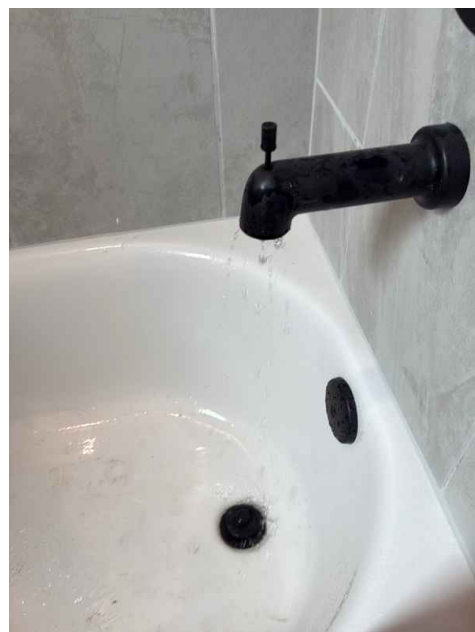
5.1.5 A. Plumbing Supply, Distribution Systems, and Fixtures

The bathtub shower head diverter is not functioning properly as it leaks water when the shower is activated.

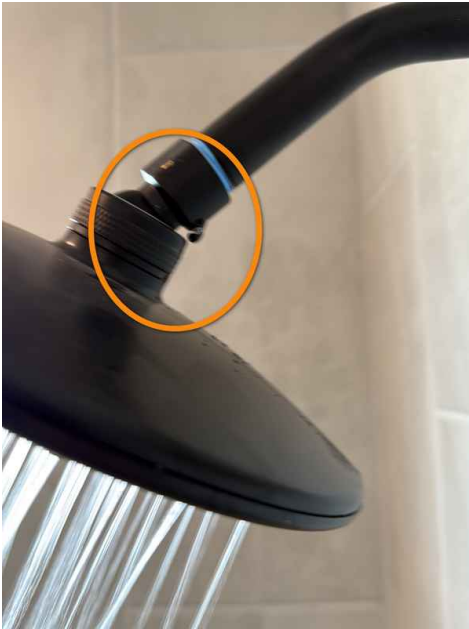
5.1.6 A. Plumbing Supply, Distribution Systems, and Fixtures

The shower head was noted to be leaking.

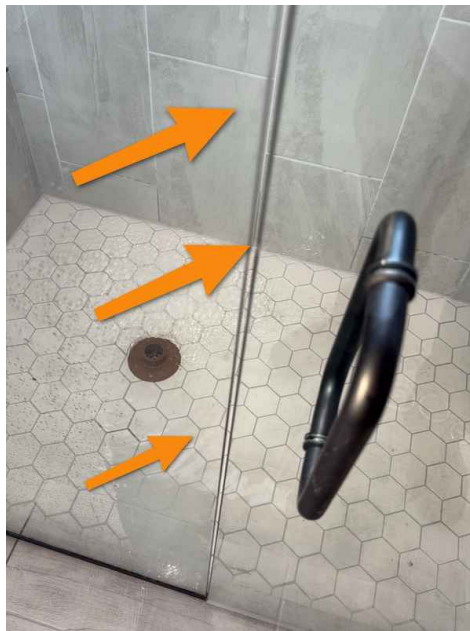
#### 5.1.7 A. Plumbing Supply, Distribution Systems, and Fixtures

Water was observed to be leaking onto the floor adjacent to the shower enclosure while checking the shower fixtures and enclosure. Enclosure was also noted to be missing the proper weather stripping at joints.

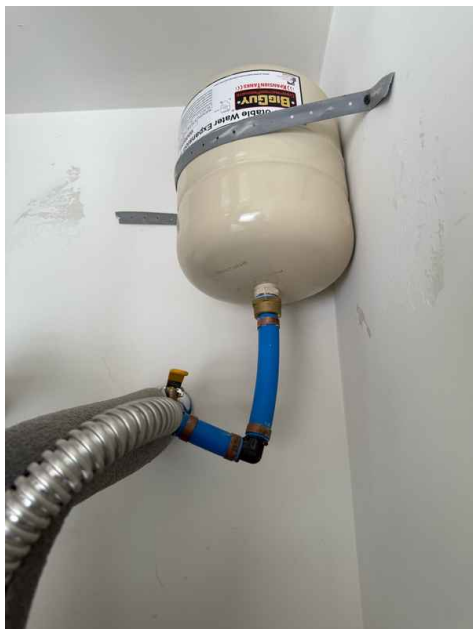
#### 5.1.8 A. Plumbing Supply, Distribution Systems, and Fixtures

Recommend mounting improvements to better secure the expansion tank at the water heater.

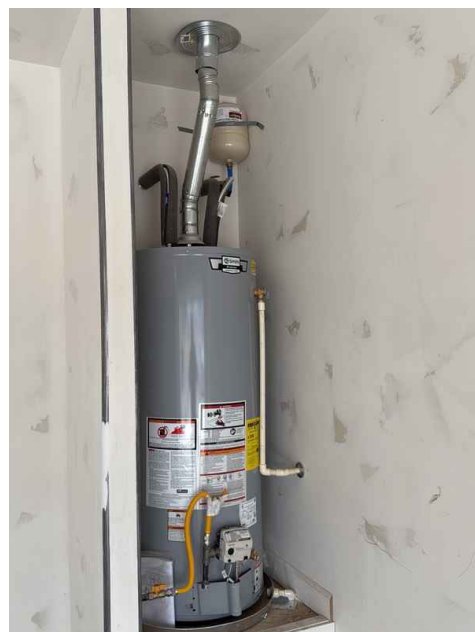
### 5.3.1 C. Water Heating Equipment

The water heater compartment does not appear to have adequate combustion air ventilation.

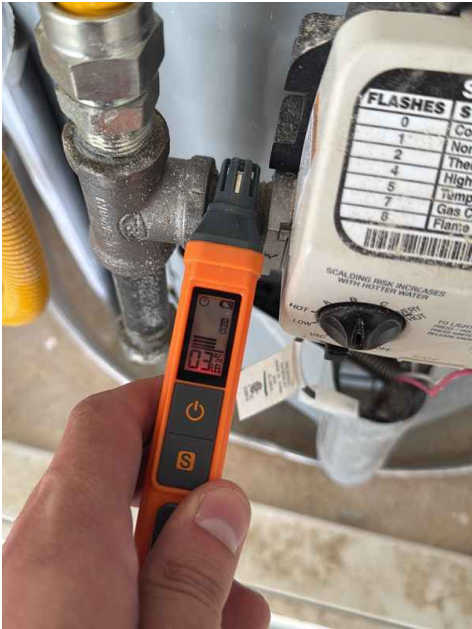
### 5.3.2 C. Water Heating Equipment

There was a gas leak detected. Gas was shut off at the appliance by the inspector for safety.

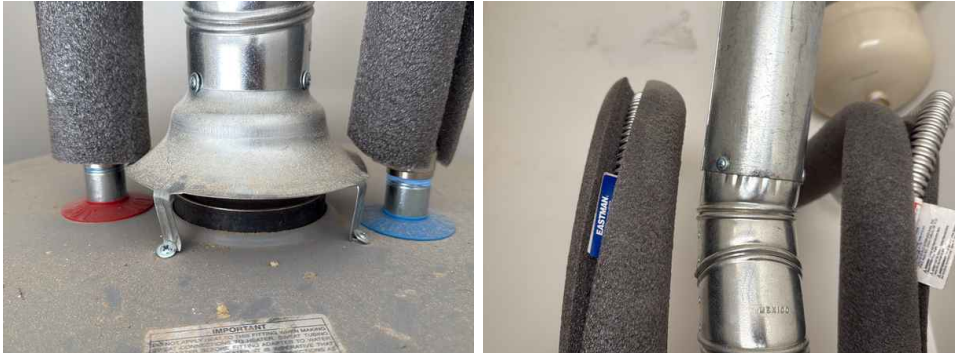
5.3.3 C. Water Heating Equipment

The water heater flue (vent pipe) has inadequate clearance from combustibles materials. Double walled vent pipes should have at least 1-inch of clearance and single walled vent pipes should have at least 6-inches of clearance from combustible material.
