NEW MEXICO RESIDENTIAL REPORT

1234 Main Street
El Paso, TX 79924

Buyer Name
12/20/2025 9:00AM

Inspector
Eric Wiles
TREC 26410
(915) 505-0288
admin@agaveinspections.com

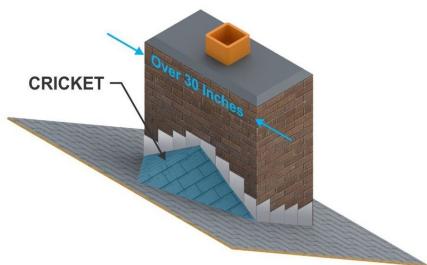
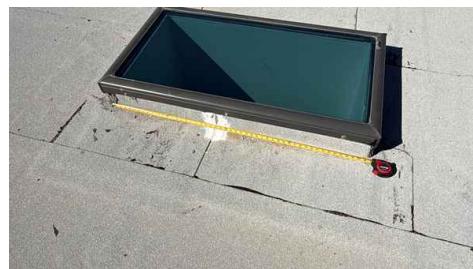
2.3.1 C. Roof Covering Materials**FLASHING - MISSING CRICKET**

There is no cricket / saddle in place behind the roof level penetration. Under current building standards, there should be a cricket or saddle installed behind the ridge side of any penetration greater than 30-inches wide.

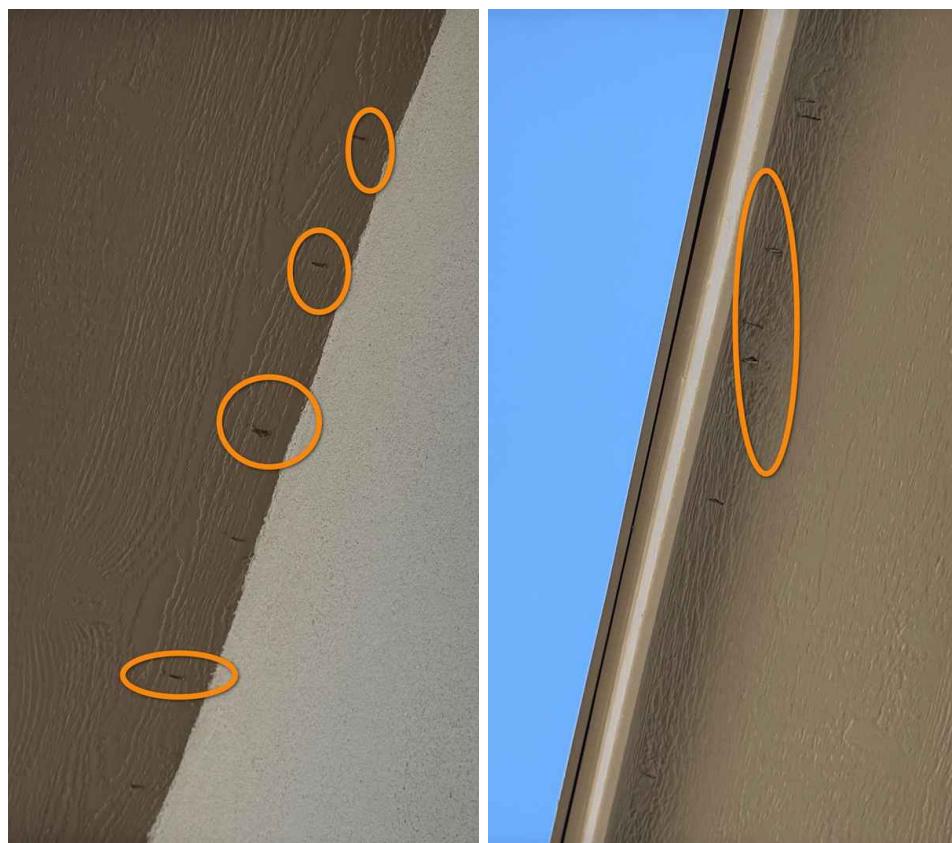
2.4.1 D. Roof Structures, Attics, Ventilation, Insulation

UNDERDRIVEN SOFFIT FASTENERS

Some of the fasteners for the soffit are under or poorly driven.

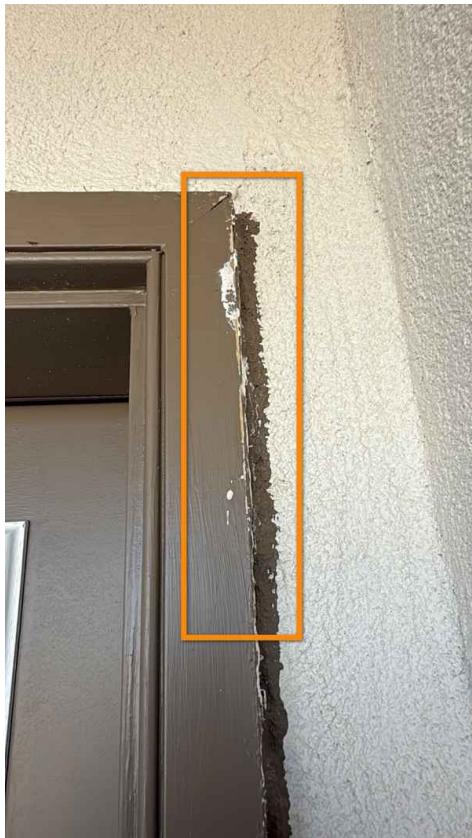
2.5.1 E. Walls (Interior and Exterior), Countertops, Cabinets

WOOD NEEDS PAINT

REAR DOOR TRIM

Exterior wood type surfaces need a fresh coat of paint to protect from exposure.

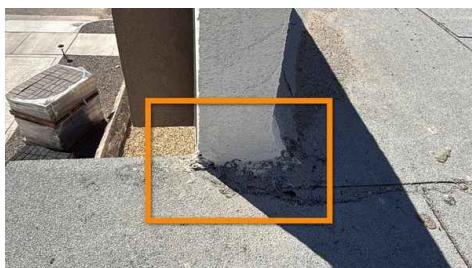
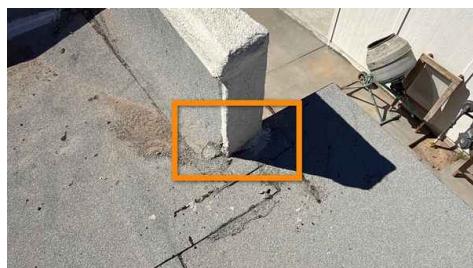
2.5.2 E. Walls (Interior and Exterior), Countertops, Cabinets

STUCCO - IN CONTACT WITH ROOF

The exterior stucco type veneer/cladding has inadequate clearance from the roofing material and/or roof structure. Most manufacturers require a minimum of 2-inches of clearance above the roof line. Due to this condition the presence and/or condition of flashing cannot be confirmed.

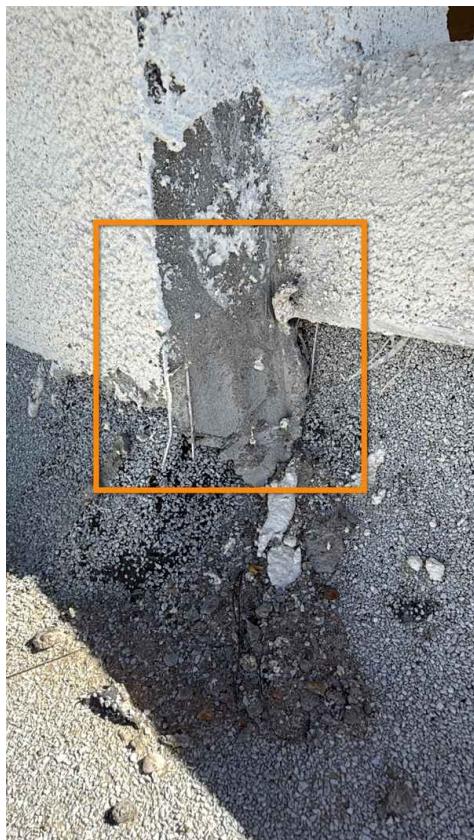
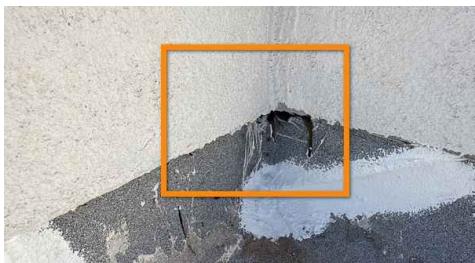
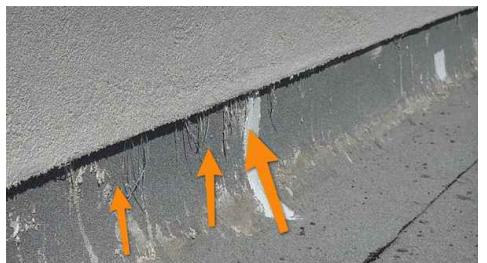
2.5.3 E. Walls (Interior and Exterior), Countertops, Cabinets

STUCCO - EXPOSED MESH

ROOF LEVEL

Exposed mesh was observed at the stucco finish. Repairs are recommended for cosmetic purposes.

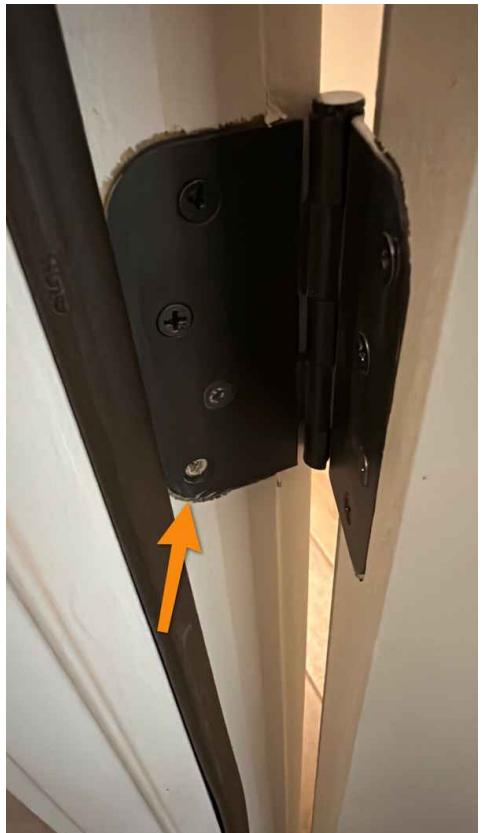
2.7.1 G. Doors (Interior and Exterior)

DOOR - HARDWARE MISSING

GARAGE ENTRY

The door hardware is missing.

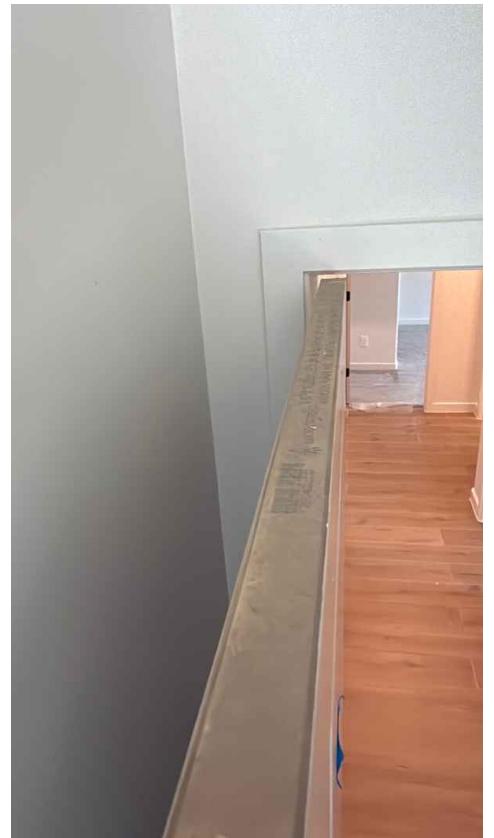
2.7.2 G. Doors (Interior and Exterior)

DOOR - LACKS PAINT ON ALL SIDES

VARIOUS DOORS

Doors are not painted on all sides. This is usually a manufacturer warranty requirement.

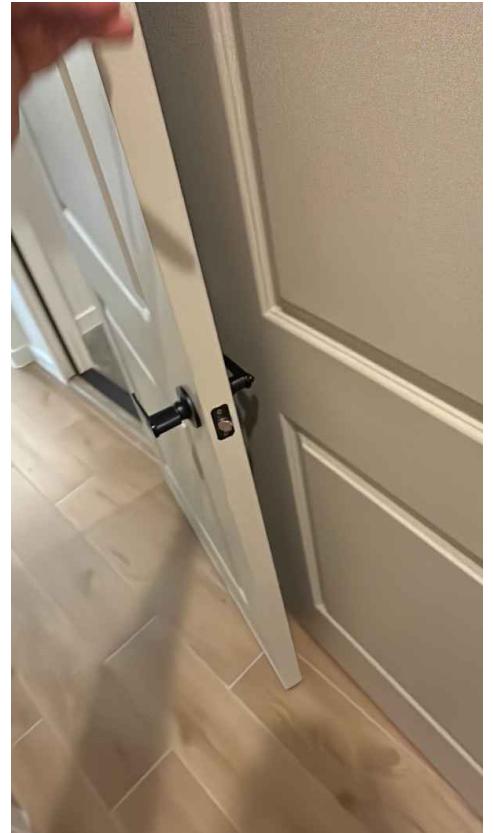
2.7.3 G. Doors (Interior and Exterior)

DOOR - MISSING STOPS

GARAGE ENTRY

One or more doors is missing a door stop mechanism.

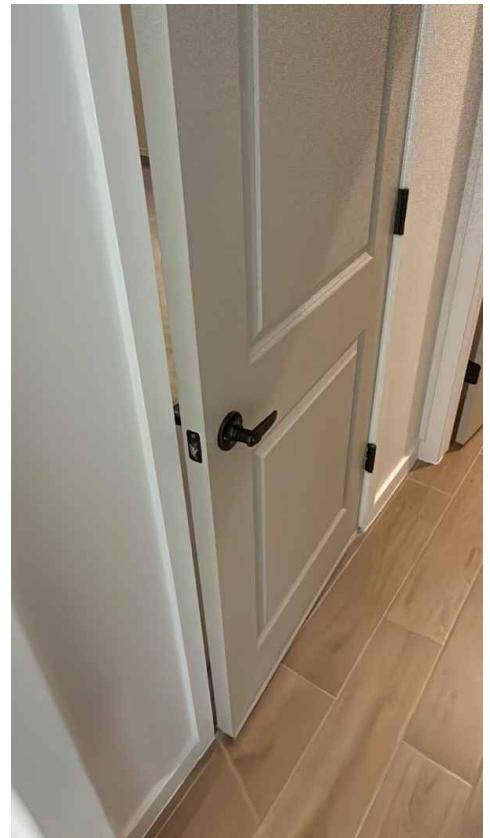
2.7.4 G. Doors (Interior and Exterior)

GARAGE ENTRY - SELF CLOSING NOT FUNCTIONAL

The garage entry door self closing hinges are not functioning properly.

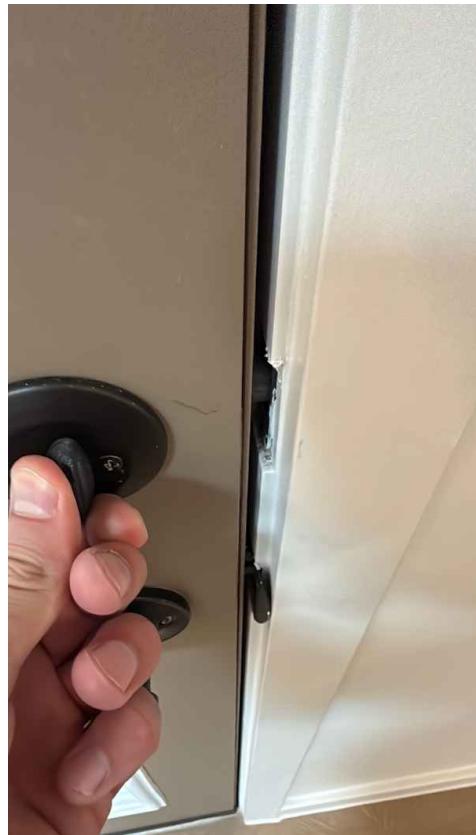
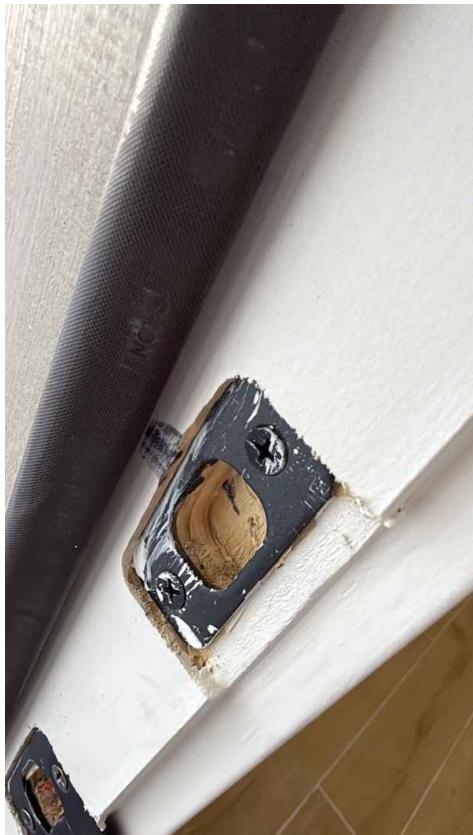
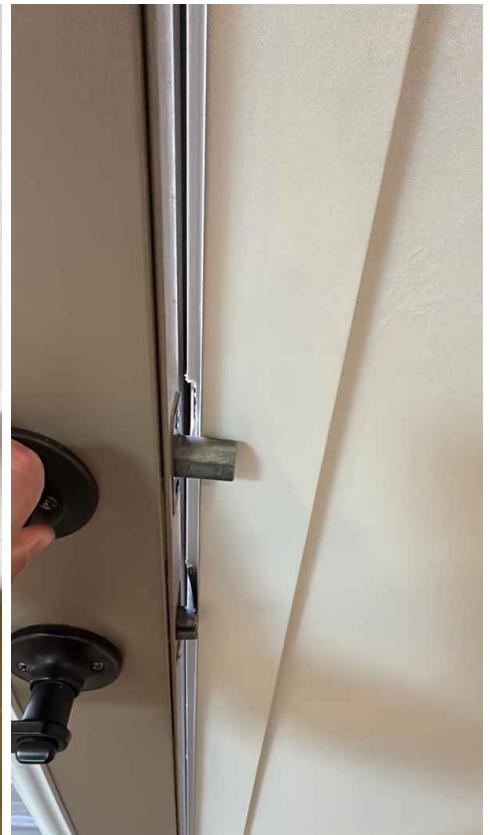
2.7.5 G. Doors (Interior and Exterior)

LOCK DOES NOT FULLY ENGAGE

REAR DOOR

The deadbolt does not appear to fully engage when locked.

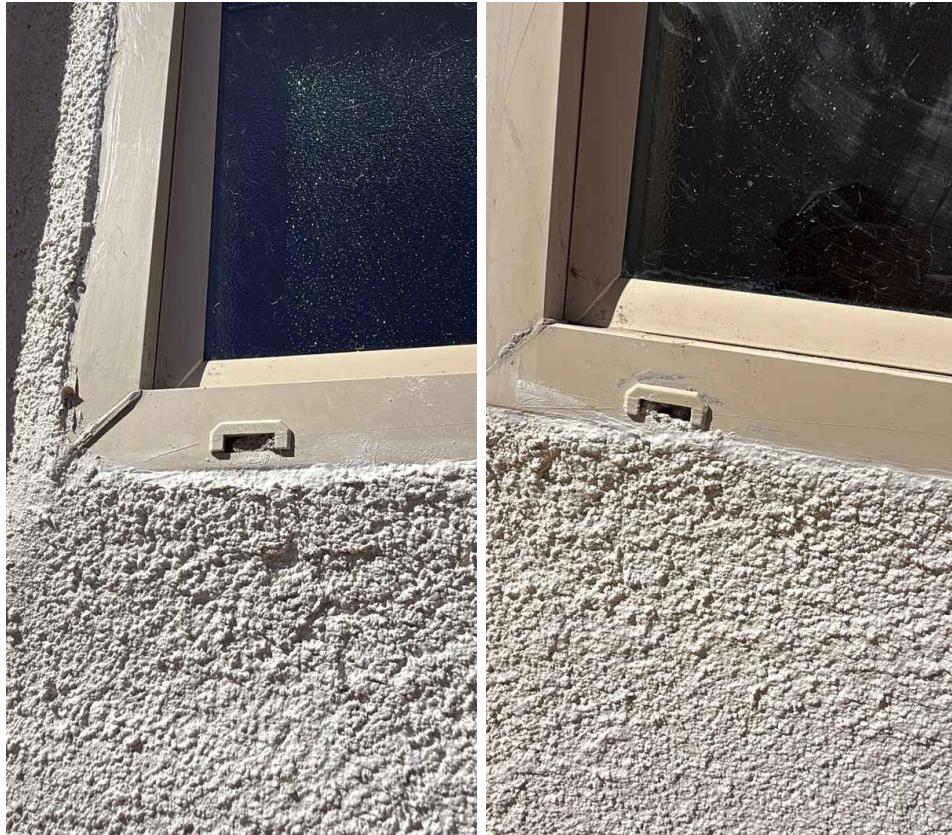
2.8.1 H. Windows

WEEP HOLES BLOCKED

PRIMARY BATH

Weep holes noted to be blocked in one or more windows.

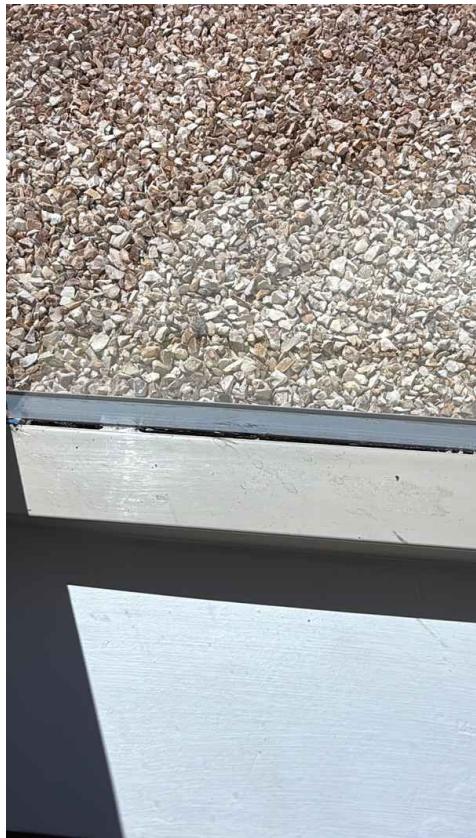
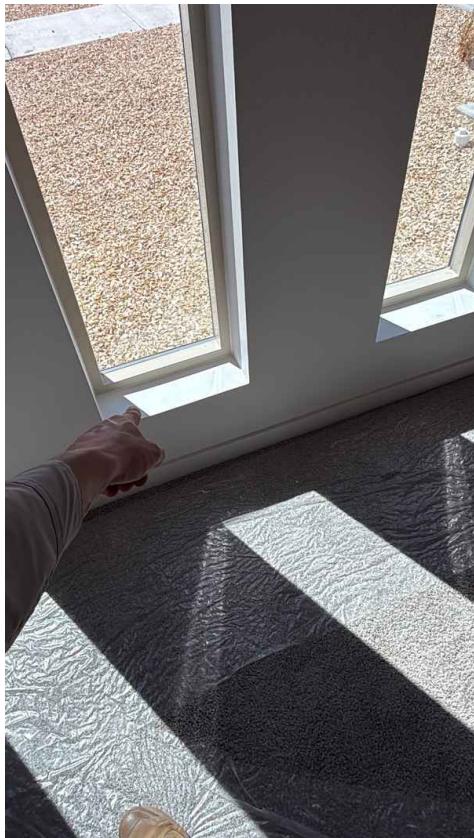
2.8.2 H. Windows

INTERIOR SEALANT

FRONT BEDROOM

One or more windows lacked sealant.

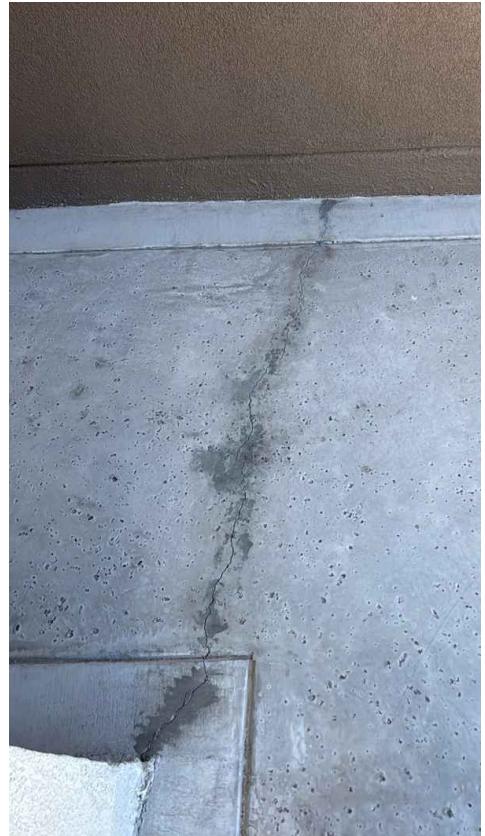
2.11.1 K. Porches, Balconies, Decks, and Carports

PATIO CRACKS

Minor cracks and/or deficiencies were observed in the patio.

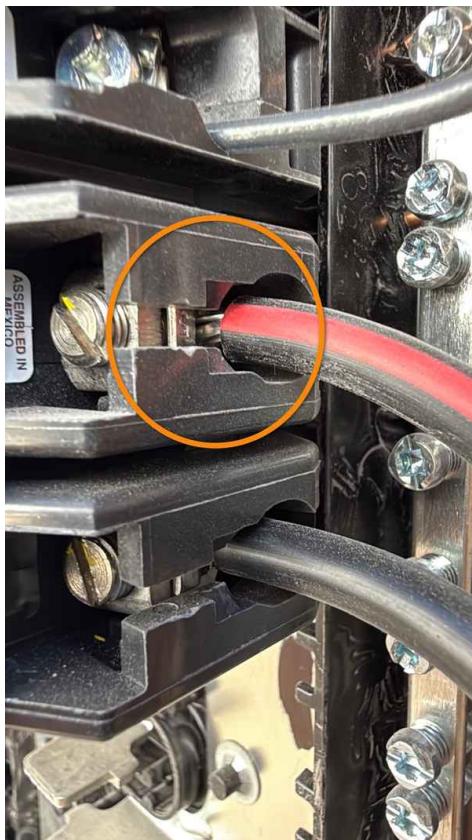
3.1.1 A. Service Entrance and Panels**NO ANTI-OXIDANT PASTE**

There was no anti-oxidant gel observed on the exposed aluminum conductor terminations.

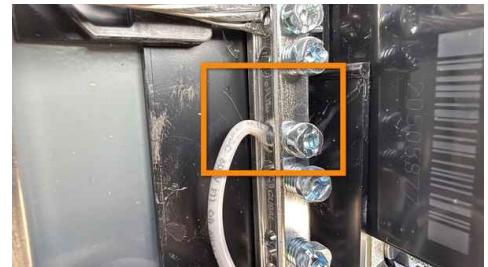
3.1.2 A. Service Entrance and Panels

INSULATION UNDER TERMINAL

A conductor is improperly terminated at the bus bar as the insulation is under the terminal screw. Requires correction.

Recommendation

Contact a qualified professional.

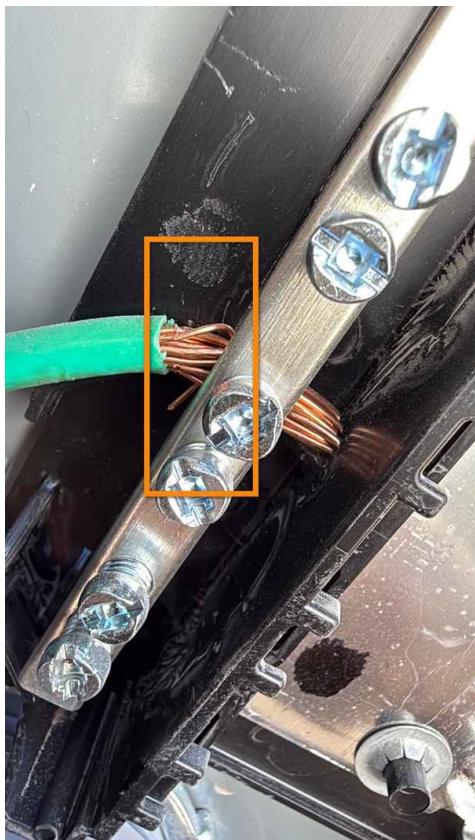
3.1.3 A. Service Entrance and Panels

CONDUCTOR NOT PROPERLY TERMINATED

Conductor does not have all strands under wire as required.

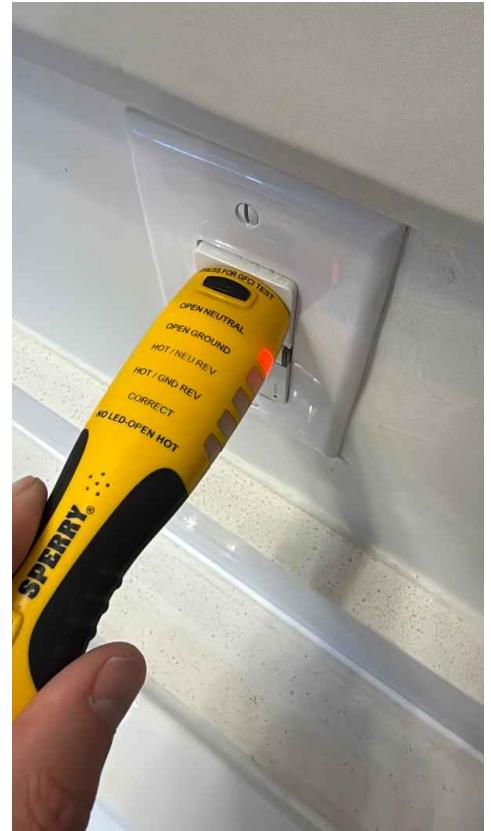
3.2.1 B. Branch Circuits, Connected Devices, and Fixtures

OPEN NEUTRAL

SECONDARY BATHROOM

One or more of the receptacles were observed to have an open neutral connection.

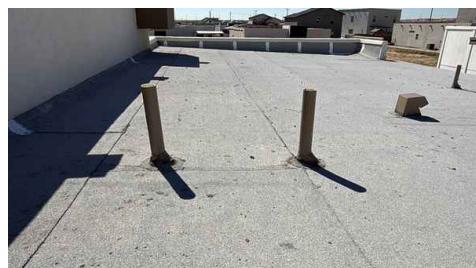
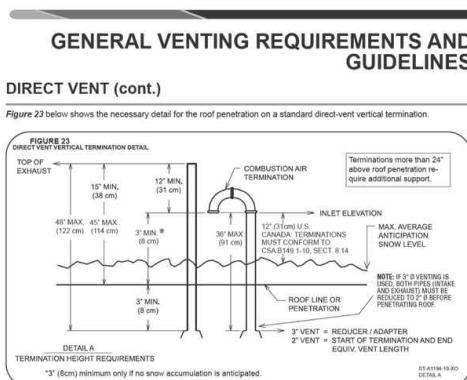
VENT IMPROPER TERMINATION

Exhaust and intake vent installation and clearances do not appear to conform with manufacturer requirements and should be corrected.

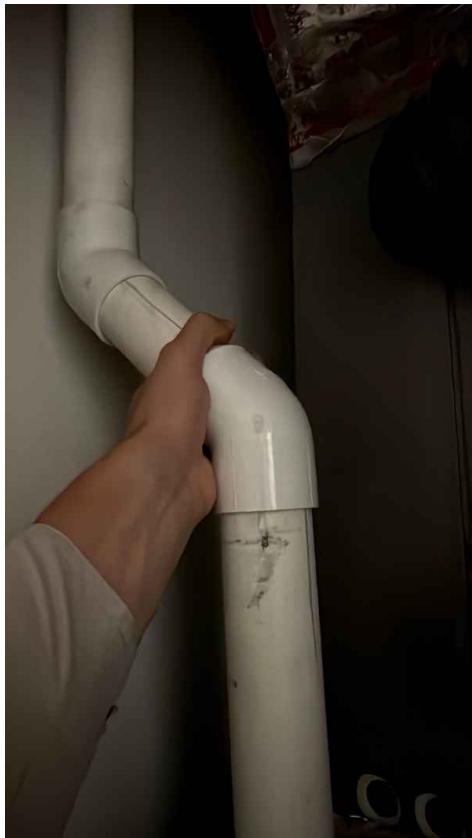
4.1.2 A. Heating Equipment

VENT NOT SECURE

Vent is not secured or glued and should be corrected in accordance with manufacturer requirements.

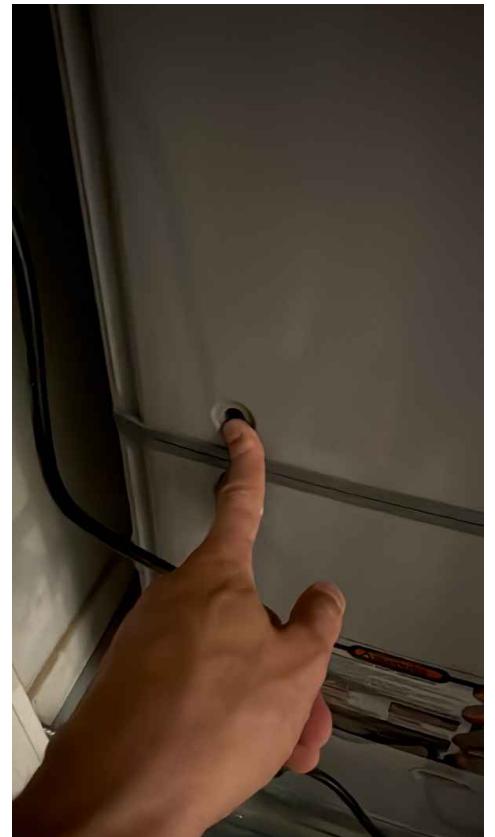
4.1.3 A. Heating Equipment

MISSING PANEL LATCH

Panel is missing the screw or device to properly secure it.

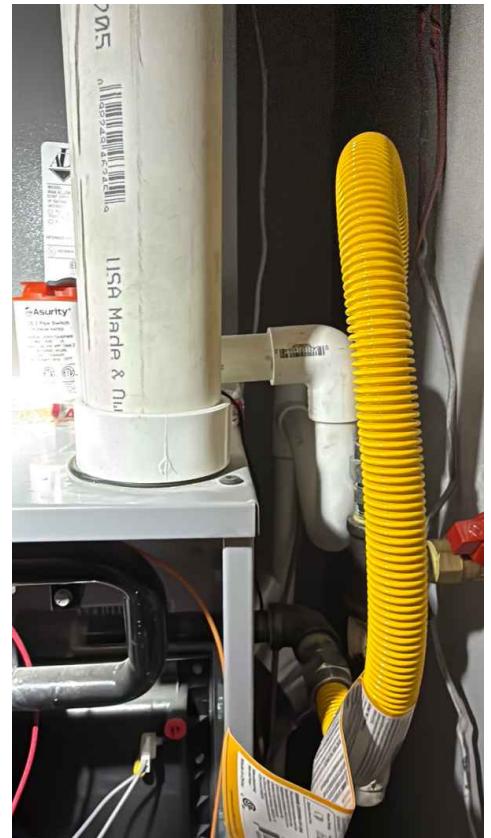
4.2.1 B. Cooling Equipment

CONDENSATE DRAIN IMPROPER SLOPE

The slope of the condensate drain line appears to be insufficient. Under current mechanical standards, the condensate drain line should have a minimum slope of 1/8-inch per foot.

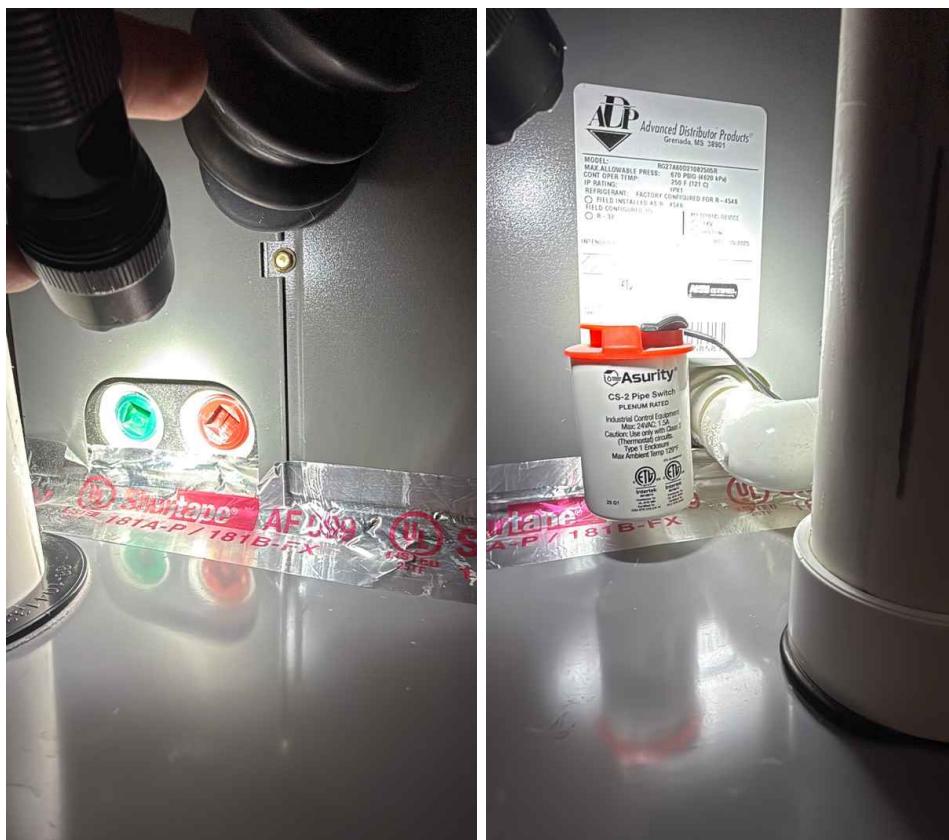
4.2.2 B. Cooling Equipment

AIR LEAKAGE

A large amount of air is leaking from the area of condensate connections and should be sealed.

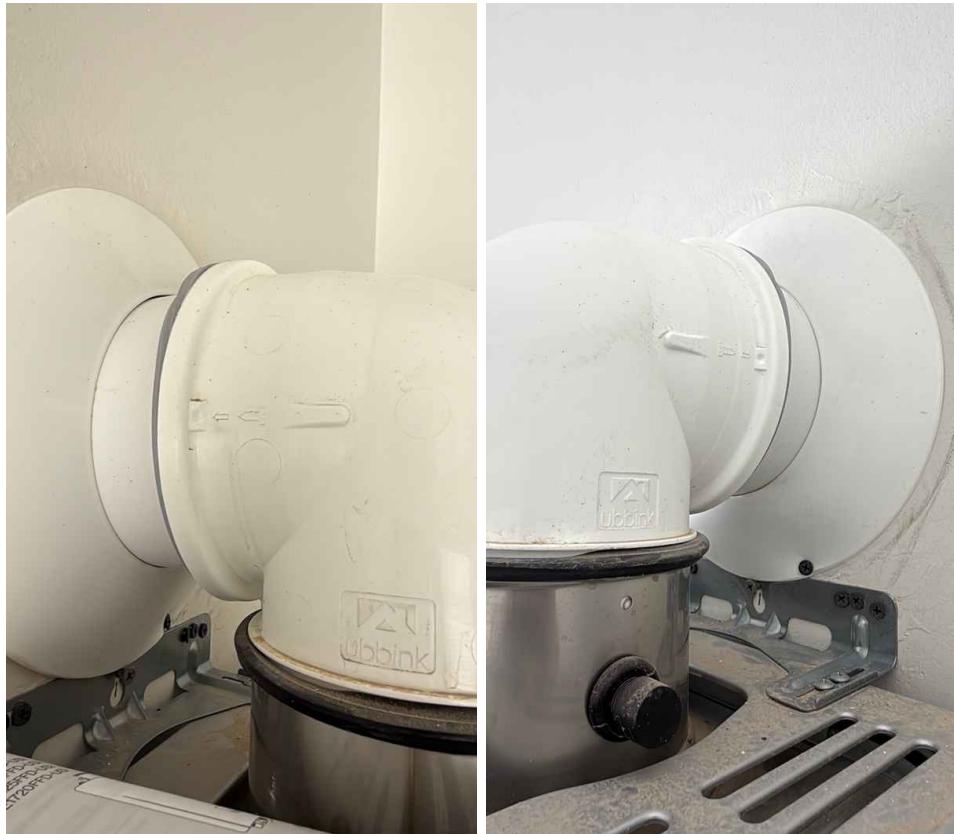
VENT MISSING SECURING SCREWS

The water heater vent is missing the required securing screws.

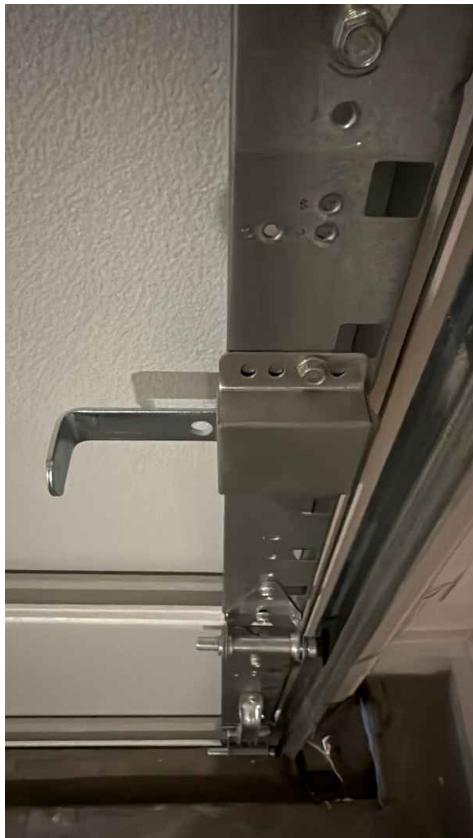
6.7.1 G. Garage Door Operators

MANUAL LOCK PRESENT

When an automatic garage door opener is in use, the manual lock should be disabled or removed.
