TEXAS RESIDENTIAL INSPECTION

1234 Main Street
El Paso TX 79924

01/24/2026 9:00AM

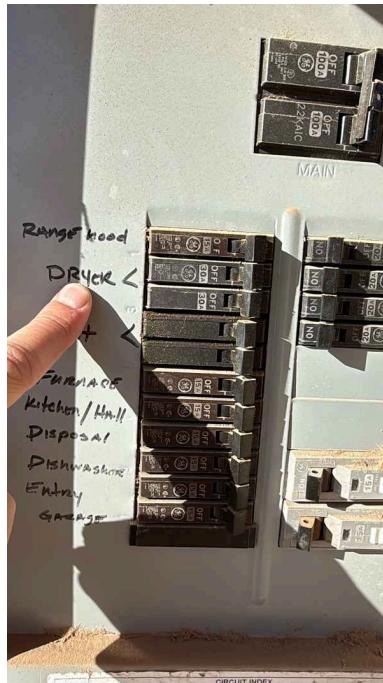
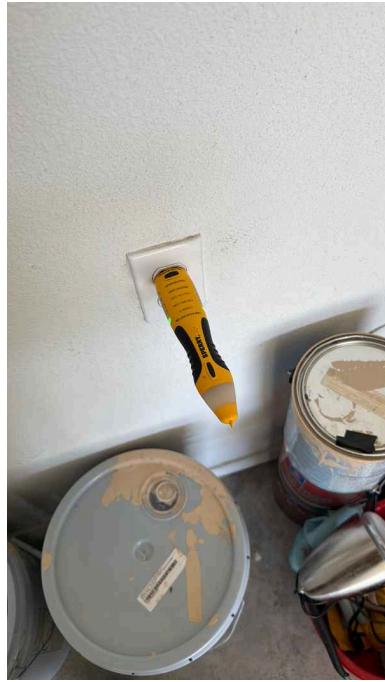
2: Missing Tamper Resistant Outlets

There are no tamper resistant receptacles installed at the time of inspection. Under current building standards, all receptacles that are less than five and a half feet above the floor should be tamper resistant. This is an "as built" condition, but per TREC standards of practice, we are required to report this condition as deficient. Tamper Resistant outlets are required per the 2008 National Electric Code. You may consider corrective measures for improved safety.

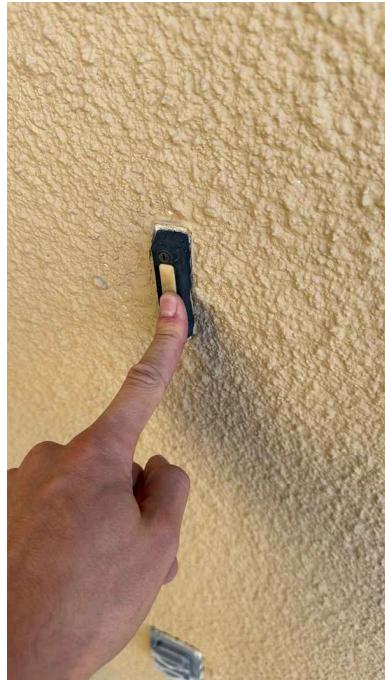
6: Doorbell - Not Functional

The doorbell chime does not appear to be functioning properly.

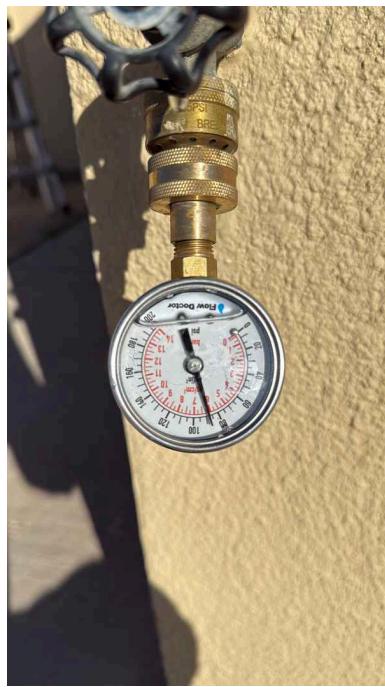
Static Water Pressure Reading: Over 80 psi

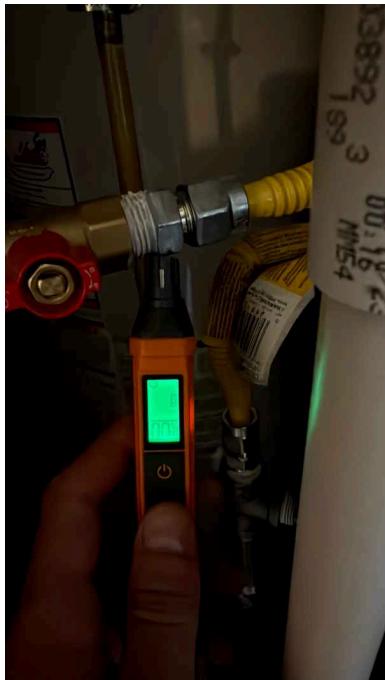
**1: No Sediment Trap**

Water Heater

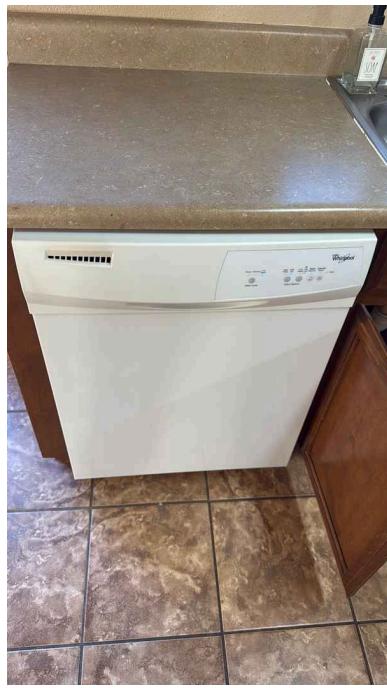
1: Improper Drainage

The dishwasher did not drain properly when operated. This condition should be further evaluated and corrected as necessary.

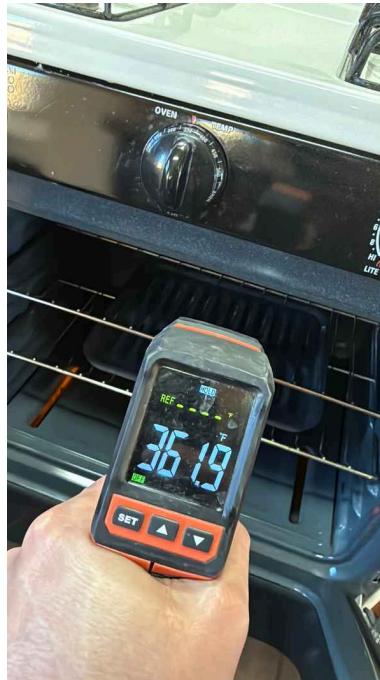
**1: Light Inoperative**

The oven light is inoperative.
